CONVERSION SERVICE BULLETIN - ENGINE – CONVERSION OF V2500 D528AQ04 TO  
D528AQ03 MODEL

V2528-D5

# V2500-ENG-72-CN-01

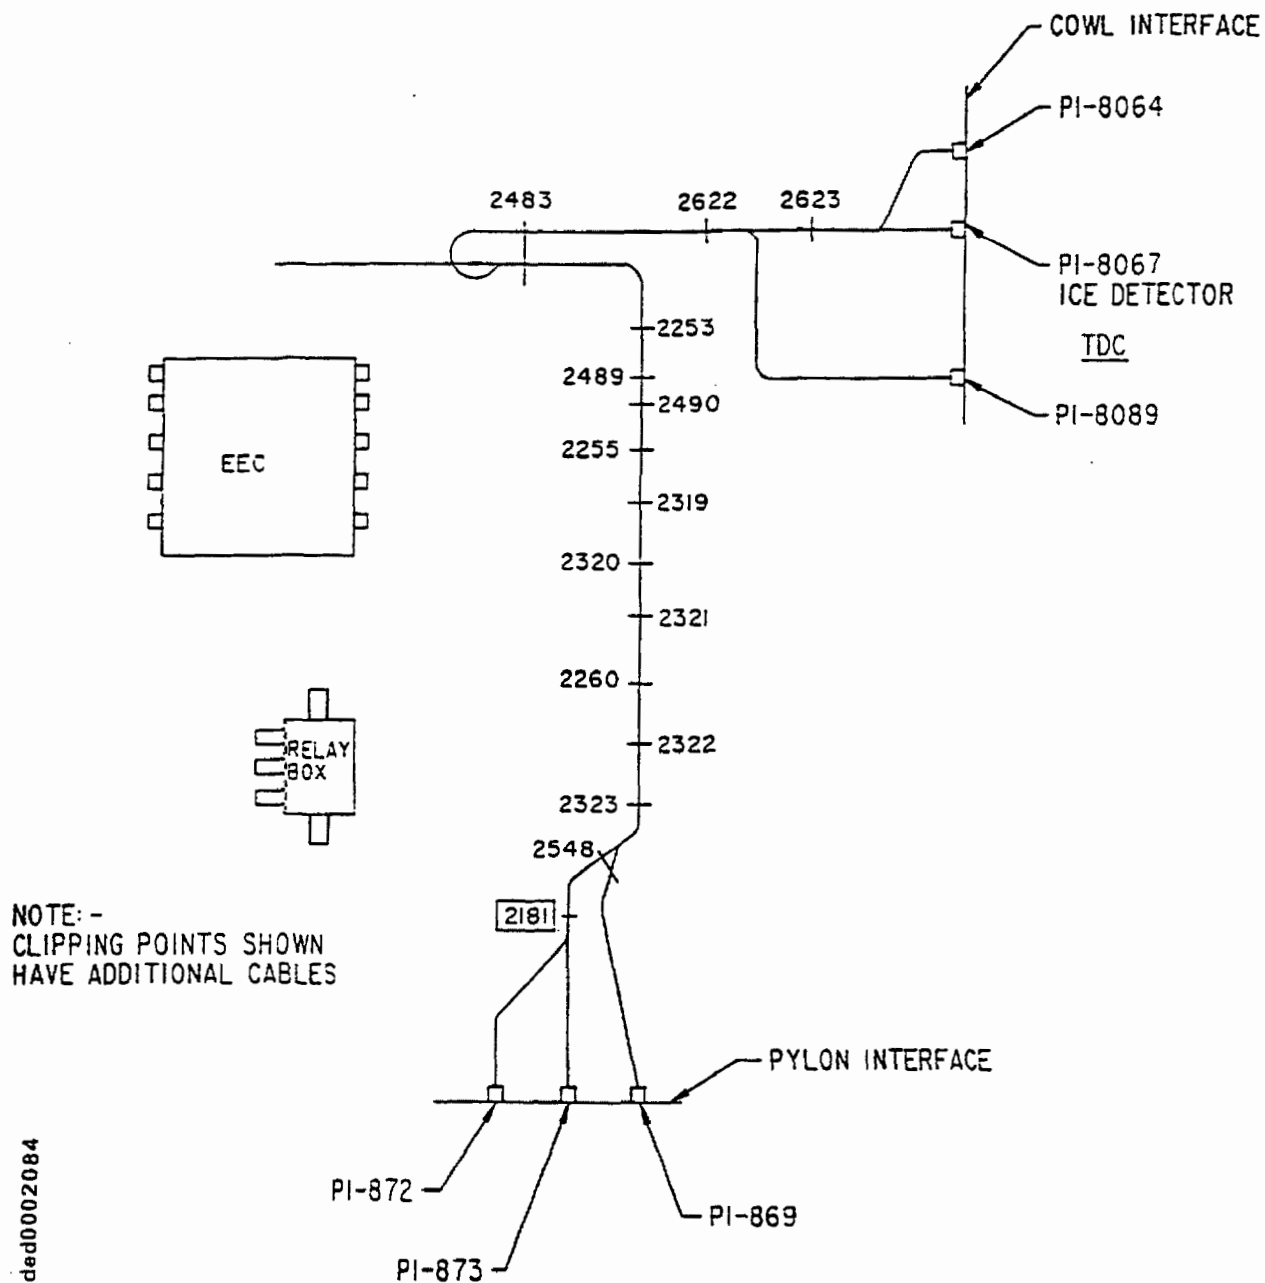
Schematic view of part of harness Loom D - Left hand installation  
Figure 1

Loom D (part number 6A6541) must be modified to remove the redundant parts. This is accomplished by removing those parts introduced by Service Bulletin 71-0187. The modified harness is re-identified as part number 6A5821. It will also be necessary to modify the affected clipping points. Figures 1 and 2 are schematics of the portion of harness to be modified.

- (1) Locate plug PI-8067 (close to top dead centre at the cowl interface).
- (2) Plug PI-8067 and all cables that run to it are to be removed, as described below.

- (3) At all positions where the cables are tied to the parent harness:
  - i. Remove the cable tie. Take care not to damage the cables.
  - ii. Separate the cables that are being removed from the parent harness.

- iii. Tie the remaining harness bundle (refer to SPP TASK 70-43-02-400-501, SUBTASK 70-43-02-400-015).
- (4) At all positions where the cables are clipped:

- i. Remove the P-clip.
  - ii. Refer to Section 2. Material Information of this Service Bulletin for details of changes (if any) to the bolt and P-clip at this clip point. If necessary, replace the bolt and/ or P-clip.

- iii. Re-assemble the clip point with the remaining harness bundle (refer to SPP TASK 70-43-02-400-501, SUBTASK 70-43-02-400-004).
- (5) The cables being removed terminate at the pylon interface connectors PI-869 and PI-873. It is necessary to remove the relevant cables and pins from these connectors, and insert blanks. Two (2) cables terminate at connector PI-869. Four (4) cables terminate at connector PI-873.
