SERVICE BULLETIN

ENGINE - FUEL AND CONTROL - ENGINE - AIR SYSTEM - INCORPORATE A CHAMFER ON THE P4.9 PRESSURE CONTROL MANIFOLD ADAPTOR - CATEGORY CODE 3 - MOD.ENG-73-0001

V2500-ENG-73-0001

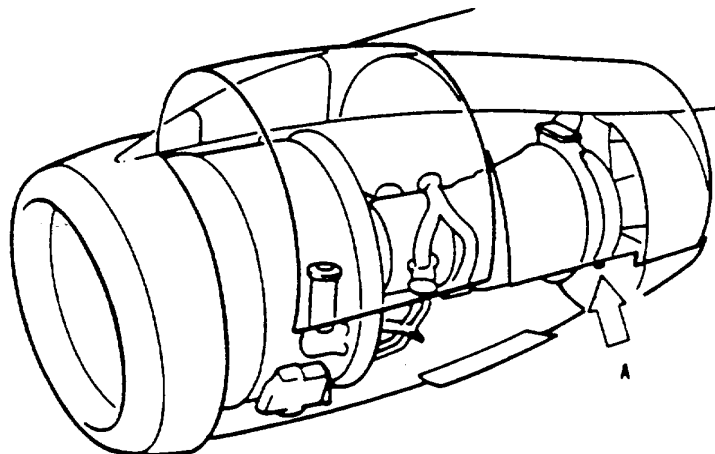
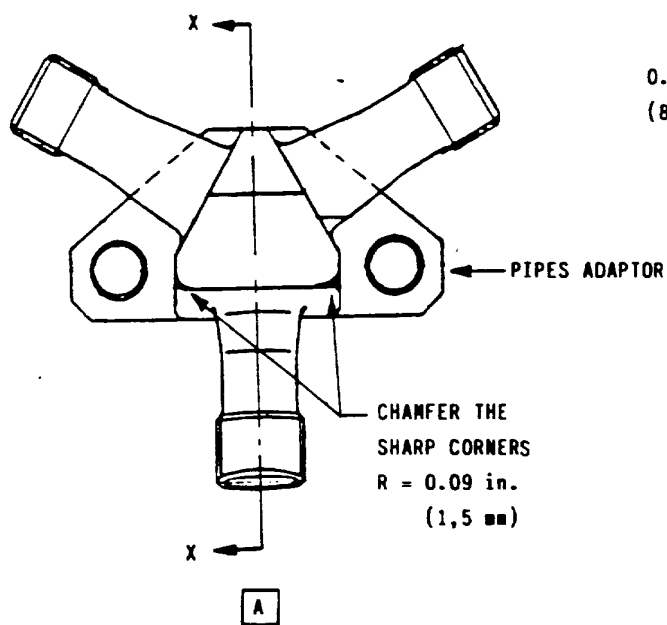
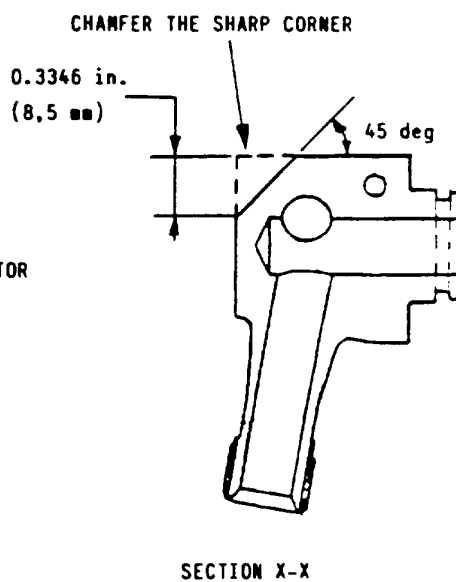
Pipes adaptor
Fig.1

The EGT wiring harness must be routed inboard as it exits the junction box, in order not to foul the C-duct rear of the bifurcations bumpers. This has caused a potential interference between the bifurcation dumpers and the P4.9 pressure control manifold adaptor.

The sharp corners of the fitting are chamfered to avoid an interference with the C-duct rear of the bifurcation bumpers.

Procedure	Supplementary Information	
(a) Chamfer the sharp corners of the pipes adaptor. Use of hand tool (file) is permissible	Refer to Figure 1	
(b) Using a vibropeen, remove the old P/N and mark the new P/N	Old P/N	New P/N
	4P8089	4P8105
