ENGINE - FUEL AND CONTROL - FUEL - REPLACE THE FUEL DIVERTER AND RETURN VALVE ATTACHING WASHER - CATEGORY CODE 4 - MOD.ENG-73-0002

V2500-ENG-73-0002

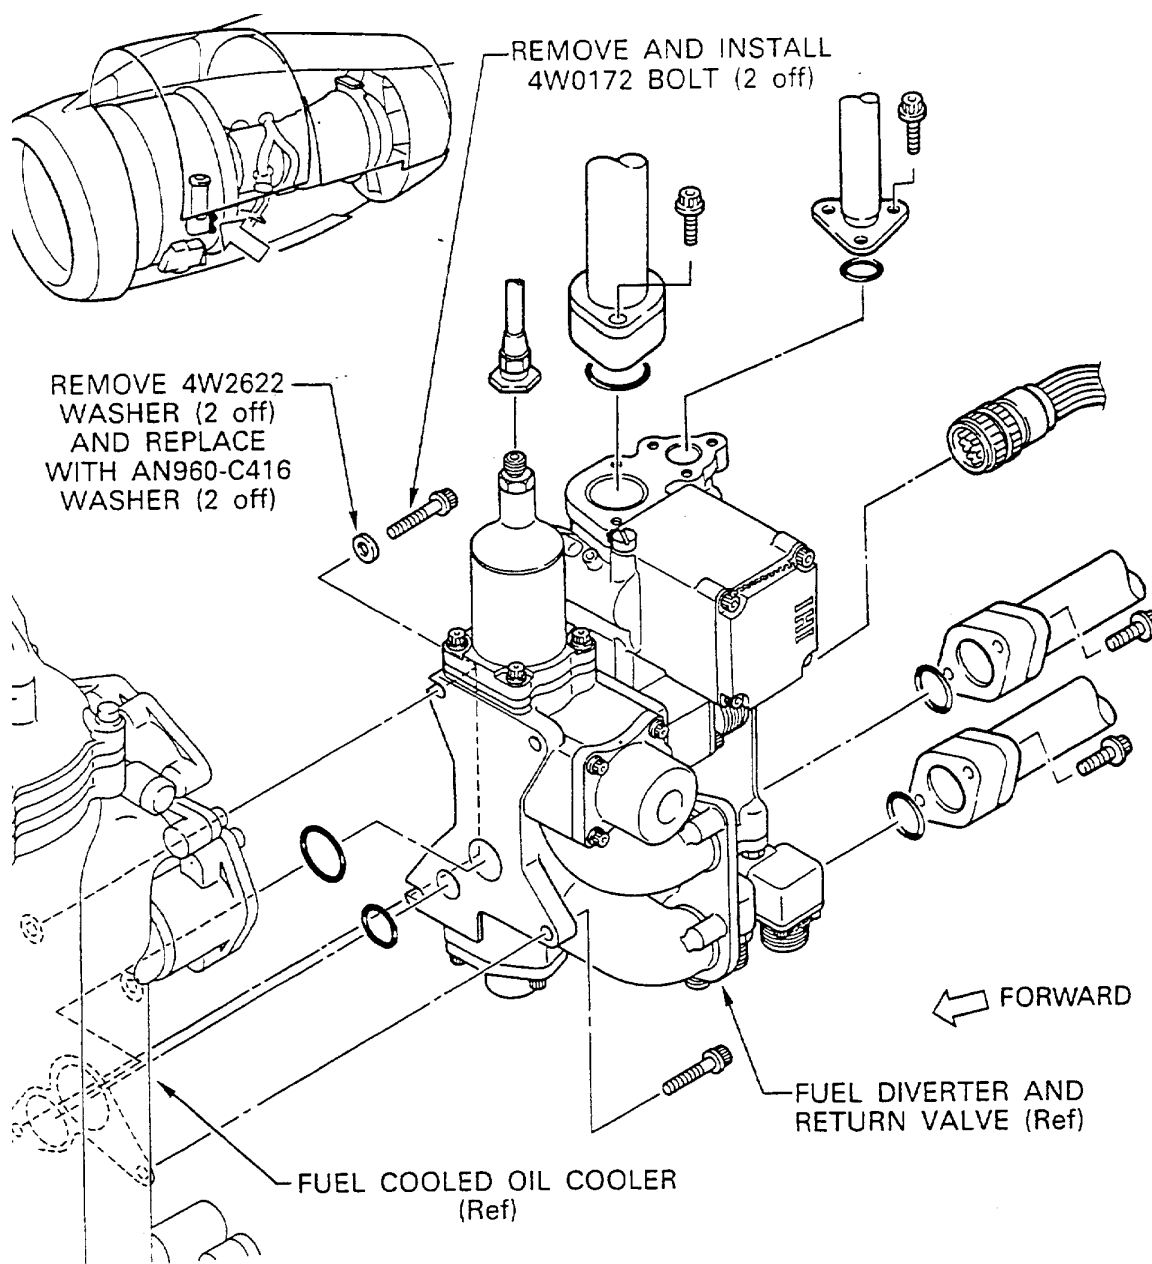
Rework of the fuel diverter and return valve attaching washer  
Fig.1

Insufficient clearance may occur between the Fuel Diverter and Return Valve attaching washers and the Fuel Diverter and return Valve housing.

Analysis has shown that too large outside diameter of the attaching washers could be the cause of this condition.

(a) The washers which attach the Fuel Diverter and return Valve have been changed from PN4W2622 to PN AN960-C416 (See Figure 1).

- (1) Remove two PN4W0172, Bolts and two PN4W2622, Washers from the Fuel Diverter and return Valve and Fuel Cooled Oil Cooler (FCOC) (Refer to Figure 1 and the Aircraft Maintenance Manual, 73-13-42, Removal/Installation).
- (2) Install two new PN AN960-C416, Washers and two PN4W0172, Bolts to the Fuel Diverter and return Valve and the FCOC (refer to Figure 1 and the Aircraft Maintenance Manual, 73-13-42, removal/Installation).
- (3) Torque the two bolts to 85-95 lbfin (9,60-10,73 Nm) (Refer to Aircraft Maintenance manual, 70-23-11, Torque Tightening technique).
