ENGINE - FUEL AND CONTROL - FUEL SYSTEM AIR TUBES, P12.5 TUBE SUPPORT BRACKET, WIRE LOCKING PROVISION - CATEGORY CODE 6 - MOD.ENG-73-0003

V2500-ENG-73-0003

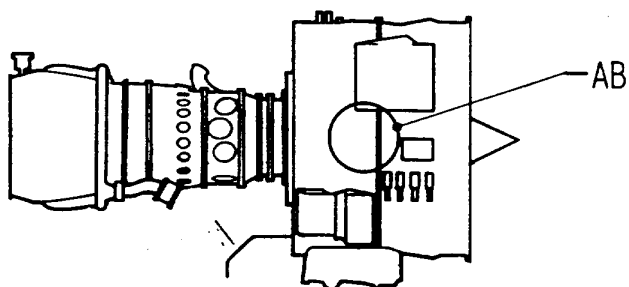
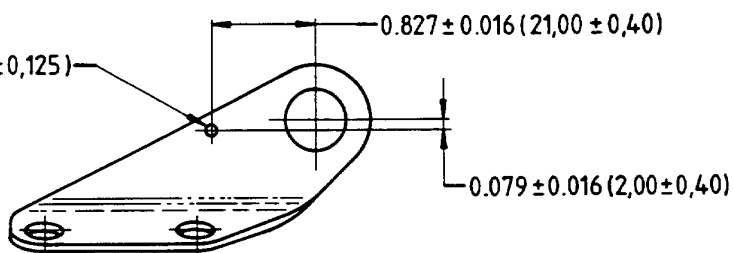
Modification of diagnostic tube support bracket
Fig.1

Potential unsatisfactory wire locking of the diagnostic system P12.5 flexible hose union and adjacent rigid tube retention nut.

The retention nut is not independently wire locked and engineering evaluation has shown the possibility of both the rigid tube retention nut and flexible hose union becoming loose.

Procedure	Supplementary Information	
(a) Mark position of the hole and centre punch the hole centre	Refer to Figure 1.	
(b) Drill the hole in the bracket	Refer to Figure 1. Clamp the bracket in the vice on a pillar drill and use 0.063in. dia (1,6 mm) drill.	
(c) Remove the burrs from around the hole		
(d) Crack test the bracket	Refer to SPM, TASK 70-23-01-230-501	
(e) Re-identify with new part number - vibro-engrave adjacent to existing part number	New Part No.	Old Part No.
	UP11228	UP11034
