ENGINE - FUEL AND CONTROL - PROVIDE NEW PRESSURE CONTROL MANIFOLDS WITH IMPROVED  
CLIPPING - CATEGORY CODE 6 - MOD.ENG-73-0004

V2500-ENG-73-0004

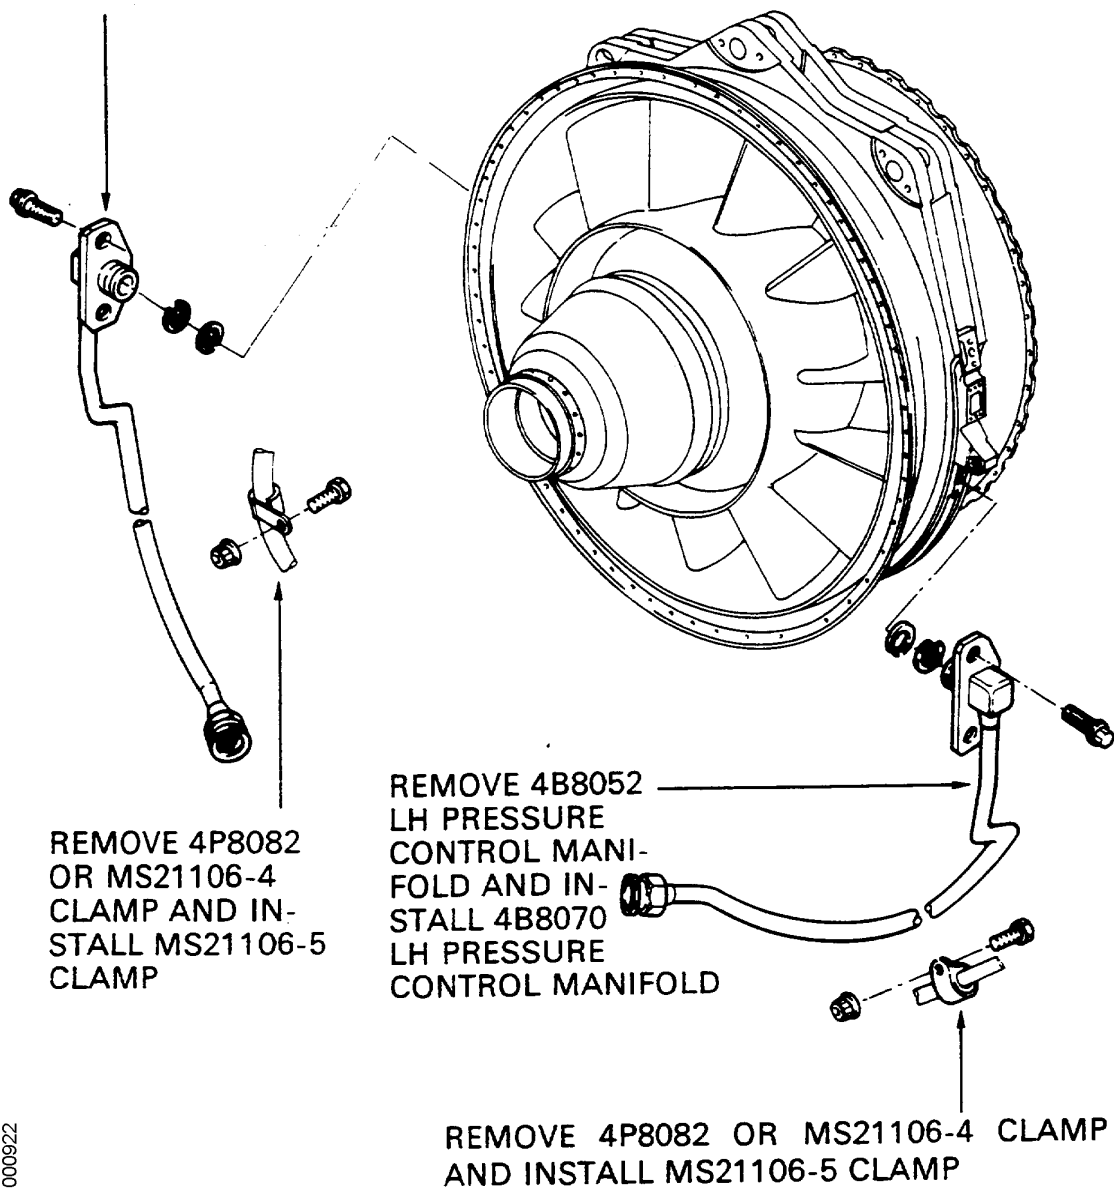
Location of Pressure Control Manifolds  
Fig.1

Chafing may occur on both pressure control manifolds at clip position.

When using clamps with stainless steel wire mesh cushions, chafing was found. Brazed wear sleeves added to the tubes at clamping points eliminates the condition.

New pressure control manifold with wear sleeves brazed at the clamping position and new clamps are provided. See Figure 1.

REMOVE 4B8051 RH PRESSURE CONTROL  
MANIFOLD AND INSTALL 4B8069 RH  
PRESSURE CONTROL MANIFOLD
