## SERVICE BULLETIN

ENGINE - FUEL AND CONTROL - ENGINE - PROVIDE AN ADDITIONAL WASHER ON THE HI-LOK PIN OF THE DATA ENTRY PLUG - CATEGORY CODE 6 - MOD.ENG-73-0005

V2500-ENG-73-0005

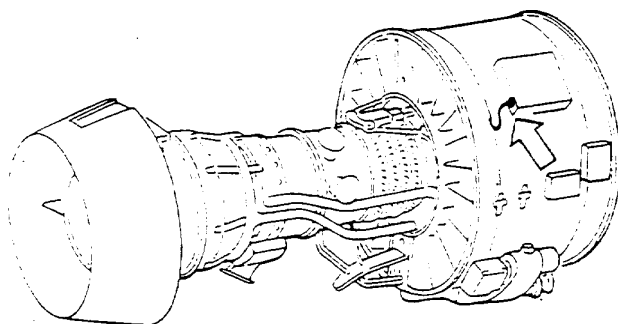
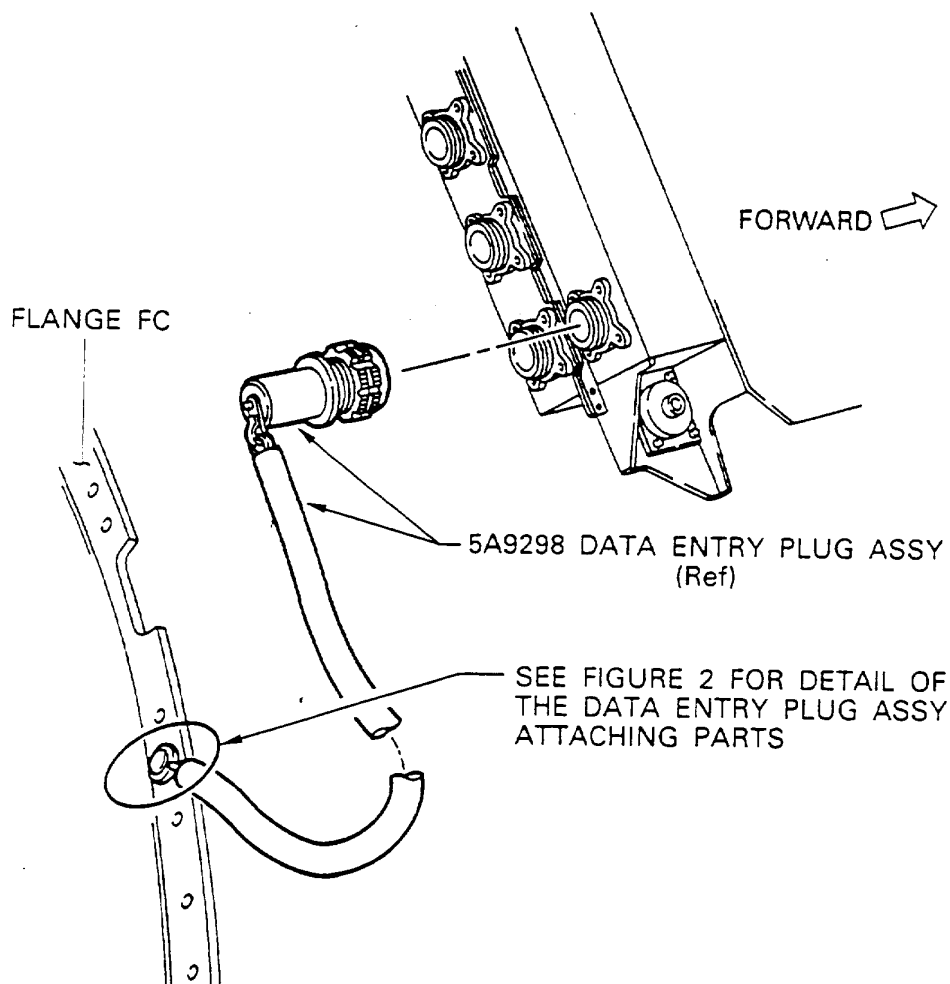
Location of the data entry plug assembly attaching parts  
Fig.1

STARBOARD UPPER REAR

- (1) Find the location of PN5A9298, Data Entry Plug Assy where it is attached to the FC Flange (Refer to Figure 1).
- (2) Remove PN HL94DU8, Hi-Lok collar, PN5A9298, Data Entry Plug Assy and PN HL12V8-4, Hi-Lok pin from the FC Flange (Refer to Figures 2 and 3).
- (3) Discard PN HL94DU8, Hi-Lok collar and PN HL12V8-4, Hi-Lok pin which are removed from the FC Flange.
- (4) Install new PN HL12V8-4, Hi-Lok pin, PN5A9298, Data Entry Plug Assy, new PN4W2622, Washer and new PN HL94DU8 Hi-Lok collar to the FC Flange (Refer to Figure 2).
- (5) Tighten new PN HL94DU8, Hi-Lok collar on new PN HL12V8-4, Hi-Lok pin until the hexagon nut of new PN HL94DU8, Hi-Lok collar is sheared off, and discard the sheared hexagon nut (Refer to Figure 3).

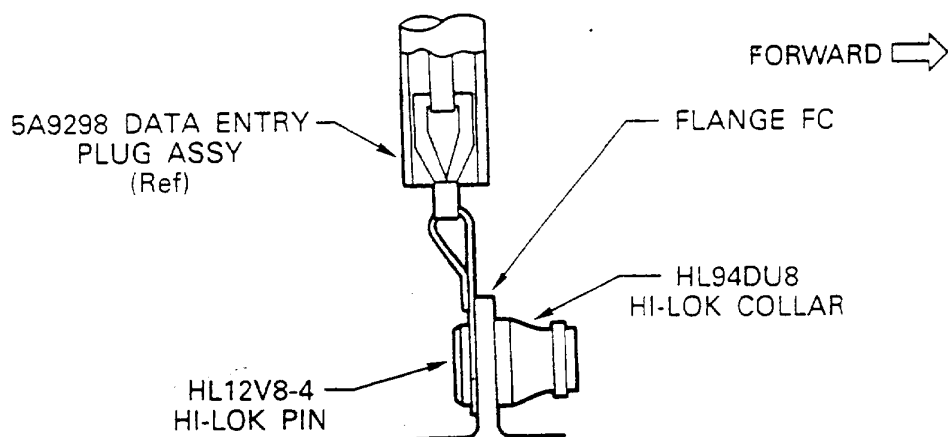
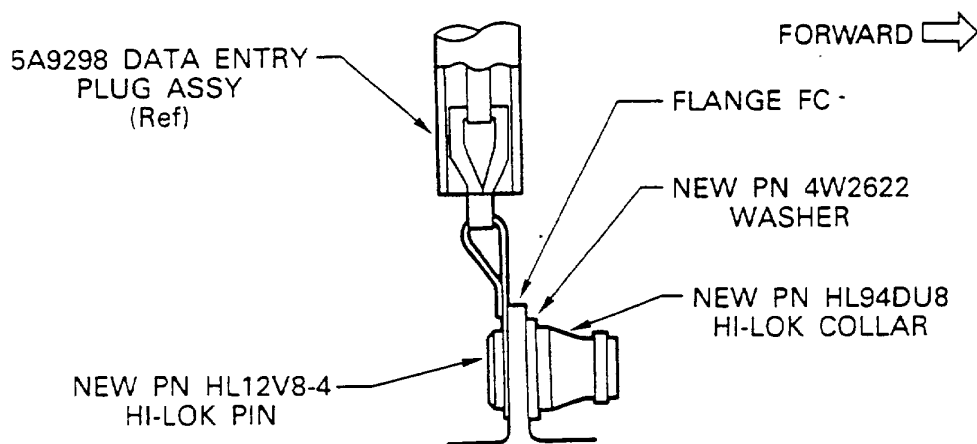
Before and after alteration of the data entry plug assembly attaching parts  
Fig.2

The Hi-Lok pin which attaches the Data Entry Plug Assembly may have an insufficient amount of threads to bottom out the pin and the Hi-Lok collar against the Flange FC.

This could cause an incorrect installation of the Hi-Lok pin and collar.

BEFORE ALTERATION

AFTER ALTERATION

- (a) The washer PN4W2622 is added between the Hi-Lok collar and the Flange FC (See Figures 1 and 2).
