SERVICE BULLETIN

ENGINE - FUEL AND CONTROL - FUEL AND CONTROL - INCORPORATE REVISED EBU HARNESS CLIPPING
REQUIREMENTS AT CP5671 AND CP1097 - CATEGORY CODE 4 - MOD.ENG-73-0006

V2500-ENG-73-0006

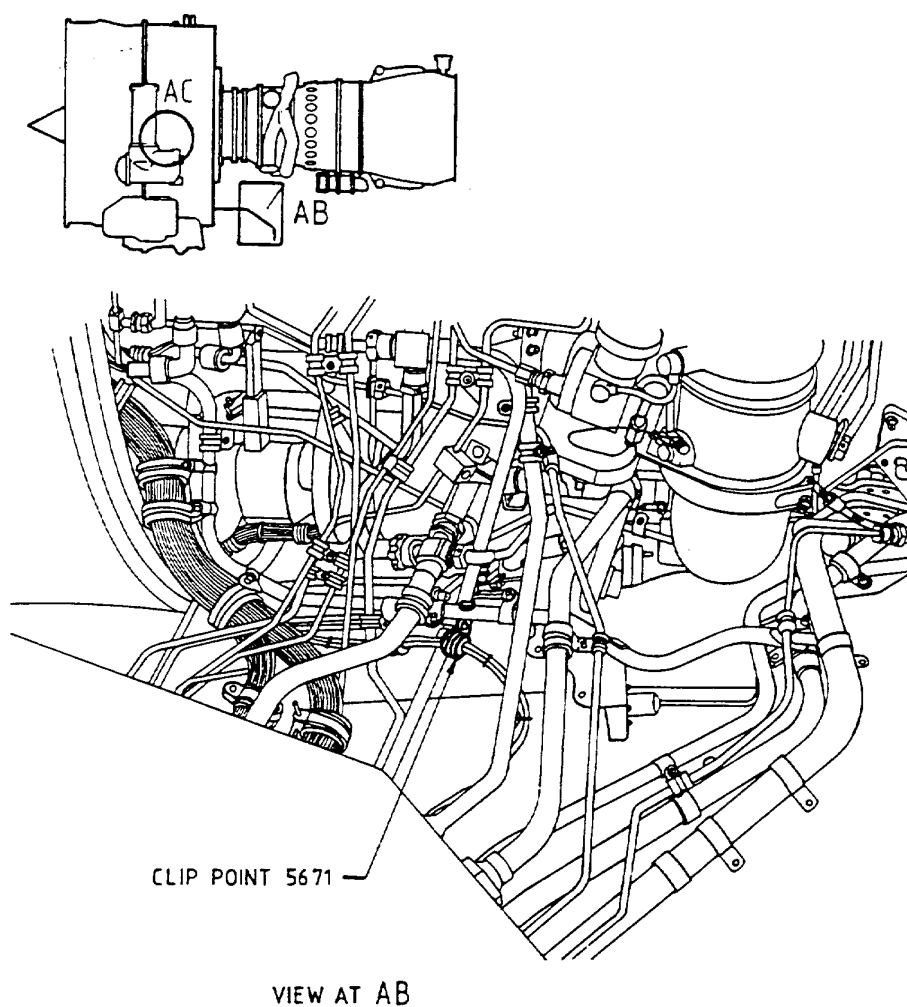
View showing clipping point 5671 - Before alteration
Fig.1

It has been found that the Low Tension (LT) harness may have insufficient clearance with an oil tube in the vicinity of the diverter valve and that the igniter/EBU harness could foul a servo fuel tube between clip points 5654 and 5671.

- (a) The LT harness is supported by a new clipping point, No.1097, and the igniter/EBU harness is moved by the addition of a 10 mm. spacer at clipping point No.5671. The position of the tube clip located at clipping point 5671 is also turned 180 degrees.

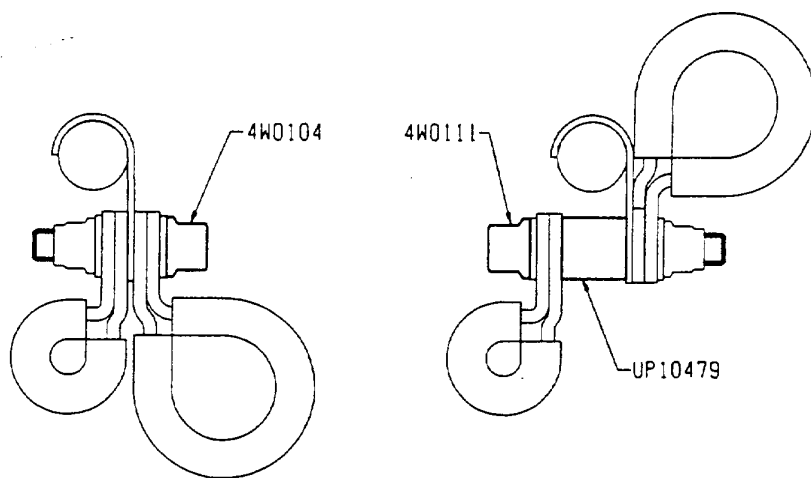
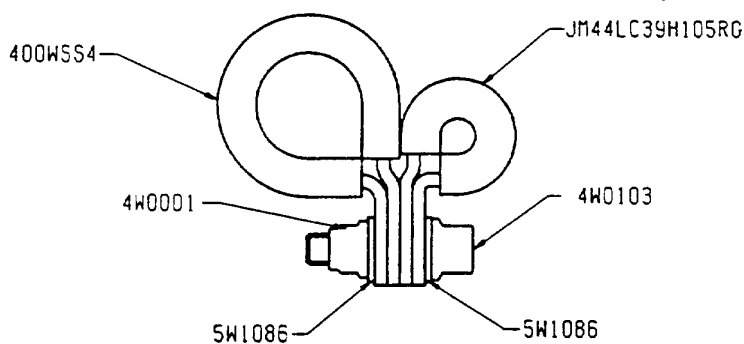
View showing clipping points - Before and after alteration
Fig.3

CLIPPING POINT 5671
BEFORE ALTERATION

CLIPPING POINT 5671
AFTER ALTERATION

CLIPPING POINT 1097
AFTER ALTERATION

- (1) The new clipping arrangements introduced by this Service Bulletin are additional. Assemble parts as shown in fig.3 in accordance with approved procedures, Engine Manual, 72-00-32 and 72-00-40, Installation.

- (A) Additional
- (B) Retain for spares for other applications
- (C) New part currently available for sale
- (S1) New parts coded (S1) are to be installed as a complete set at clipping point No.1097
- (S2) New parts coded (S2) replace old parts coded(S2) as a complete set at clipping point 5671
