SERVICE BULLETIN

ENGINE - FUEL AND CONTROL - INCORPORATE A NEW ELECTRONIC ENGINE CONTROL (EEC)
CONFIGURATION - CATEGORY CODE 4 - MOD.ENG-73-0007

V2500-ENG-73-0007

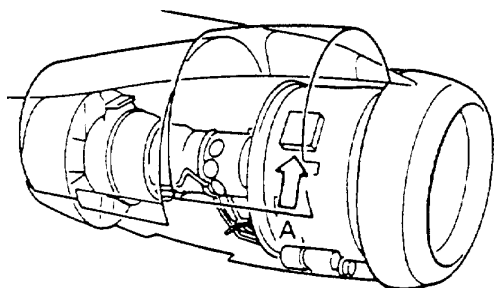
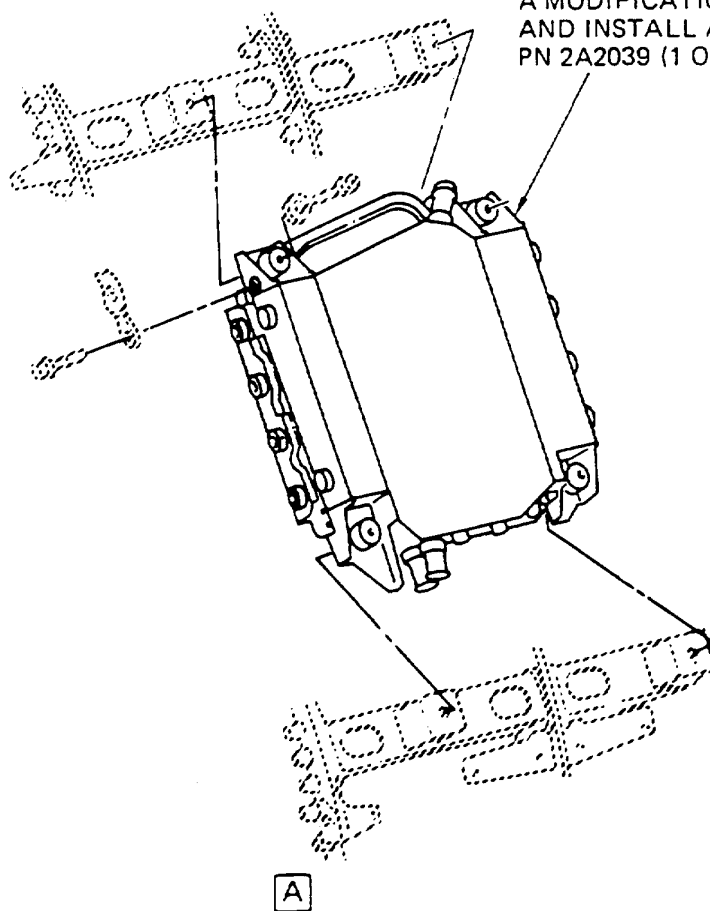
Location of Electronic Engine Control
Fig.1

The present software (SNC10B) does not give the necessary Stator Vane Actuator minimum limit protection.

Intermittent loss of N2 speed caused an engine to stall during engine test, because of vane misscheduling.

- (1) Remove the PN 2A1988 or 2A1989 RElectronic Engine Control by the approved procedure in Reference (2), Chapter/Section 73-22-34, Removal/Installation. Refer to Figure 1.

REMOVE PN 2A1988 OR
PN 2A1989 ELECTRONIC
ENGINE CONTROL, DO
A MODIFICATION, IDENTIFY
AND INSTALL AS
PN 2A2039 (1 Off)
