SERVICE BULLETIN

ENGINE - FUEL AND CONTROL - FUEL AND CONTROL - INTRODUCE A REVISED ELECTRICAL CONNECTOR
COOLING SHIELD BRACKET - CATEGORY CODE 4 - MOD.ENG-73-0008

V2500-ENG-73-0008

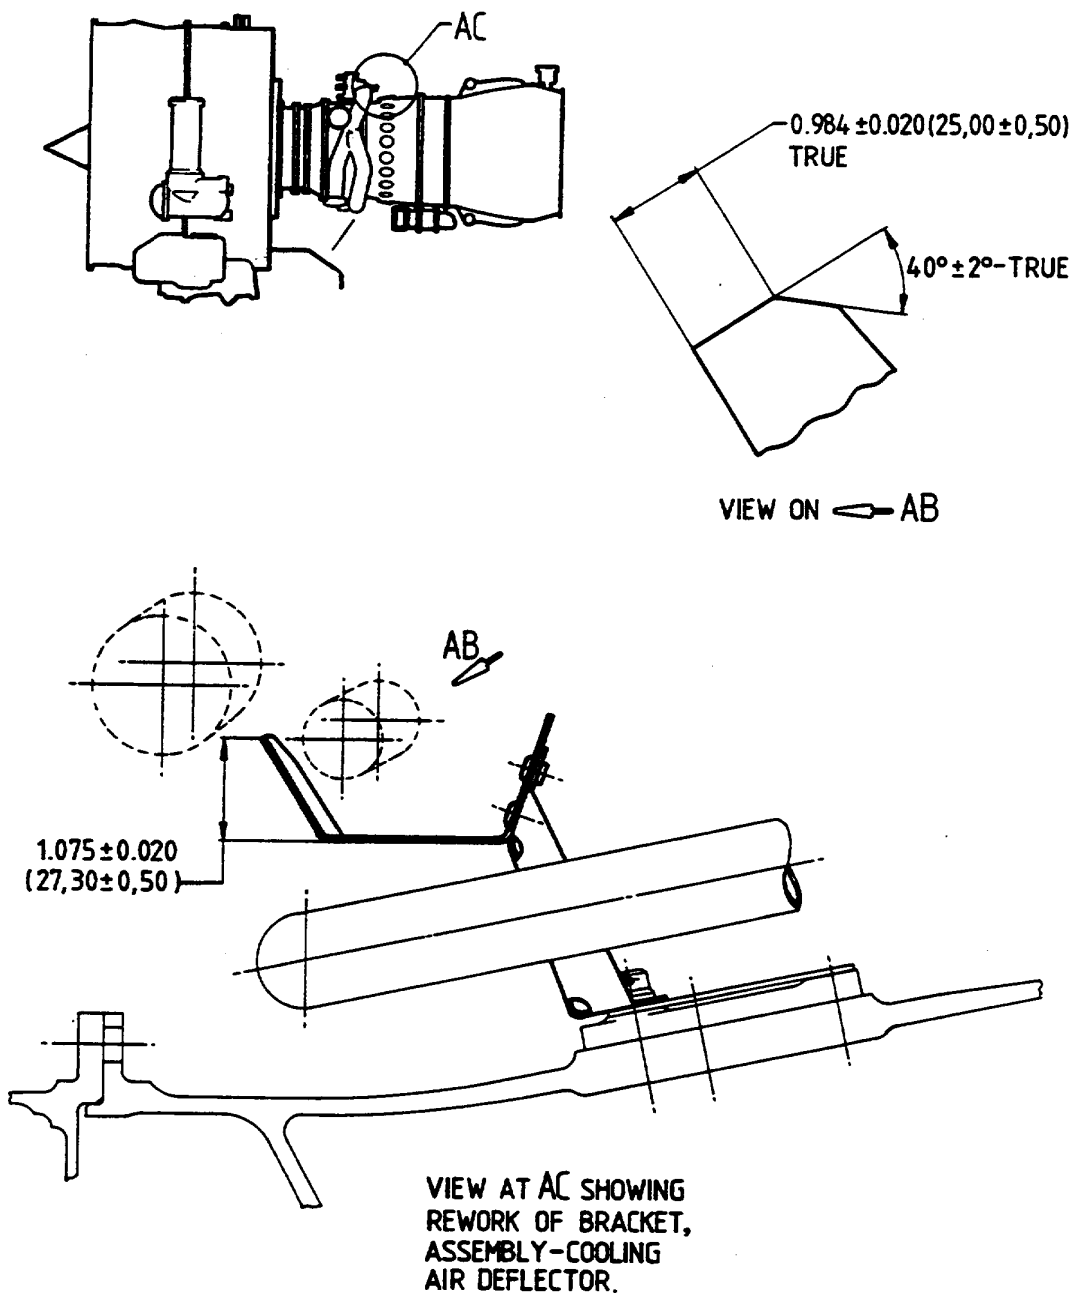
Modification of air deflector bracket
Fig.1

The existing air deflector bracket fitted to deflect the cooling air onto the 7/10th stages cabin air valve electrical connector, could foul the servo pipe which feeds the cabin air valve, also the upper edge of this bracket may not provide sufficient clearance with the valve body.

(A) A modified air deflector bracket is introduced with the upper edge reduced in height by 0.078in. (2,00 mm) and includes a chamfer on the adjacent upper corner.

(4) Existing air deflector brackets can be reworked see fig 1.

Procedure	Supplementary Information	
(a) Mark out area to be removed	Refer to Fig 1	
(b) Remove the material to the 1.075 +/- 0.020in. dimension (27,30 +/- 0,5 mm)	Use hand tools	
(c) Produce the chamfer at 40 degrees true to the surface	Use hand tools	
(d) Remove the sharp edges and the burrs	Use hand tools	
(e) Crack test the bracket	SPM TASK 70-23-01-230-501	
(f) Re-number adjacent to the existing part number	Old Part Number	New Part Number
	6A3996	6A4115
