ENGINE - FUEL AND CONTROL - FUEL AND CONTROL - INCORPORATE A RECONTOURED P2/T2 AIR TUBE
ASSEMBLY - CATEGORY CODE 6 - MOD.ENG-73-0010

V2500-ENG-73-0010

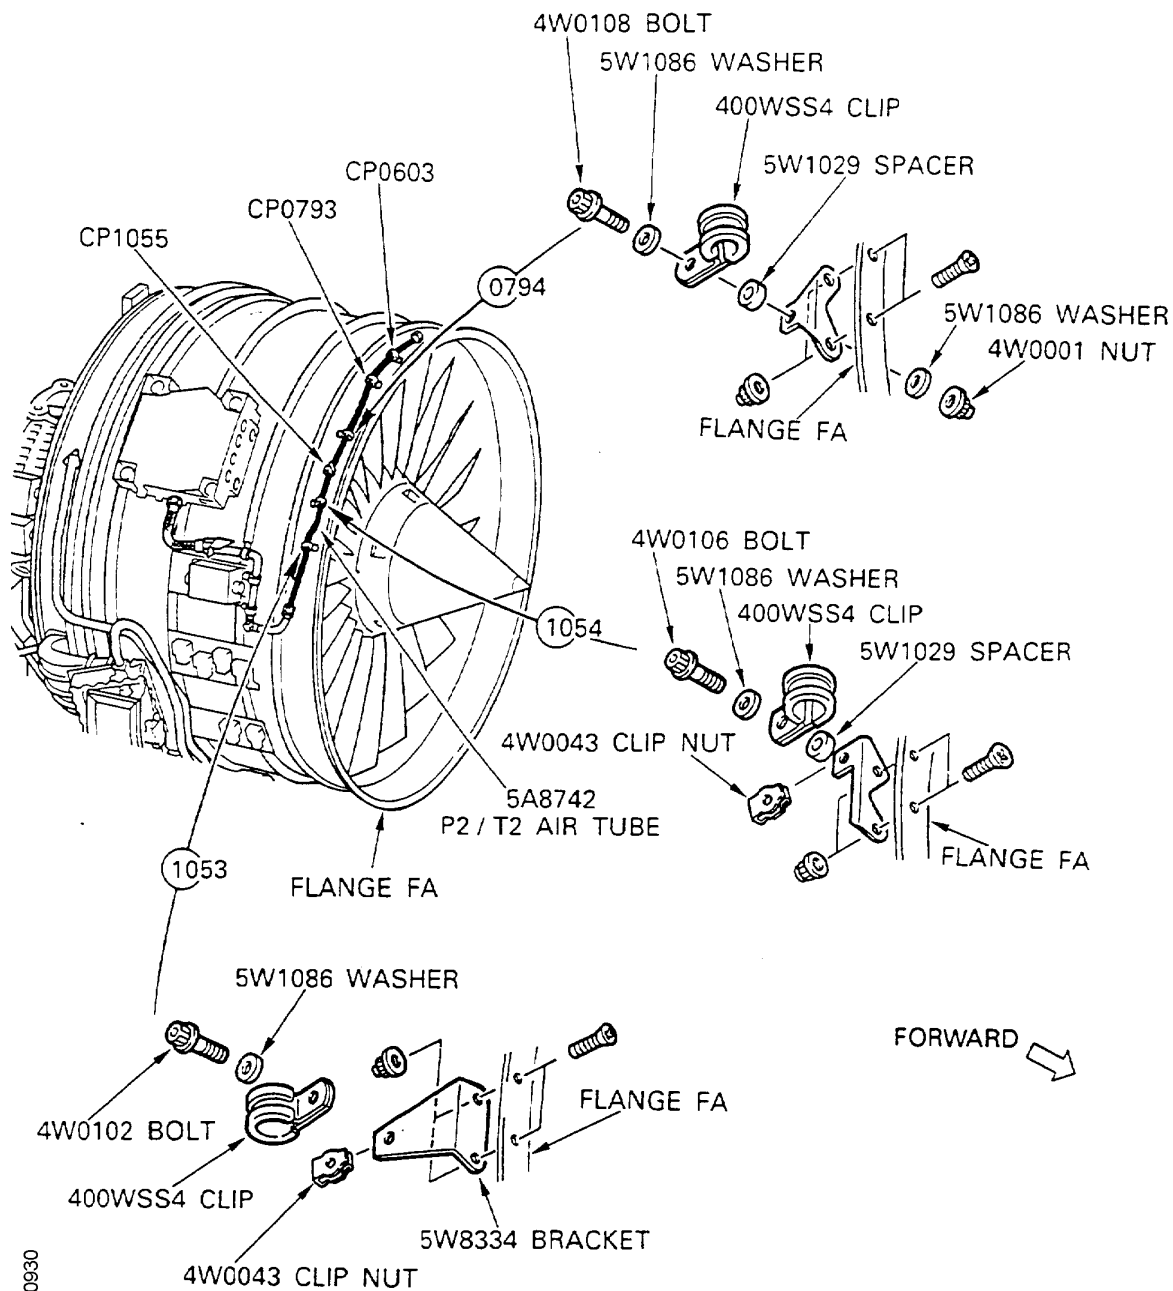
Insufficient clearance may exist between the Nose Cowl rear flange (Flange FA) and the P2/T2 Air Tube.

This condition was seen on some development engines. A review for the routing of P2/T2 Air Tube has shown that the re-routing is necessary to get sufficient clearance between the Tube and the Flange FA in the area of clipping positions CP0794, CP1053 and CP1054.

The P2/T2 air tube and the clipping details - Before alteration
Fig.1

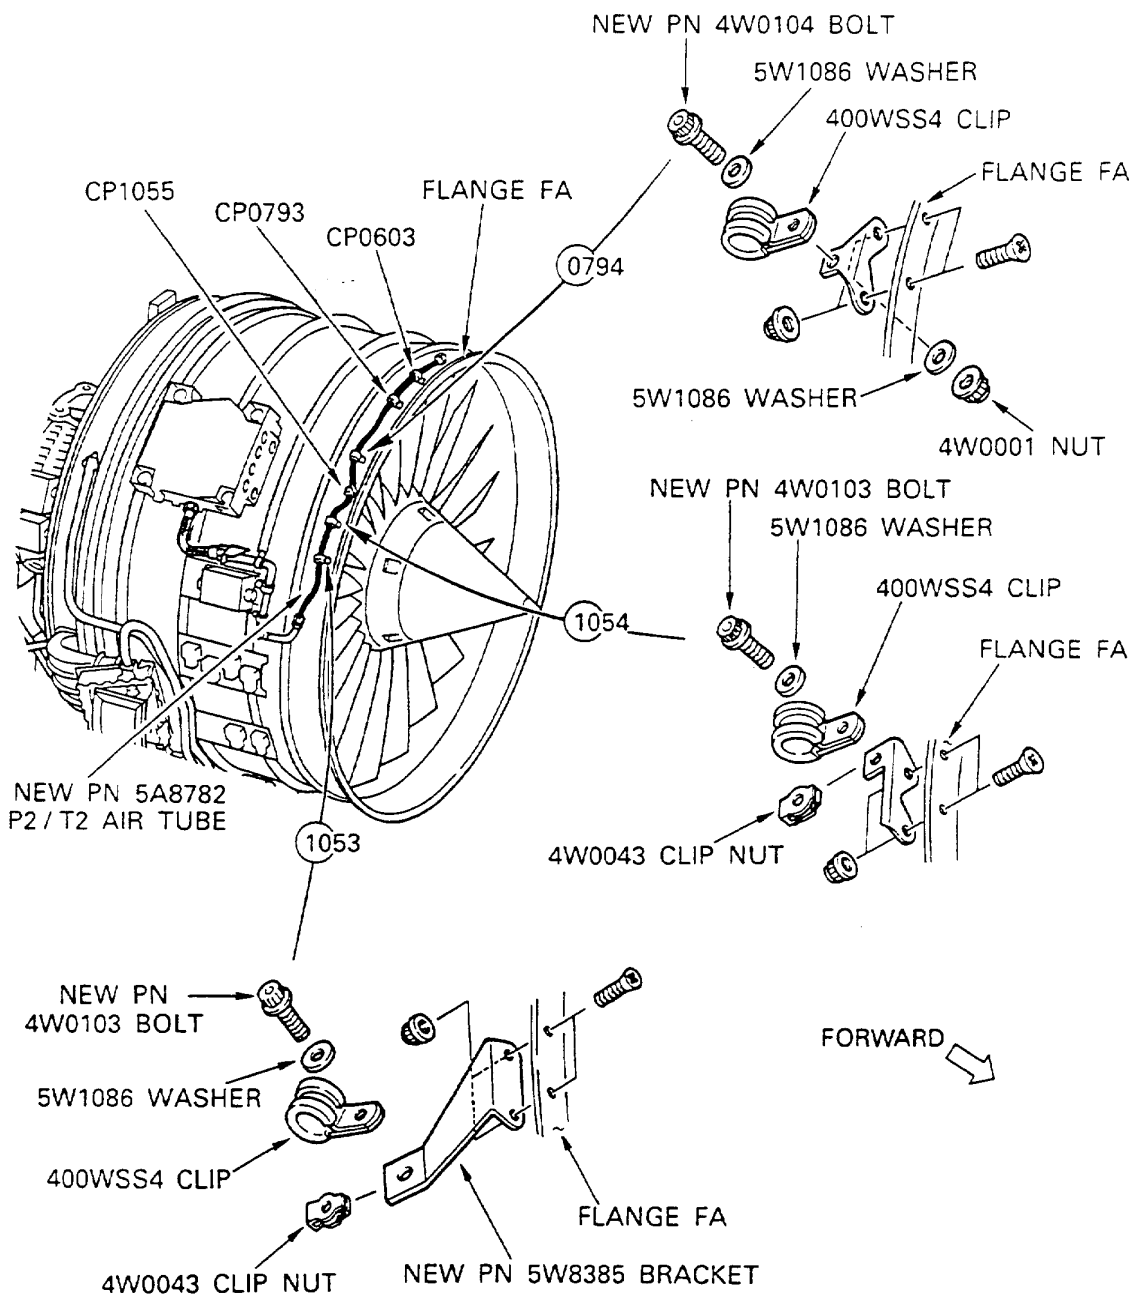
- (1) The changes introduced by this Service Bulletin are as follows: (See Figures 1 and 2).
- (a) The P2/T2 Air Tube is re-routed to get sufficient clearance between the Tube and the Flange FA.

- (b) The Bracket which supports the P2/T2 Air Tube at CP1053 is changed in its shape and also the stock thickness is increased from 0.047 in (1,20 mm) to 0.063 in. (1,60 mm) to clear the resonance with new P2/T2 Air Tube.

- (c) At CP0794 and CP1054, each of 5W1029, Spacers has been deleted and the clip locations are tuned rearwards.
 - (d) At CP0794, the Bolt is changed to shorter bolt from the existing 4W0108 to the new 4W0104.

- (e) At CP1054, the Bolt is changed to shorter bolt form the existing 4W0106 to the new 4W0103.
 - (f) At CP1053, the Bolt is changed to longer bolt from the existing 4W0102 to the new 4W0103 in line with an installation of the new thickened bracket.

The P2/T2 air tube and the clipping details - After details Fig.2

- (1) Install the new 5W8385, Bracket, to the Flange FA by the approved procedures in the Engine Manual, 72-00-32, Installation, TASK 72-00-32-420-001. (Refer to Figure 2, and 1.K.(2)).

- (2) Install the new 5A8782, P2/T2 Air Tube to the Module by the approved procedures in the Engine Manual, 72-00-32, Installation, TASK 72-00-32-420-003. (Refer to Figure 2, and 1.K.(2)).

- (3) At CP0794, install the new 4W0104, Bolt, the two 5W1086, Washers, 400WSS4, Clip, and 4W0001, Nut, to the new Tube and the Bracket with a new clipping configuration. Torque the Nut to 36 - 45 lbin. (4,00 - 5,00 Nm). (Refer to Figure 2, and 1.K.(3)).

- (4) At CP1054, install the new 4W0103, Bolt, 5W1086, Washer, 400WSS4, Clip, and 4W0043, Clip Nut, to the new Tube and the Bracket. Torque the Bolt to 36 - 45 lbfin. (4,00 - 5,00 Nm). (Refer to Figure 2, and 1.K.(3)).

- (5) At CP1053, install the new 4W0103, Bolt, 5W1086, Washer, 400WSS4, Clip, and 4W0043, Clip Nut to the new Tube and the new Bracket. Torque the Bolt to 36 - 45 lbfin (4,00 - 5,00 Nm). (Refer to Figure 2, and 1.K.(3)).
