ENGINE - FUEL AND CONTROL - FUEL AND CONTROL - REWORK THE PS3 BURNER AIR TUBE ASSEMBLY TO INCORPORATE ENLARGED MOISTURE TRAP DRAIN HOLES - CATEGORY CODE 4 - MOD.ENG-73-0011

V2500-ENG-73-0011

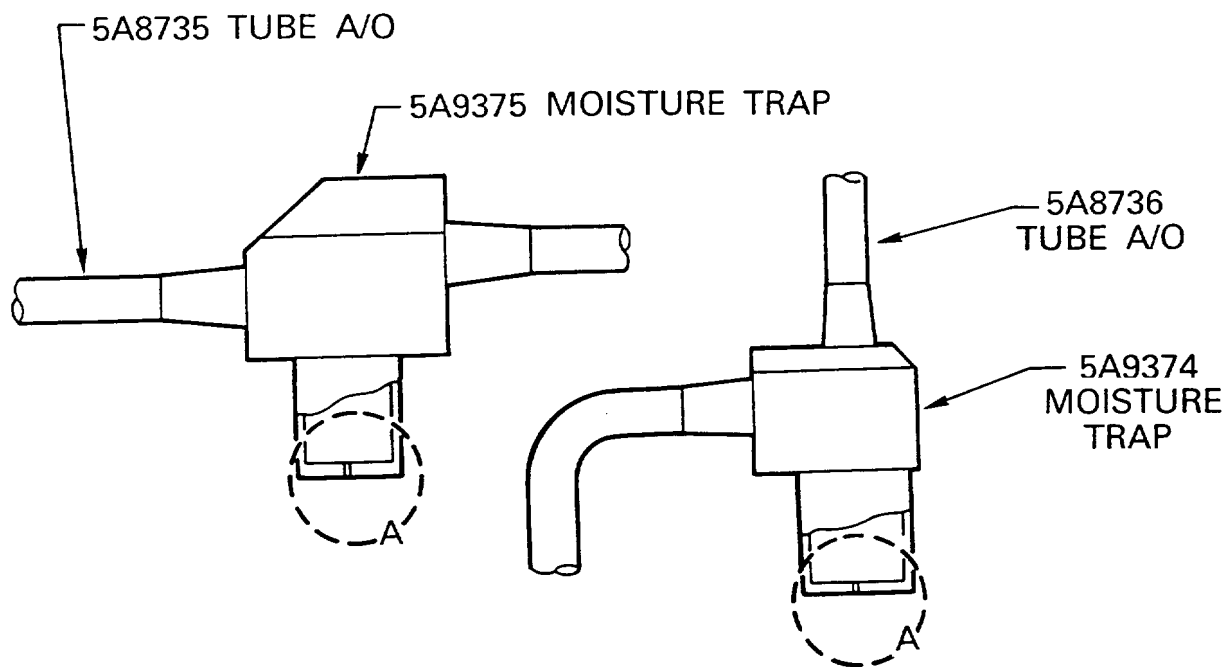
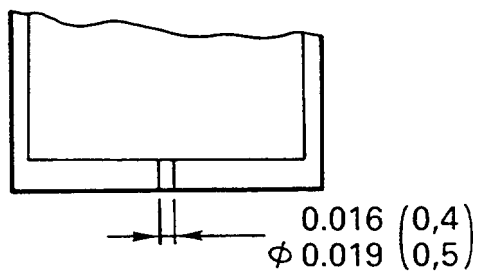
Moisture Traps in the PB Air Tubes (Fuel System Air Tubes) - Before alteration
Fig.1 Sheet 1 of 2

Investigations have shown the presence of moisture/water in the PB Air Tubes though these tubes have the Moisture Traps with 0.016 - 0.019in. (0,4 - 0,5 mm) diameter drain holes. Also, investigation of an EEC recently removed showed the presence of white powdery contamination in the PB Sensor Screen of the EEC.

DRAIN HOLES
DETAIL A

- (a) The diameters of drain holes in the Moisture Traps in PB Air Tubes are increased from the existing 0.016 – 0.019 in. (0,4 – 0,5 mm) in diameter to the new 0.023 – 0.027in. (0,59 – 0,68 mm) in diameter to improve drainage of moisture/water in the PB Air Tubes. (See Figure 1).
- (b) The existing Part Numbers of the Tube A/O's and the Moisture Traps are changed to the new Part Numbers.
