ENGINE - FUEL AND CONTROL - SELECTIVE REPROGRAMMING OF THE DATA ENTRY PLUG ASSEMBLY -
CATEGORY CODE 4 - MOD.ENG-73-0013

V2500-ENG-73-0013

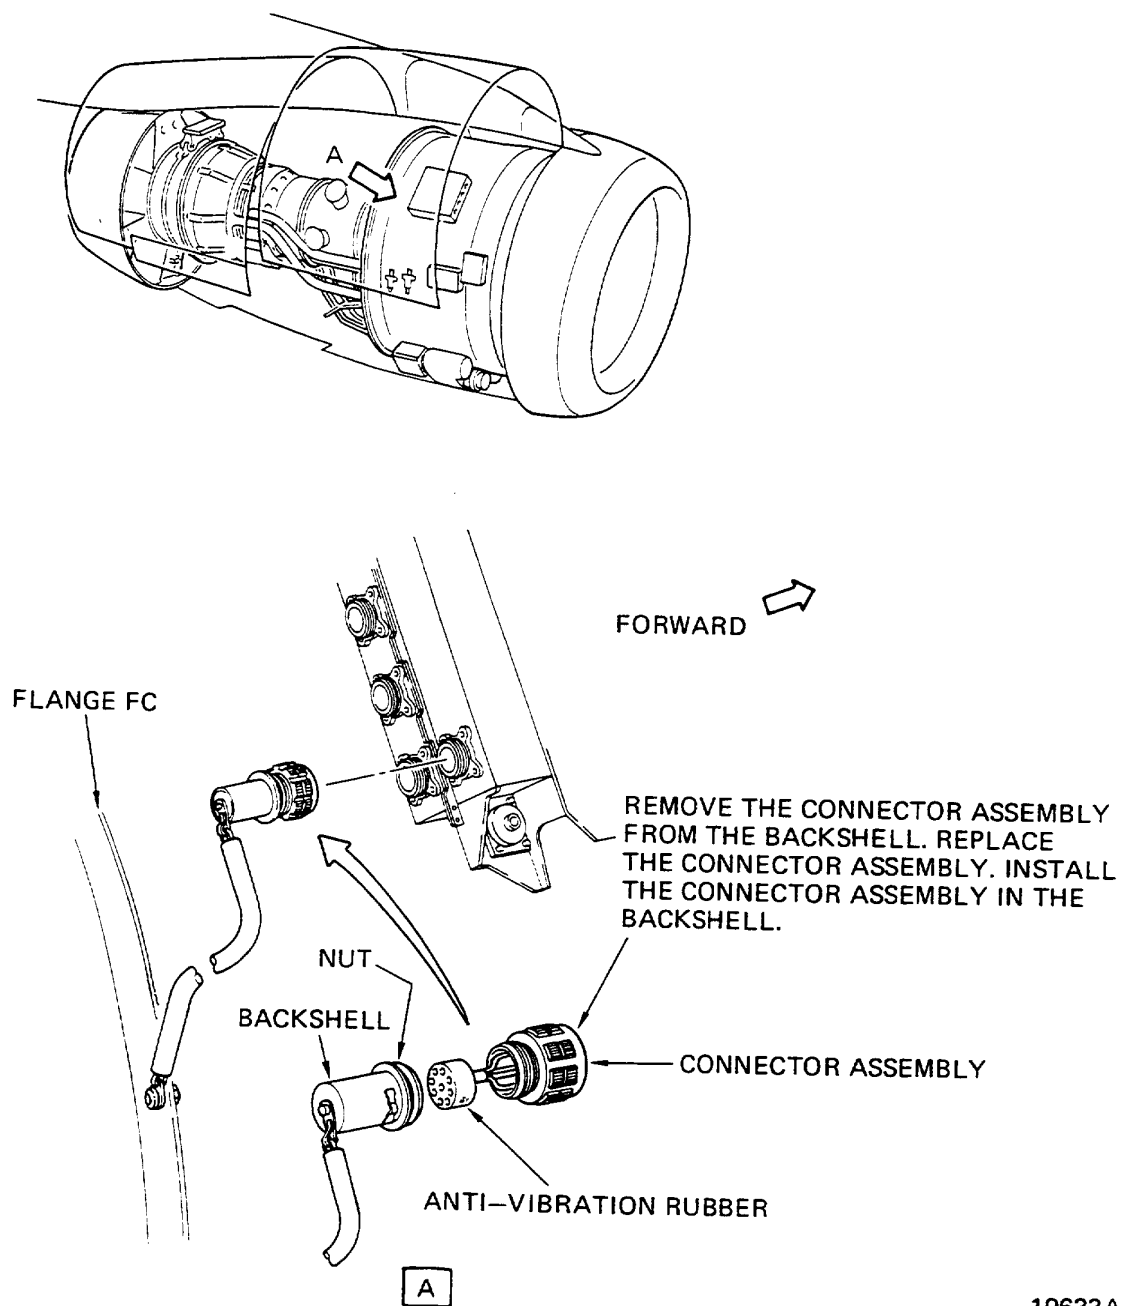
Data Entry Plug Assembly
Fig.1

The Data Entry Plug Assembly in some service engines is not wired for the correct EPR modifier class or the engine serial number.

- (1) Remove the lockwire from the Data Entry Plug Backshell and the Connector. Refer to Figure 1.
- (2) Loosen the Backshell Nut, but do not remove the Backshell. Use a TG-70 Strap Wrench, or equivalent.
- (3) Disconnect the Data Entry Plug Assembly from the EEC. Use the IAE 1J12018 EEC Harness Wrench.

- (1) Remove the lockwire from the Data Entry Plug Backshell and Connector Assembly. Refer to Figure 1.
- (2) Remove the Connector Assembly from the Backshell.
- (3) Remove the Anti-Vibration Rubber from the Connector Assembly.
- (4) Replace the Connector Assembly.
- (5) Install the Anti-Vibration Rubber on the new Connector Assembly.
- (6) Install the Connector Assembly into the Backshell.
- (7) Tighten and torque the Backshell to 19 - 26 lbfin (2,147 - 2,938 Nm) with a strap wrench by use of the approved procedure in Reference (1), Chapter/Section 70-23-11, (TASK 70-23-11-911-012).

- (1) Connect the Data Entry Plug Assembly to the EEC. Refer to Figure 1.
- (2) Tighten and torque the Plug Assembly to 32 lbfin (3,6 Nm). Use the IAE 1J12018 EEC Harness Wrench. See Reference (2), Chapter/Section 70-41-00, (TASK 70-41-00-400-501).
- (3) Tighten and torque the Backshell to 53 - 58 lbfin (5,99 - 6,55 Nm). Use a TG-70 Strap Wrench, or equivalent. See Reference (2), Chapter/Section 70-41-00, (TASK 70-41-00-400-501).
- (4) Safety the Backshell to the Connector with CoMat 02-138 Lockwire. See Reference (1), Chapter/Section 70-41-11, (TASK 70-40-11-911-012).
