Subject: Transmittal of Revision 2 to Service Bulletin No. V2500-ENG-73-0015

V2500 Propulsion System — Engine

ENGINE - FUEL AND CONTROL - INCORPORATE A NEW ELECTRONIC ENGINE CONTROL (EEC)  
CONFIGURATION AND REWORK THE DATA ENTRY PLUG ASSEMBLY  
TO THE SCN11E SOFTWARE CONFIGURATION

V2500-ENG-73-0015

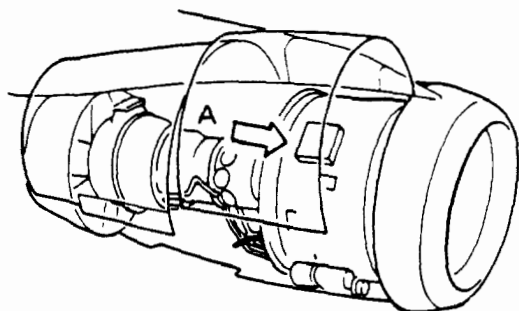
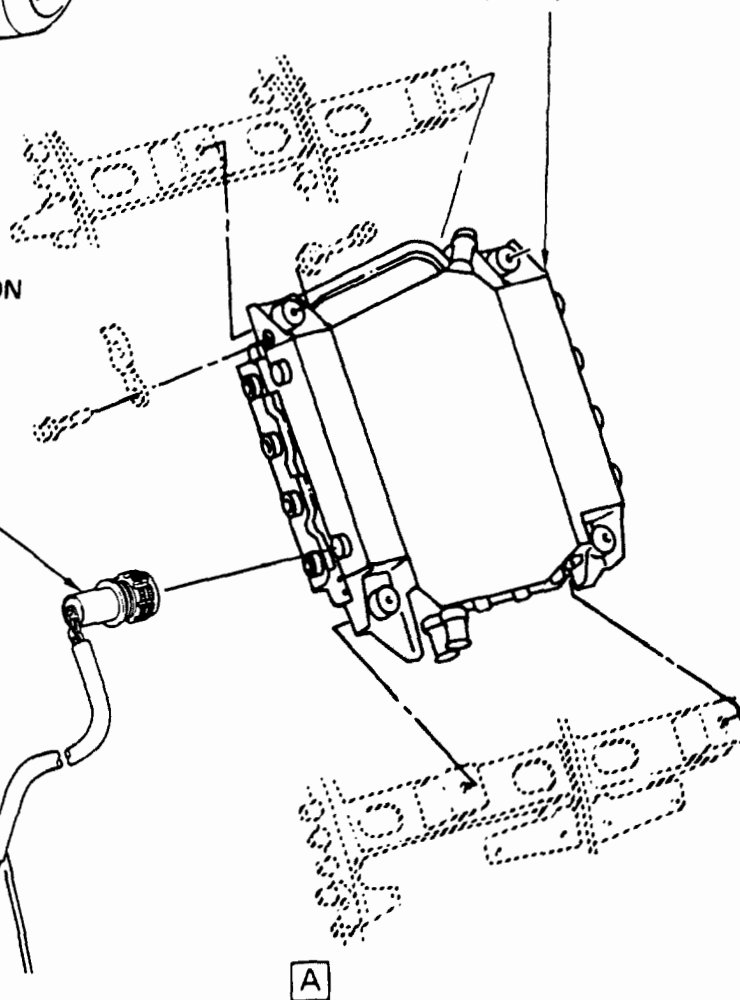
REMOVE PN 2A2039 ELECTRONIC  
ENGINE CONTROL AND INSTALL  
PN 2A2189 (1 Off)

REMOVE PN 5A9298 OR  
5A0357 DATA ENTRY PLUG  
ASSEMBLY, DO A MODIFICATION  
AND INSTALL PN 5A0431 OR  
PN 5A0432 DATA ENTRY PLUG  
ASSEMBLY (1 Off)

DO NOT REMOVE THE  
CONNECTING CHAIN

Location of electronic engine control and  
data entry plug assembly

- (2) Loosen the Backshell Nut, but do not remove the Backshell. Use TG-70 Strap Wrench or equivalent.
- (3) Disconnect the Data Entry Plug Assembly from the EEC. Use the IAE1J12018 EEC Harness Wrench. Refer to Fig.1.

- (4) Remove the 2A2039 Electronic Engine Control by the approved procedure in Reference (3), Chapter/Section 73-22-34, Removal/Installation. Refer to Fig.1.

- (1) Install 2A2189 Electronic Engine Control by the approved procedure in Reference (3), Chapter/Section 73-22-34, Removal/Installation by Fig.1 except as follows:
- (a) Tighten and torque all the EEC Electrical Harness Connectors to 32 lbf·in (3,6 Nm). Use the IAE1J12018 EEC Harness Wrench. See Reference (4), Chapter/Section 70-41-00, (TASK 70-41-00-400-501).
- (2) Connect the Data Entry Plug Assembly the the EEC. Refer to Fig.1.
- (3) Tighten and torque the Data Entry Plug Assembly to 32 lbf·in (3,6 Nm). Use the IAE1J12018 EEC Harness Wrench. See Reference (4), Chapter/Section 70-41-00, (TASK 70-41-00-400-501).
