ENGINE - FUEL AND CONTROL - FUEL AND CONTROL - REPLACEMENT OF FUEL FEED TUBE -  
CATEGORY CODE 4 - MOD.ENG-73-0018

V2500-ENG-73-0018

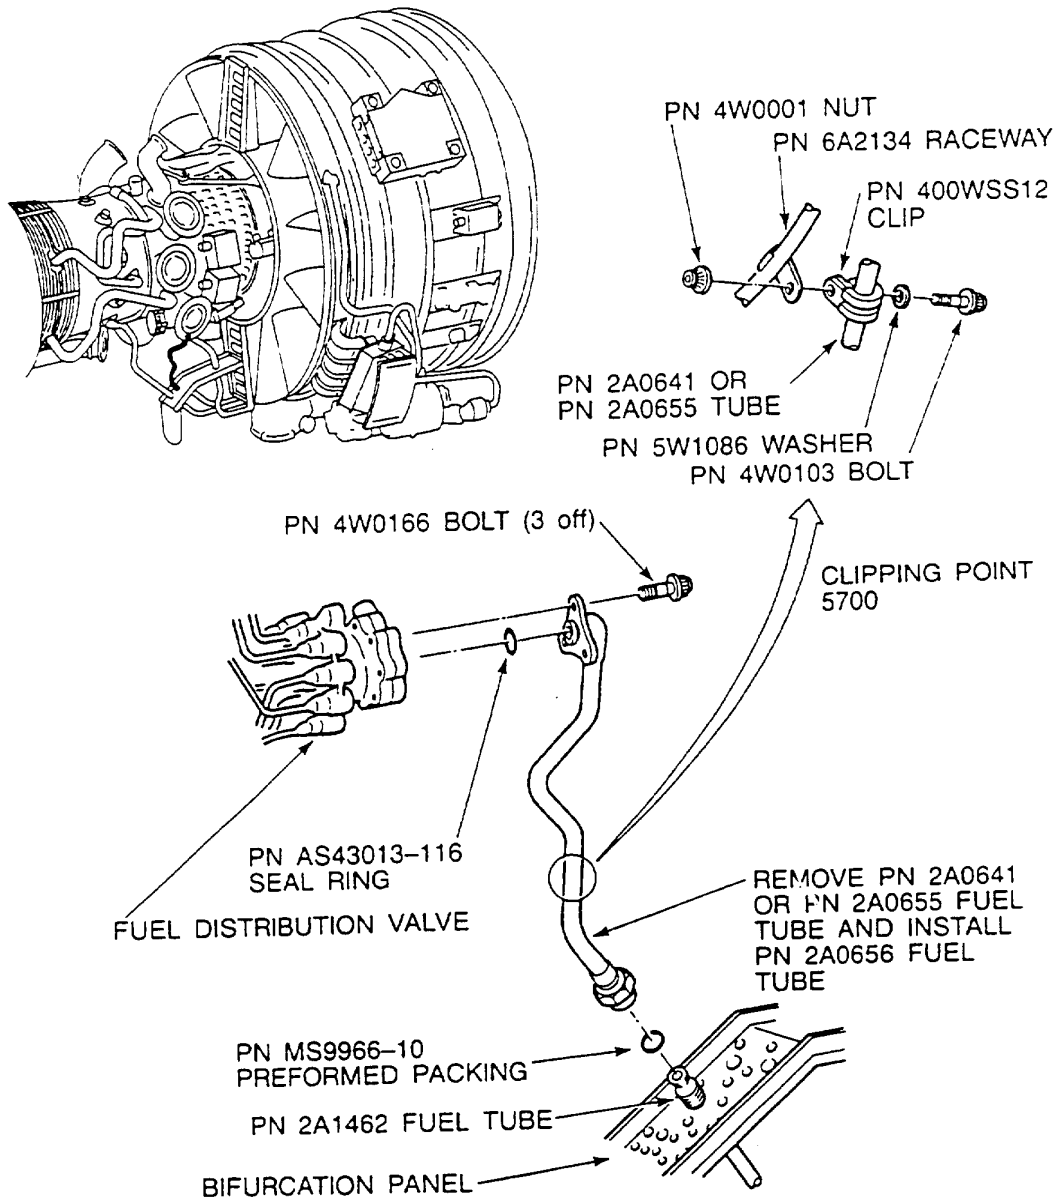
Replacement of fuel feed tube  
Fig.1

Mismatching may occur at both ends of the fuel feed tube connecting the bifurcation panel to fuel distribution valve.

Difficulty of tube connection was reported. Investigation clarified that the fuel tube is slightly short.

(a) 2A0656 Tube supersedes 2A0655 and/or 2A0641 Tube.

- (1) Remove 400WSS12 Clip from 2A0641 and/or 2A0655 Tube.
  - (a) Remove 4W0001 Nut, 5W1086 Washer and 4W0103 Bolt to release the clip.
  - (b) Remove the clip from the tube.
- (2) Remove 2A0641 and/or 2A0655 Tube.

- (b) Lightly lubricate a new AS43013-116 Seal ring with CoMat 10-038 petroleum jelly or CoMat 10-060 liquid paraffin. Install the seal ring on 2A0656 Tube.
- (c) Attach 2A0656 Tube to the fuel distribution valve with three 4W0166 Bolts.
- (d) Connect 2A0656 Tube to the 2A0641 Tube at the bifurcation panel.
- (e) Torque the bolts to 85 to 105 lbfin (10 to 12 Nm). Torque the tube connector to 1150 to 1250 lbfin (130 to 141 Nm). Safety with CoMat 02-126 lockwire.
- (4) Clip 2A0656 Tube to 6A2134 Raceway.
  - (a) Install 400WSS12 Clip to 2A0656 Tube.
  - (b) Install the clip to the lug of 6A2134 Raceway using 4W0103 Bolt, 5W1086 Washer and 4W0001 Nut.
  - (c) Torque the nut to 36 to 45 lbfin (4 to 5 Nm).
