ENGINE - FUEL AND CONTROL - REPLACE THE TUBE CLIP AT CLIPPING POINT 0795 - CATEGORY
CODE 4 - MOD.ENG-73-0021

V2500-ENG-73-0021

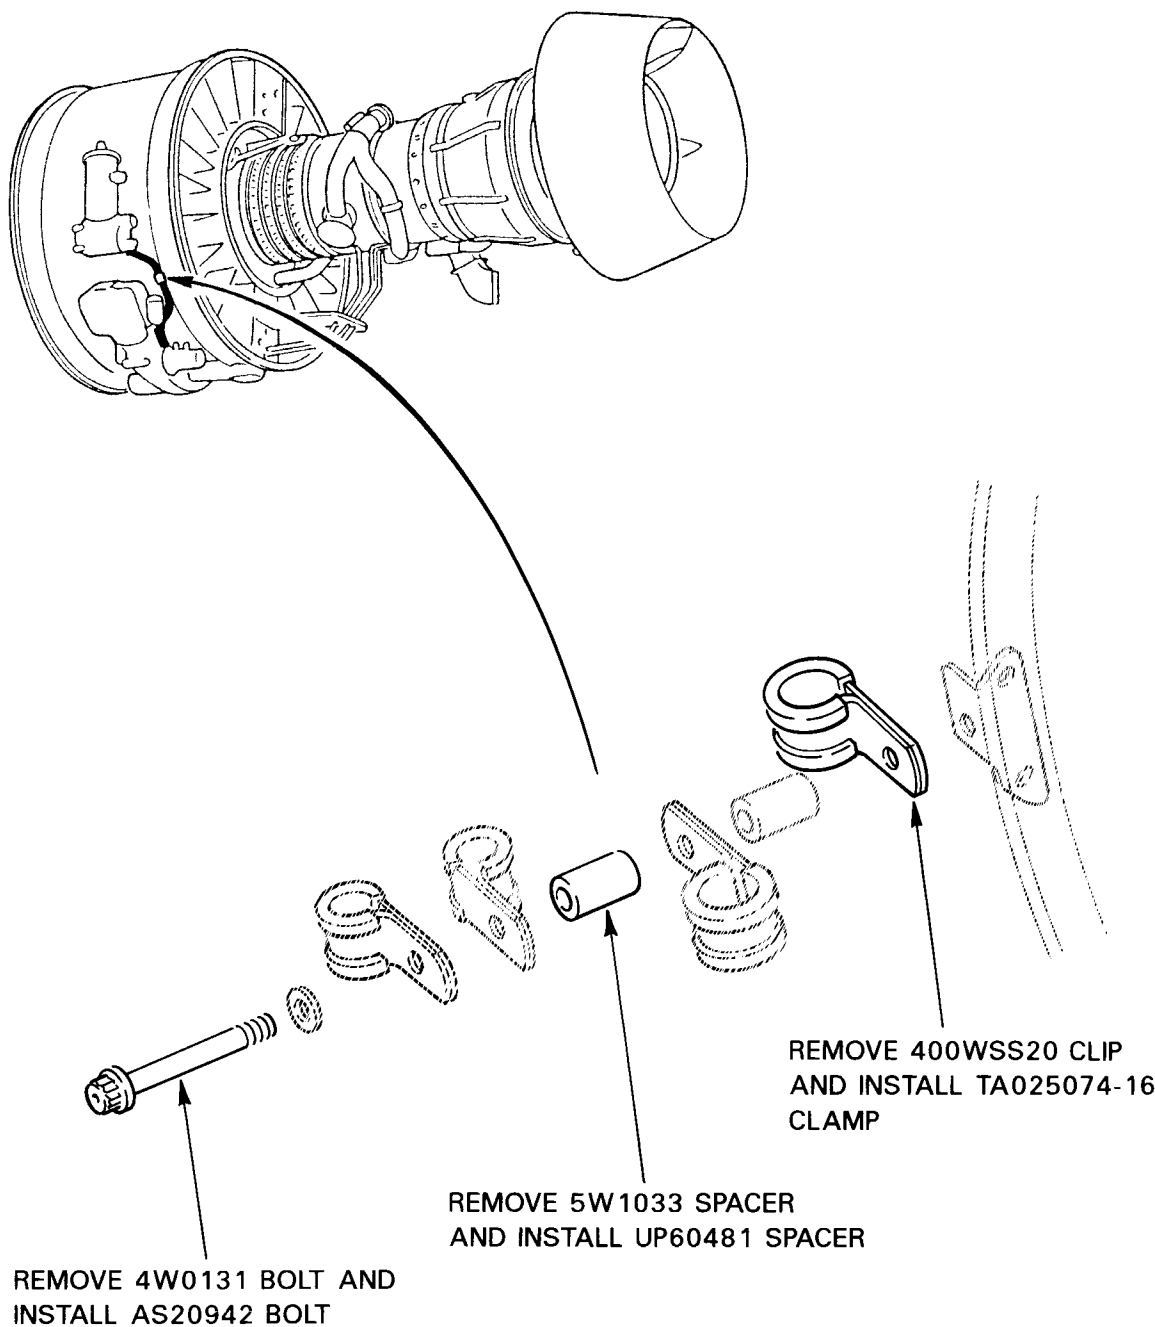
Location at clipping point 0795
Fig.1

Fretting could occur on the fuel cooled oil cooler (F.C.O.C.) to fuel pump fuel tube in the area of clipping point 0795.

An instance of fretting between the 'P' clip at clipping point 0795 and the fuel tube has been reported.

The fretting results from relative movement between the clip and tube, the metal clip eventually wearing through the rubber sleeve to fret directly on the tube. The movement is permitted due to loose a fit of the clip on the tube.

- (a) A tube clamp with a thicker rubber sleeve replaces the existing clip at clipping point 0795. The new clamp has a tighter fit with the tube compared to the existing clip.
- (b) A longer spacer is introduced to avoid fouling between the new clamp and adjacent tubes and a longer bolt is introduced to accommodate the longer spacer.
