ENGINE - FUEL AND CONTROL - REPLACE THE TUBE AT CLIPPING POINT 0306 - 4 -
MOD.ENG-73-0022

V2500-ENG-73-0022

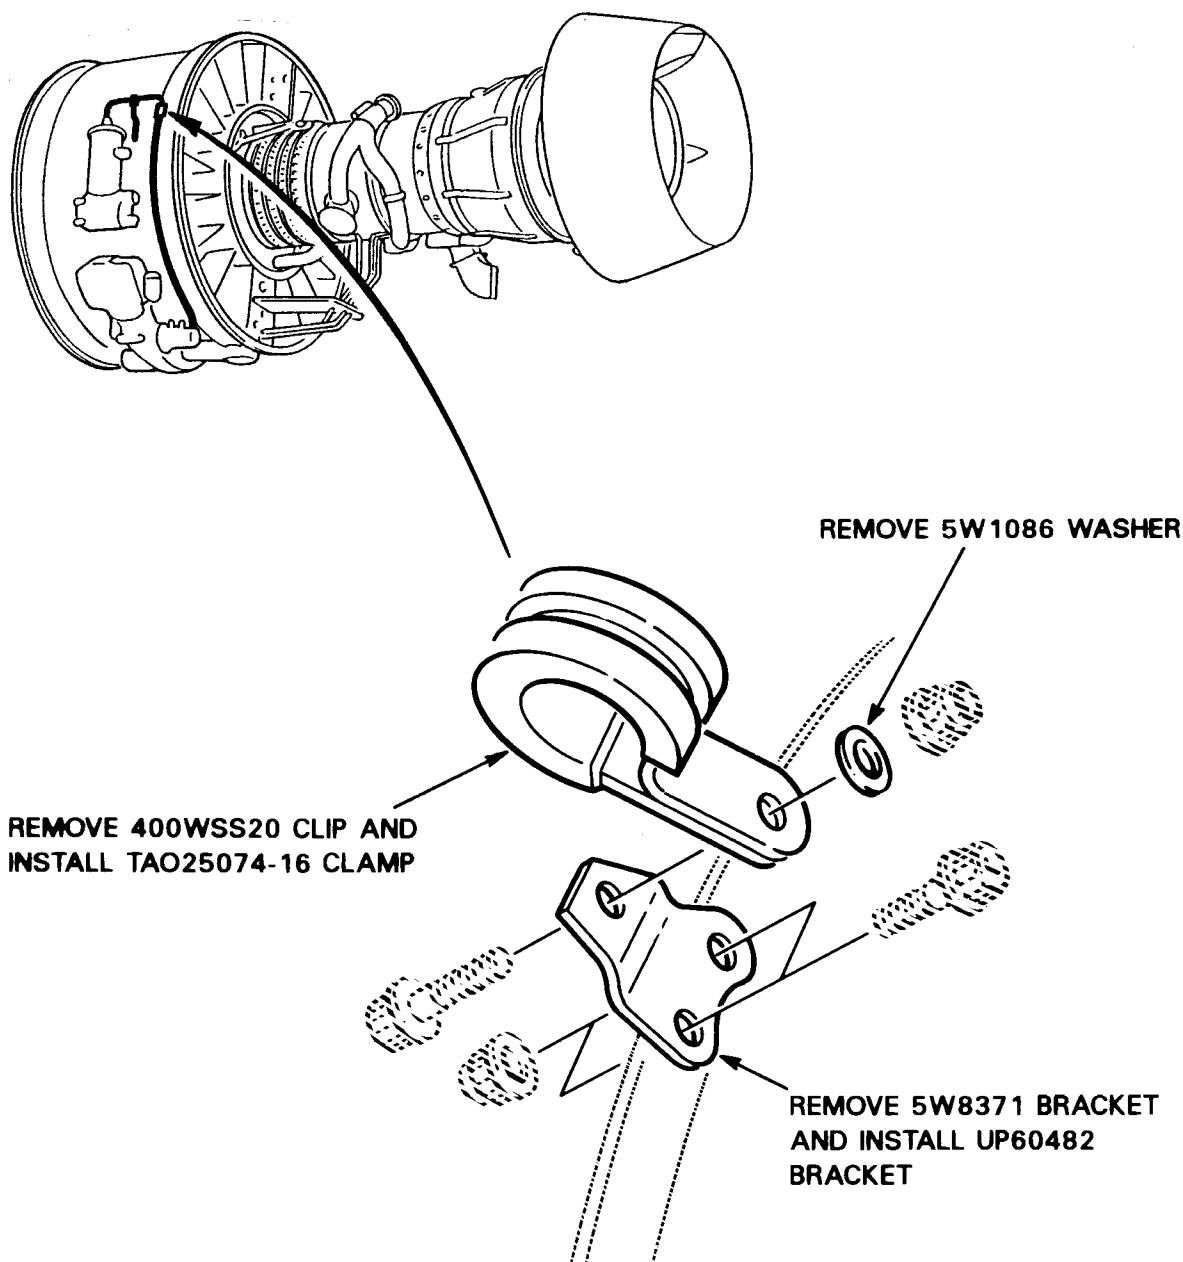
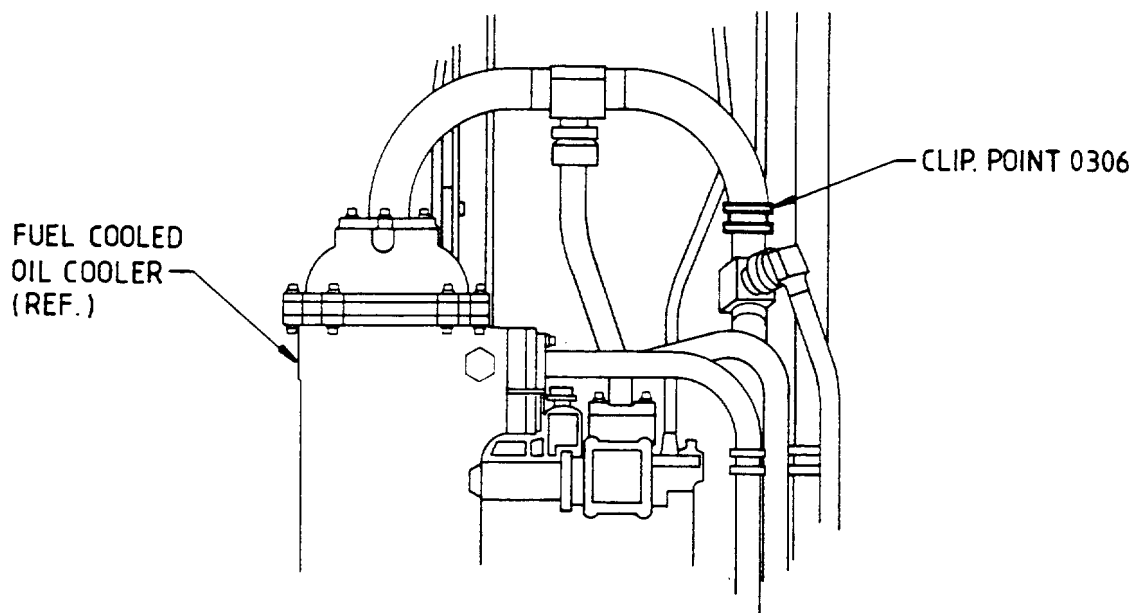
Location at clipping point 0306
Fig.1

Fretting could occur on the fuel pump to fuel cooled oil cooler (F.C.O.C.) fuel tube in the area of clipping point 0306.

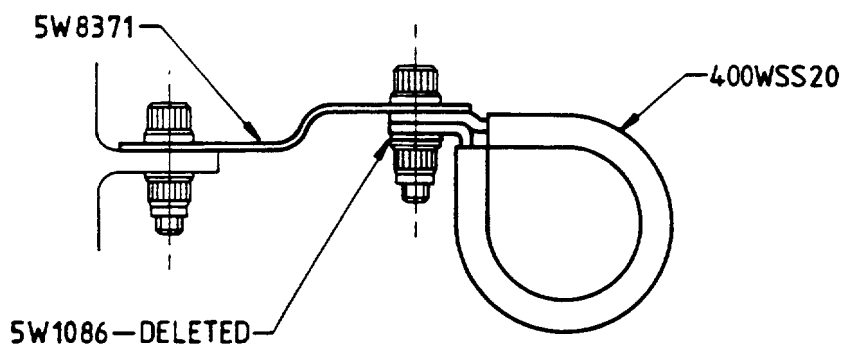
Location at clipping point CP0306 - Before alteration
Fig.2

An instance of fretting between 'P' clip at clipping point 0306 and the fuel tube has been reported.

The fretting results from relative movement between the clip and tube, the metal clip eventually wearing through the rubber sleeve to fret directly on the tube. The movement is permitted due to too loose a fit of the clip on the tube.

- (1) Remove the bolt 4W0102, the washer AN960XC10L or 5W1086 and the nut 4W0001 from clipping point 0306.
- (2) Remove clip 400WSS20 from the fuel pump to F.C.O.C. tube.
- (3) Discard washer AN960XC10L or 5W1086 and clip 400WSS20.
- (4) Remove bolts 4W0163 (2 off), nuts 4W0002 (2 off), and bracket 5W8371 from flange FC.
