SERVICE BULLETIN

<u>ENGINE - FUEL AND CONTROL - TO PROVIDE A NEW ELECTRONIC ENGINE CONTROL (EEC) WITH THE SCN11G/J SOFTWARE CONFIGURATION - CATEGORY CODE 8 - MOD.ENG-73-0027</u>

(1) Aircraft: Airbus A320

(2) Engine: V2500-A1 Engines before Serial Nos.V0223.

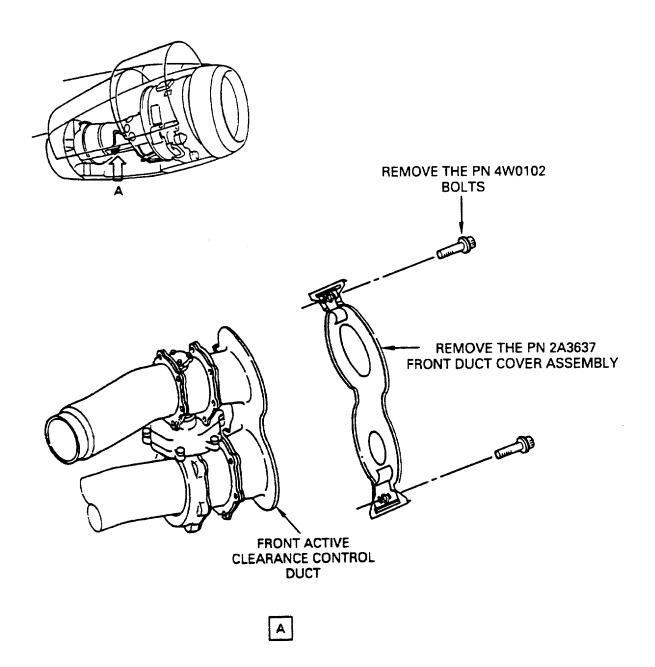
Location of the ACC Front Duct Cover Assembly Fig.2

NOTE: When you incorporate this Service Bulletin with the new SCN11G/J software logic, the Front Duct Cover Assembly given in Reference (1) must be removed.

- Remove the Active Clearance Control (ACC) Front Duct Cover Assembly. Refer to Reference (1) and Figure 2.
 - (a) Locate the Front ACC Duct.
 - (b) Remove the two 4W0102 Bolts from the Front Duct Cover Assembly.

(c) Remove the 2A3637 Front Duct Cover Assembly.

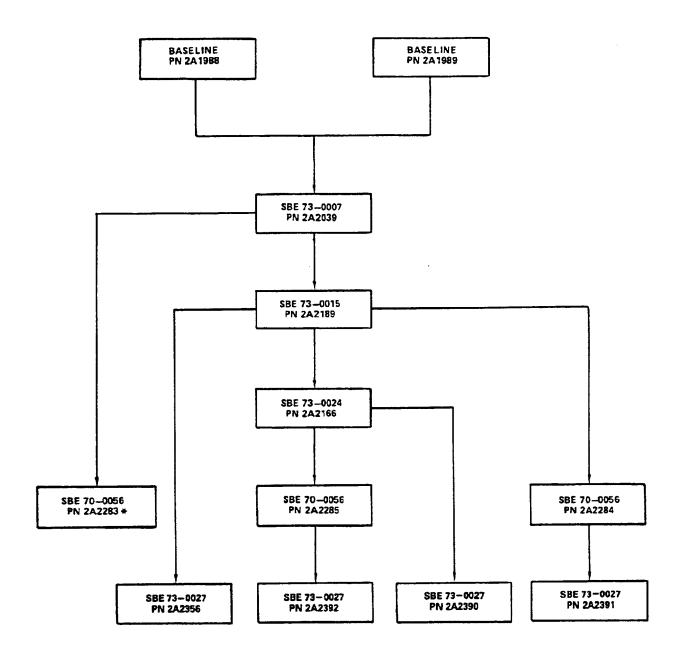
Family Tree - Electronic Engine Control (EEC) Fig.3

* THERE IS NO PROCEDURE TO ADVANCE THIS CONFIGURATION
