ENGINE - FUEL AND CONTROL - TO PROVIDE A NEW ELECTRONIC ENGINE CONTROL (EEC) WITH THE  
SCN11H SOFTWARE CONFIGURATION - CATEGORY CODE 8 - MOD.ENG-73-0032

V2500-ENG-73-0032

## **ENGINE FUEL AND CONTROL - EEC150-1 ELECTRONIC ENGINE CONTROL - INCORPORATION OF NEW SOFTWARE CONFIGURATION**

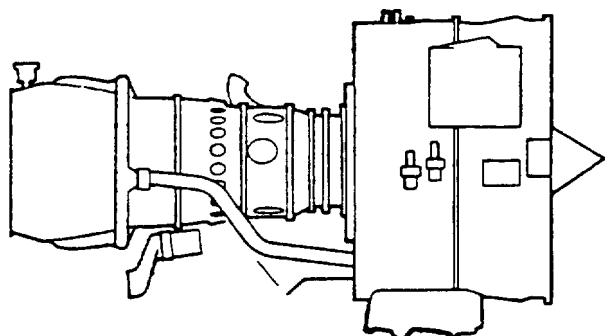
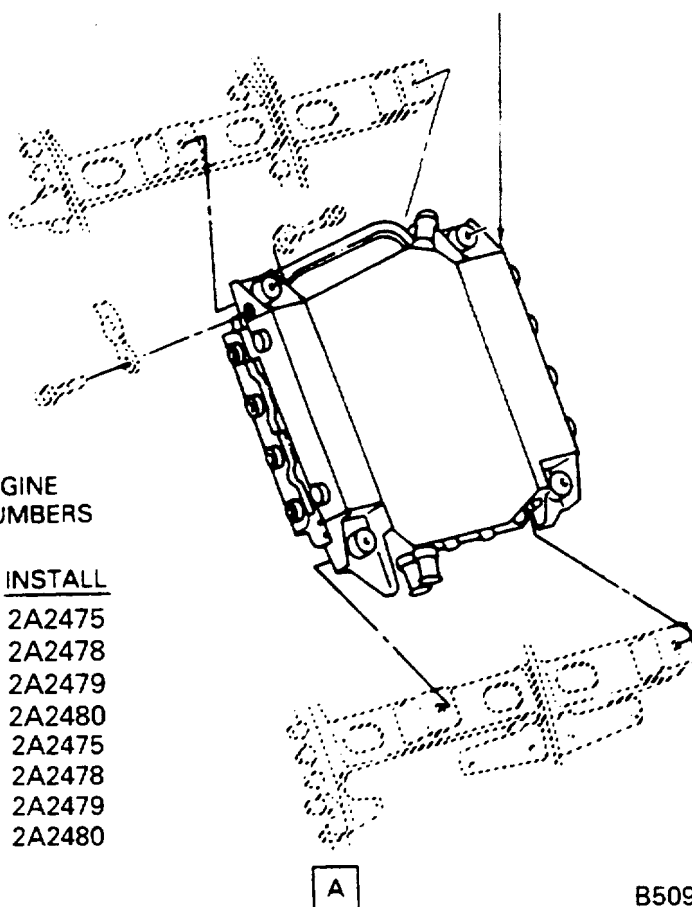
Location of Electronic Engine Control (EEC)  
Fig.1

REMOVE THE APPLICABLE PART NUMBER\*  
ELECTRONIC ENGINE CONTROL, DO A  
MODIFICATION, IDENTIFY AND INSTALL  
THE APPLICABLE PART NUMBER\*  
(1 Off)

Procedure	Supplemental Information
(a) Send the Electronic Engine Control to the approved vendor to be modified.	See Figure 1.

- (1) Install the 2A2475, 2A2478, 2A2479, or 2A2480 Electronic Engine Control (1 off) by the approved procedure given in Reference (5), Chapter/Section 70-00-32, Installation-02. See Figure 1.

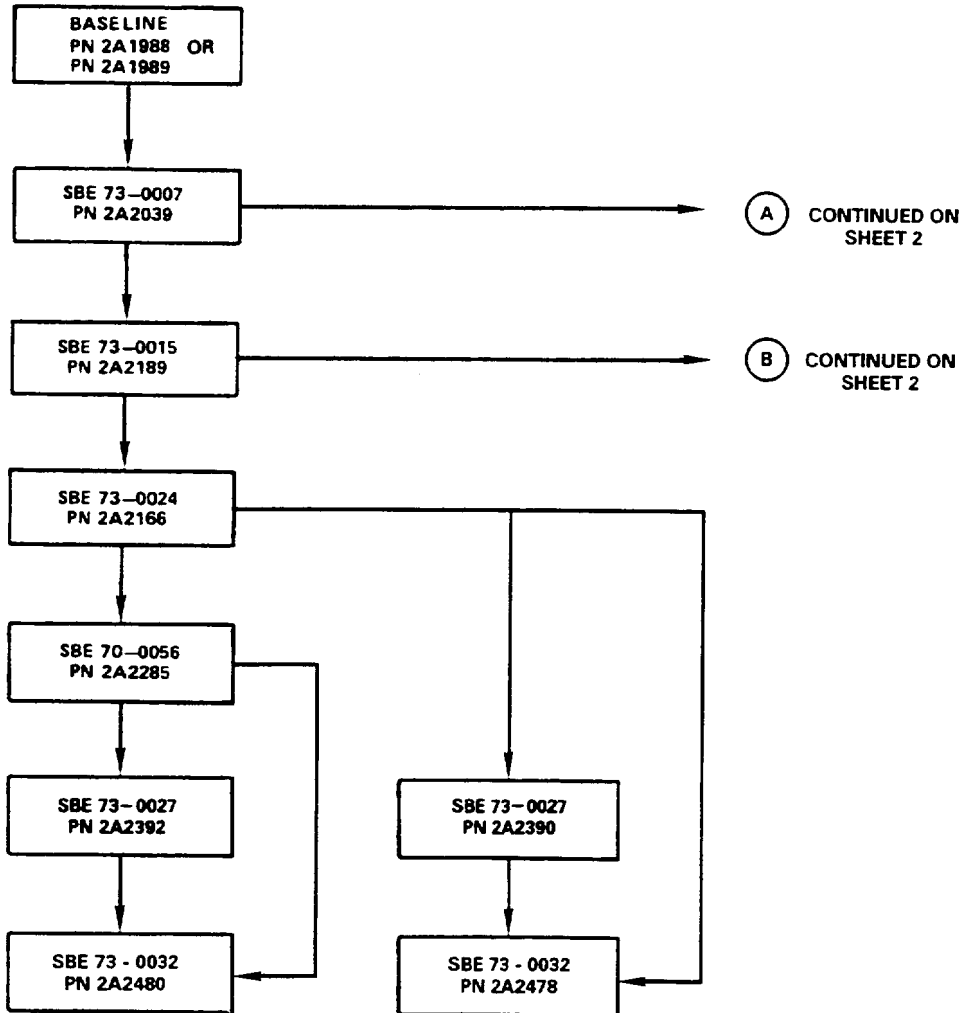
Family Tree - Electronic Engine Control (EEC)  
Fig.3 (Sheet 2)

\* Incorporation of the latest software configuration, given in V2500-ENG-73-0032, will include all the software improvements which were made in V2500-ENG-73-0027. This is why there is more than one old part number progressing up to the same new part number.

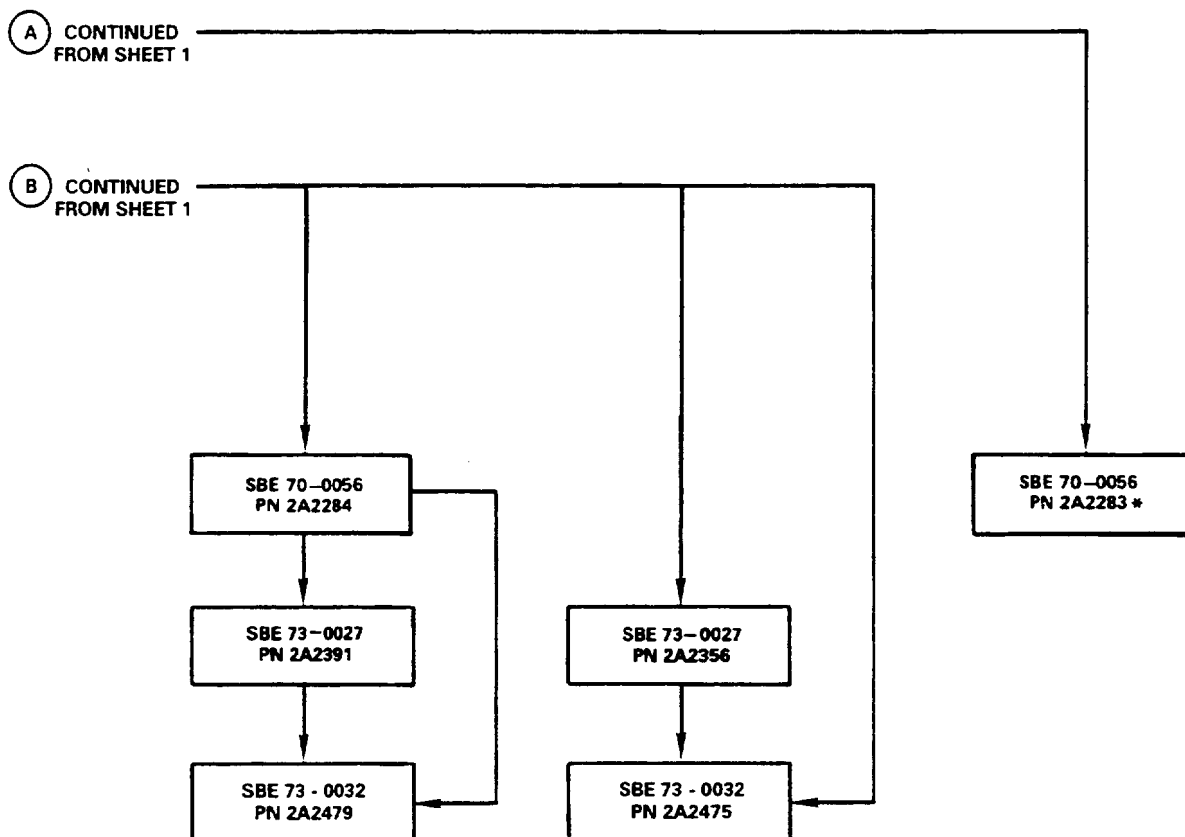
Family Tree - Electronic Engine Control (EEC)  
Fig.3 (Sheet 2)

• THERE IS NO PROCEDURE TO  
ADVANCE THIS CONFIGURATION
