V2500-A1 SERIES PROPULSION SYSTEMS SERVICE BULLETIN

V2500-ENG-73-0038

ENGINE - FUEL AND CONTROL - PROVIDE A NEW P2/T2 PROBE AIR TUBE ASSEMBLY AND
ATTACHMENT AT CLIPPING POINT CP0603

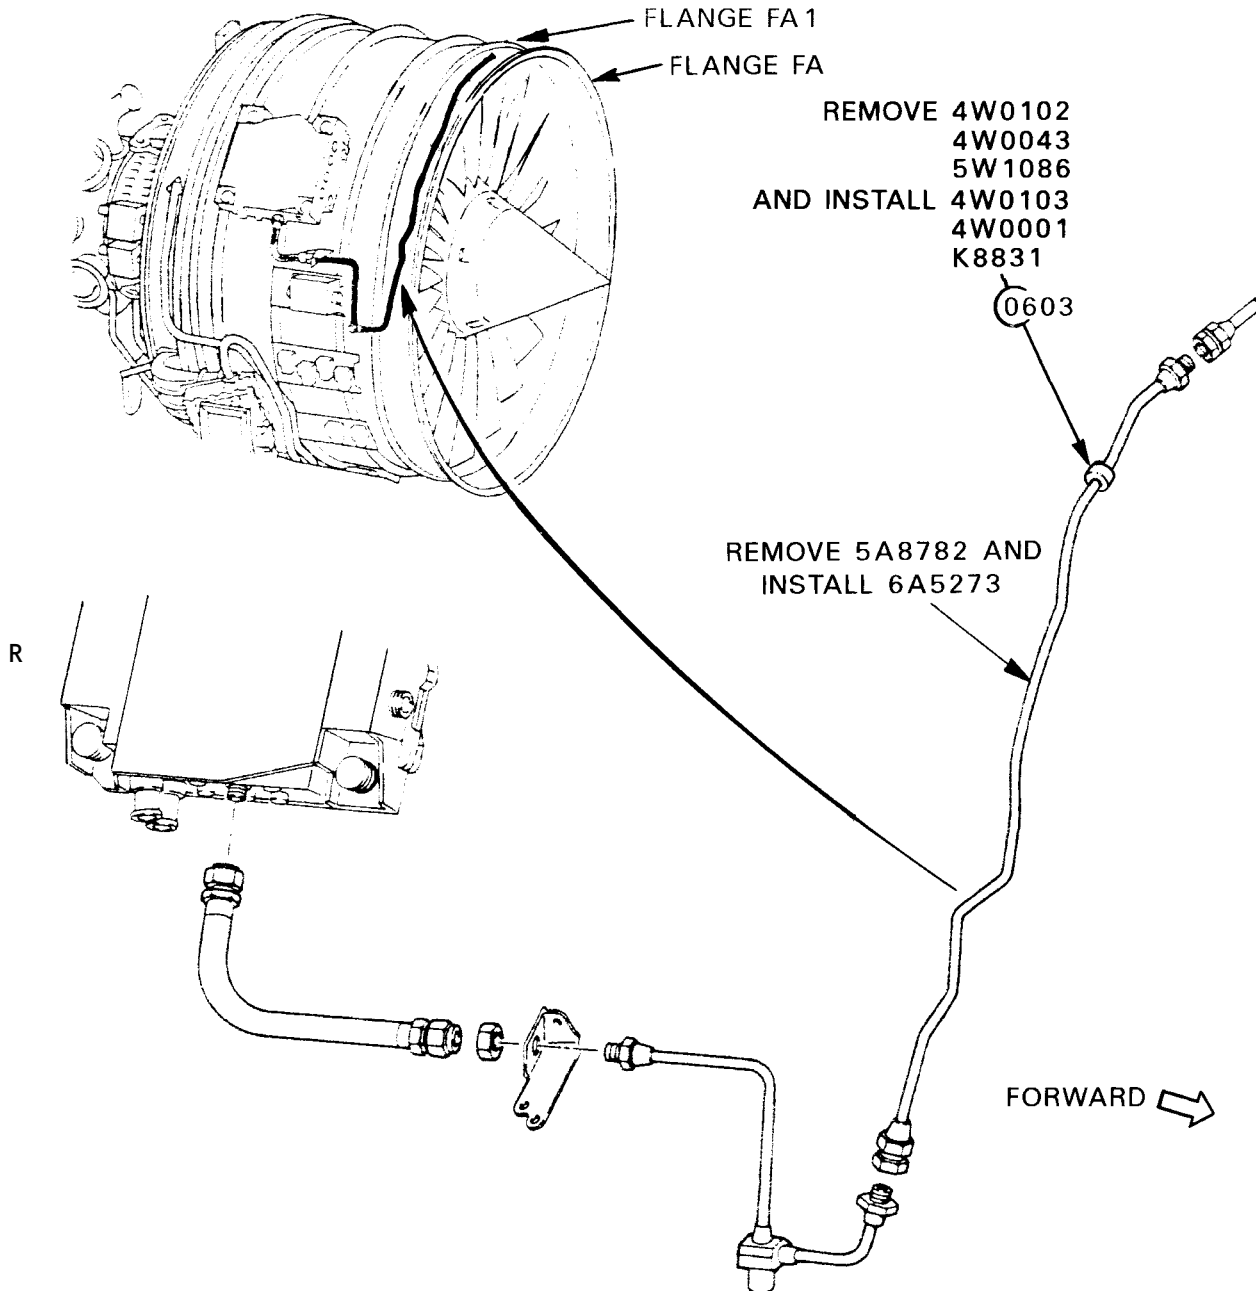
Location of P2/T2 tube assembly and clipping point CP0603
Fig.1

In certain instances there may be insufficient clearance between clipping point CP0603 and the thermal anti-icing (TAI) duct.

During fitting of the TAI duct, damage may occur at the rubber clip on clipping point CP0603. The clip involved fastens the P2/T2 tube to the front flange of the fan case.

- (1) Disassemble clipping points 1053, 1054, 1055 and 0603 sufficiently to remove the 5A8782 tube. Refer to Figure 1.
- (2) Disconnect the couplings at each end of the 5A8782 tube and remove the tube.
- (3) Install the 6A5273 tube and connect the hose and tube couplings.
- (4) Assemble clipping points 1053, 1054 and 1055.
- (5) Assemble the modified clipping point 0603 using the new 4W0103 bolt, K8831 washer and 4W0001 nut. Refer to Figure 2.
- (6) Torque the hose nut to 135 to 145 lbfin (15,26 to 16,39 Nm).
- (7) Torque the tube coupling nut to 70 to 80 lbfin (7,9 to 9,0 Nm).
- (8) Safety the hose nut and the tube coupling nut with CoMat 02-126 lockwire.
- (9) Torque the bolts at clipping points 1053, 1054, 1055 and 0603 to 36 to 45 lbfin (4 to 5 Nm).
