**SERVICE BULLETIN**

ENGINE - FUEL AND CONTROL - DO A CLEARANCE CHECK BETWEEN THE BRACKET AND THE FUEL
NOZZLE SUPPLY MANIFOLD - CATEGORY CODE 3 - MOD.ENG-73-0042

V2500-ENG-73-0042

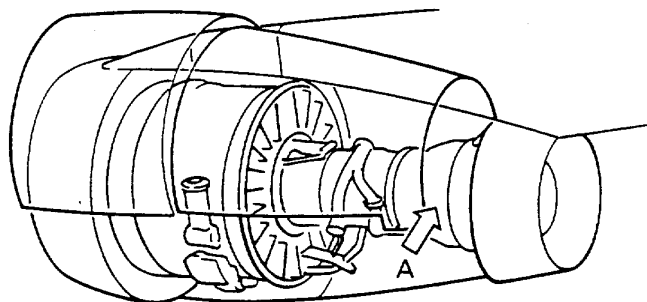
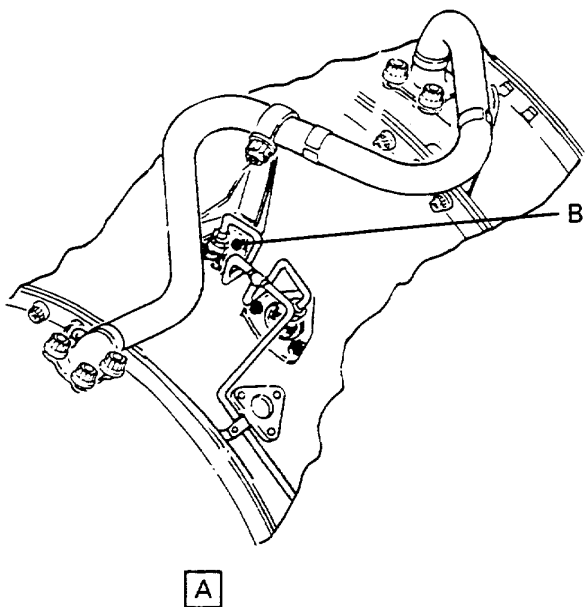
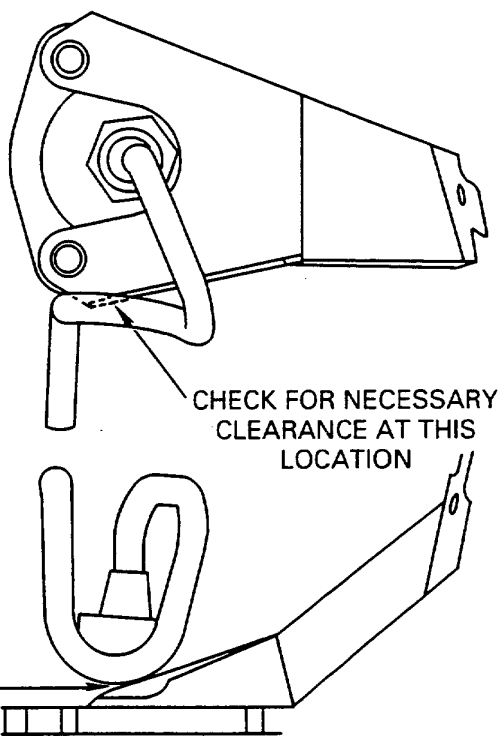
Inspection location fuel nozzle supply manifold (No. 18 position) to bracket clearance
Fig.1

The clearance between the 2A1488 Bracket and the 2A1389-01 Fuel Nozzle Supply Manifold on certain engines can be insufficient.

- (5) Measure and make a record of the minimum clearance between the 2A1488 Bracket and the 2A1389-01 Fuel Nozzle Supply Manifold. Refer to Figure 1.

CHECK FOR NECESSARY
CLEARANCE AT THIS
LOCATION

VIEW AT LOCATION **B**

- (c) If the clearance is 0.098 in. (2,489 mm) or more no further action is necessary.

- (d) If the clearance is between 0.000 and 0.035 in. (0,000 and 0,89 mm) proceed as follows:
- 1 Replace the 2A1389-01 Fuel Nozzle Supply Manifold immediately. Do the approved procedure in reference (1), Control No./TASK No. 73-11-41-400-010.

- (e) If the clearance is between 0.035 and 0.098 in. (0,89 and 2,49 mm) proceed as follows:
- 1 Replace the 2A1989-01 Fuel Nozzle Supply Manifold at the next scheduled 'A' Check, subsequent to the inspection or within 400 hours. Do the approved procedure in reference (1), Control No./TASK No. 73-11-41-400-010.

- (f) After the new Fuel Nozzle Supply Manifold is installed, do an inspection to make sure that there is a minimum of 0.098 in (2,489 mm) clearance between the manifold and the 2A1488 Bracket.
