## SERVICE BULLETIN

ENGINE - FUEL AND CONTROL - TO PROVIDE A NEW ELECTRONIC ENGINE CONTROL (EEC) WITH THE  
SCN12B SOFTWARE CONFIGURATION - CATEGORY CODE 4 - MOD.ENG-73-0044

# V2500-ENG-73-0044

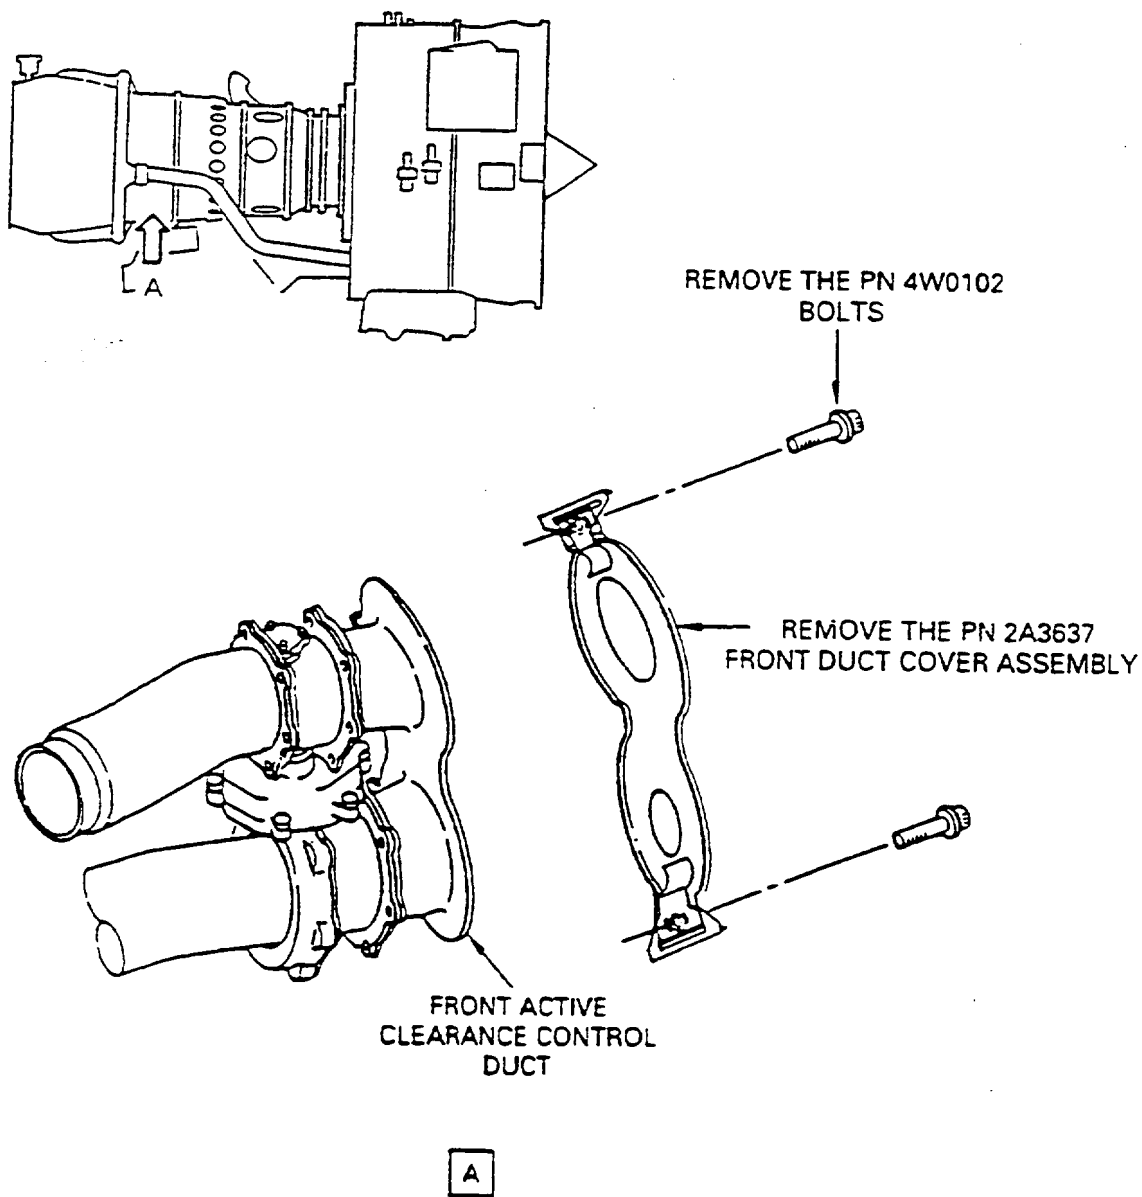
Location of ACC Front Duct Cover Assembly  
Fig.2

NOTE: When you incorporate this Service Bulletin with the new SCN12B software logic, the Front Duct Cover Assembly given in Reference (1) must be removed.

- (a) Send the Electronic Engine Control to the approved vendor to be modified. See Figure 1.
- (2) Remove the Active Clearance Control (ACC) Front Duct Cover Assembly. Refer to Reference (1) and Figure 2.
  - (a) Locate the Front ACC Duct.
  - (b) Remove the two 4W0102 Bolts from the Front Duct Cover Assembly.
  - (c) Remove the 2A3637 Front Duct Cover Assembly.
