ENGINE - FUEL AND CONTROL - ENGINE - FUEL SYSTEM TUBES - RESET FUEL RETURN TUBE -
DISCONNECT TO FUEL METERING UNIT - CATEGORY CODE 7 - MOD.ENG-73-0049

V2500-ENG-73-0049

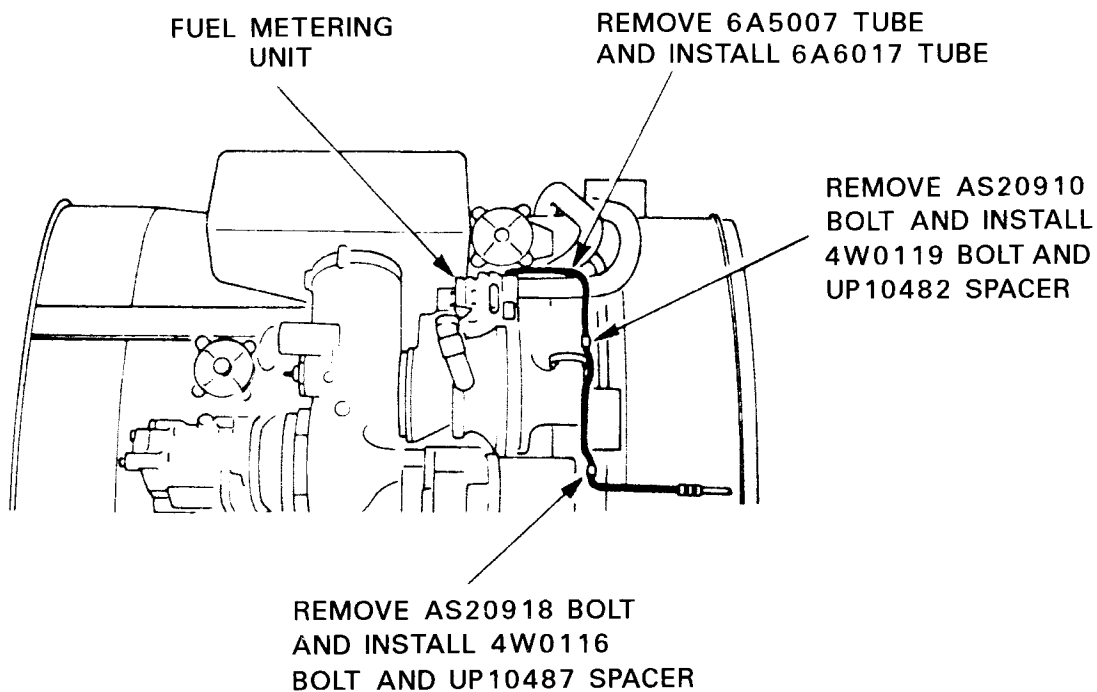
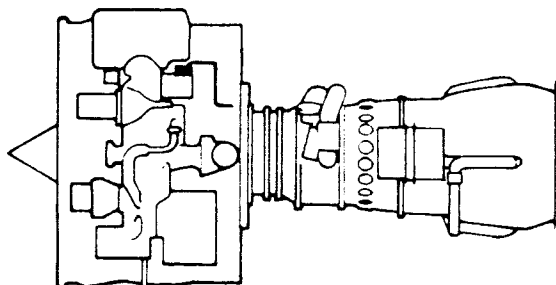
Location of fuel return tube - Disconnect to F.M.U.
Fig.1

Limited clearance between two fuel tubes has been reported on engine build of V2500-A5.

During build of the V2500-A5 first production engine a possible interface condition was highlighted between the fuel return tube - disconnect to F.M.U. and the fuel servo tube from the F.M.U. to the L.P. fuel pump.

- (1) Find the 6A5007 fuel tube. Refer to Figure 1.

- (2) Put the container in position under the 6A5007 fuel tube.

- (3) Remove the three bolts that attach the 6A5007 tube to the FMU, cut the lockwire and disconnect the fuel tube connector.

- (7) Remove the 6A5007 fuel tube.

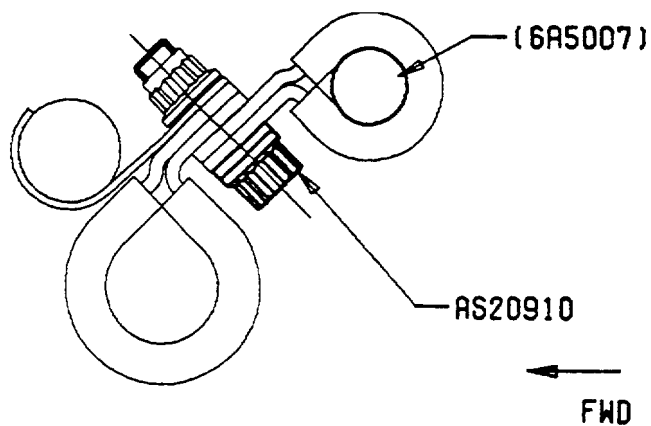
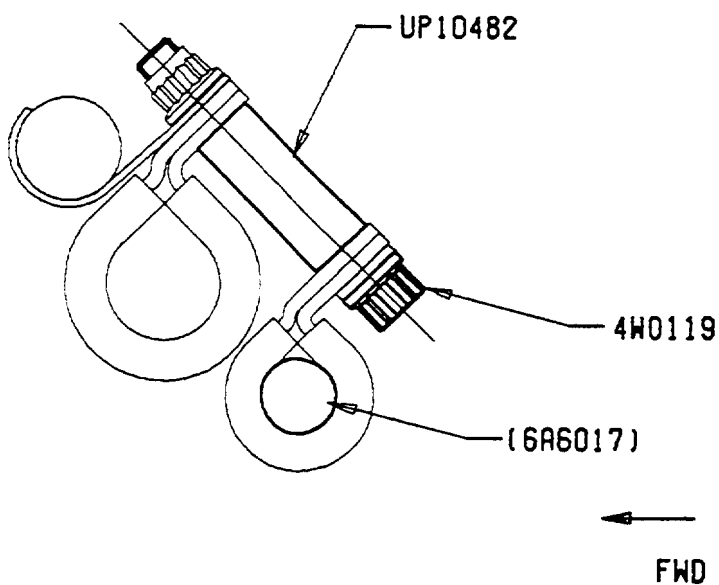
Clipping point CP 1131
Fig.3

- (1) A new fuel return tube assembly having a revised run local to the L.P. fuel pump and F.M.U. is introduced.
- (2) Existing clipping points (CP1131 and CP1134 are modified by the addition of a spacer to accommodate the new tube run.

- (5) Remove the bolt, washer, clips and nut at clipping point CP 1131 sufficiently to allow removal of the 6A5007 fuel tube.

- (14) Install the 4W0119 bolt, washer, UP10482 spacer, clips and nut at clipping point CP1131.

(16) Torque the nut and bolt at clipping points CP 1131 and CP 1134 to 36 to 45 lbfin (4 to 5 Nm).
