ENGINE - FUEL AND CONTROL - PROVIDE RE-ROUTED P4.9 PRESSURE CONTROL MANIFOLDS -  
CATEGORY CODE 7 - MOD.ENG-73-0050

V2500-ENG-73-0050

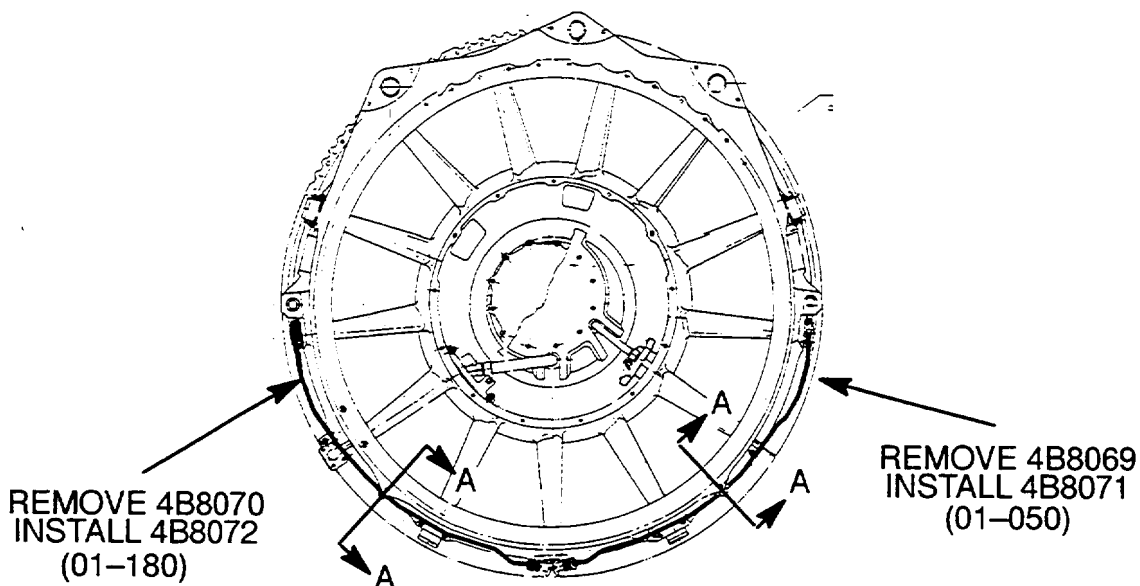
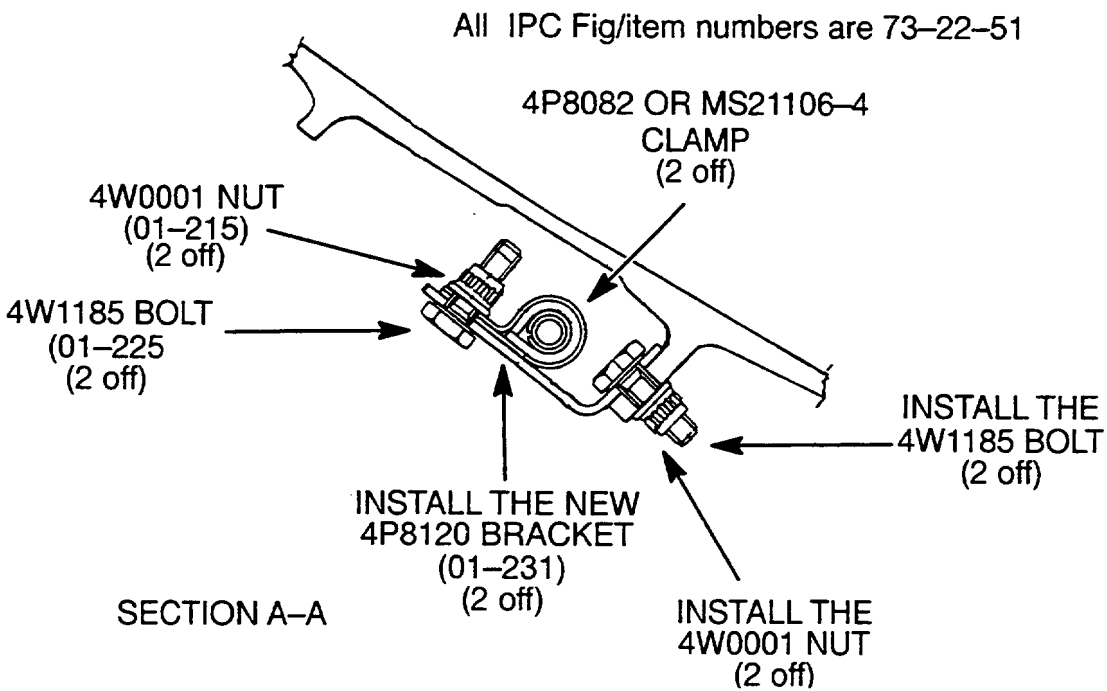
Pressure control manifolds - New configuration  
Fig.1

Potential of limited clearance between thrust reverser heat shield and P4.9 manifold

Wear on P4.9 manifold has been reported in service.

This Service Bulletin introduce re-routed P4.9 pressure manifolds designed to proper clearance with the thrust reverser. In addition two new brackets have been added.

- (1) Install the two new 4P8120 brackets on to the TEC. See figure 1 for position and details. Install the bolts and the nuts. Torque the nuts and the bolts to 40 lbf·in (4,5 Nm.)
- (2) Install the new 4B8071 and 4B8072 pressure control manifolds by the approved procedure in Reference (3) Chapter/section 73-22-51, Removal/Installation.
