SERVICE BULLETIN

ENGINE – FUEL AND CONTROL – TO PROVIDE A NEW ELECTRONIC ENGINE CONTROL (EEC) WITH THE
SCN9A SOFTWARE CONFIGURATION AND HARDWARE CHANGES TO ADDRESS NACELLE DRAINAGE
REQUIREMENTS – CATEGORY CODE 3 – MOD.ENG-73-0052

V2500-ENG-73-0052

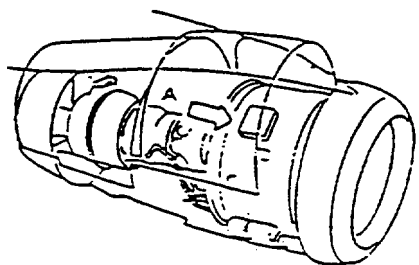
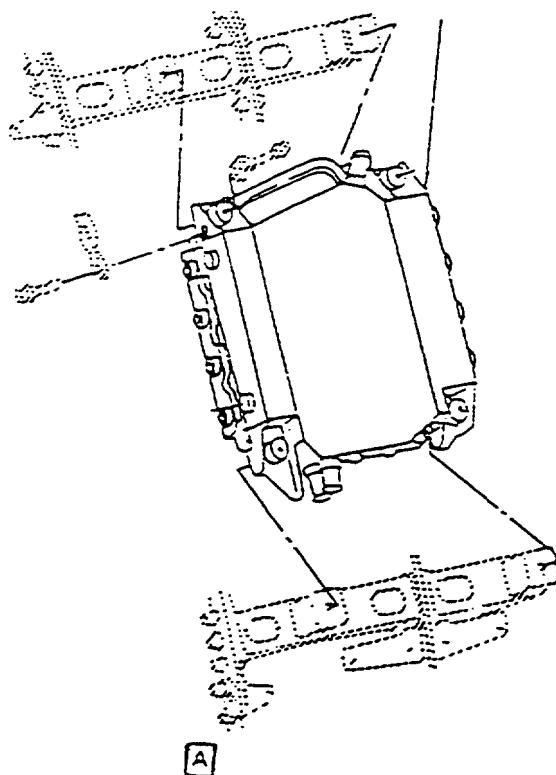
Location of Electronic Engine Control (EEC)
Fig.1

- (o) EEC Fluid Drainage: The EEC150-20 Upper Shock Mounts are retaining 3.5 to 11.5 cubic centimeters (CC) of fluid, which is in excess of the certification requirement of 3 CC.

(o) EEC Fluid Drainage: During the Nacelle Drainage certification testing, on the A321/V2500-A5, the EEC150-20 upper shock mounts retained fluid in excess of the 3CC maximum allowed. The cause of the fluid retention is a result of the position of the the EEC as mounted on the Fan Case.

- (1) Remove the 2A2989 Electronic Engine Control by the approved procedure given in Reference (3), Chapter/Section 73-22-34, Removal/Installation. Refer to Figure 1.

- (1) Install the 2A3098 Electronic Engine Control (1 off) by the approved procedure given in Reference (3), Chapter/Section 73-22-34, Removal/Installation. See Figure 1.

REMOVE THE 2A2989
ELECTRONIC ENGINE
CONTROL AND INSTALL
THE 2A3098 ELECTRONIC
ENGINE CONTROL (1 off)
