ENGINE - FUEL AND CONTROL - ENGINE FUEL AND CONTROL - FUEL SYSTEM TUBES - FUEL SERVO
TUBE WITH REPOSITIONED CLIPPING LUG - CATEGORY CODE 7 - MOD.ENG-73-0053

V2500-ENG-73-0053

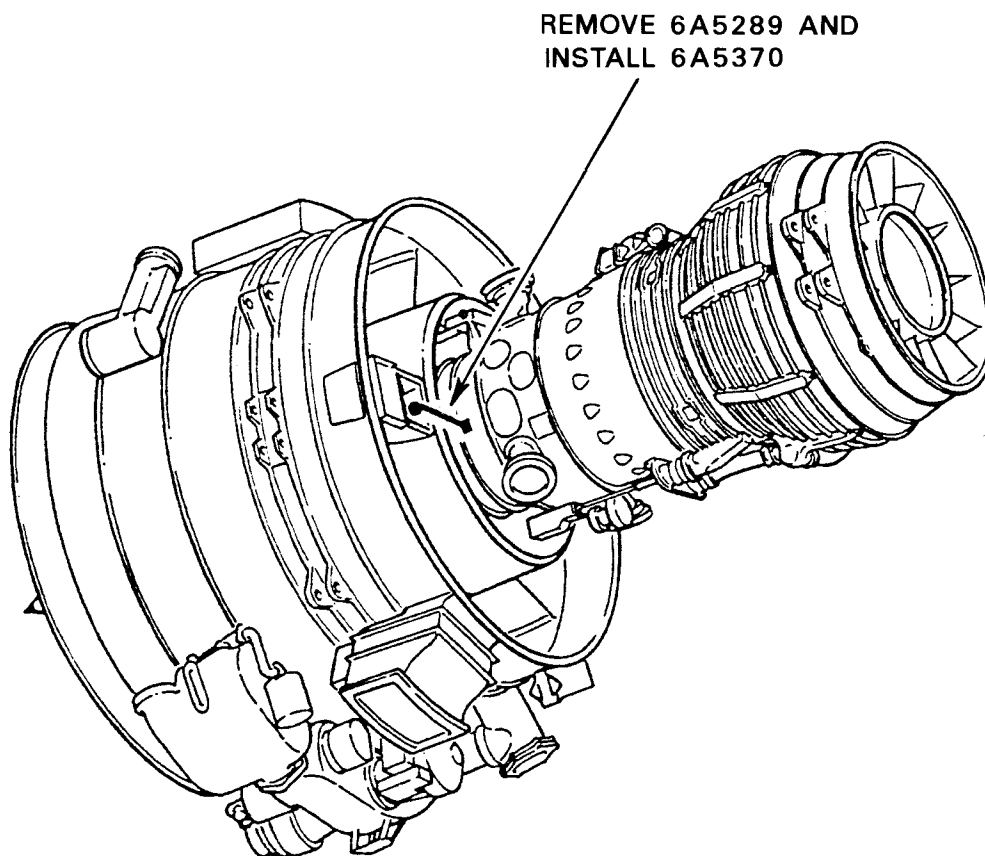
Location of fuel servo tube
Fig.1

Insufficient access to secure clip point 7004.

At build of the first D5 engine it was not possible to tighten the bolt at clip point 7004. The proximity of the LH bifurcation box cross-beam precluded spannering access. The clip point secures together the servo fuel supply and return tubes between the bifurcation box and 4 way adaptor.

The tube supplying fuel to the B.S.B.V. actuators is replaced by an identical tube on which the clipping lug has been repositioned.

Clip point CP7004A is replaced by CP7004.

REMOVE 6A5289 AND
INSTALL 6A5370
