ENGINE - FUEL AND CONTROL - NEW FUEL DIVERTER AND RETURN VALVE ASSEMBLY WITH NEW CAP SEAL AND ENLARGED SOLENOID ORIFICE - CATEGORY CODE 5 - MOD.ENG-73-0054

No. 13298-73-003

ENGINE - FUEL AND CONTROL - NEW FUEL DIVERTER AND RETURN VALVE ASSEMBLY WITH NEW CAP SEAL AND ENLARGED SOLENOID ORIFICE

No. 17300-73-003

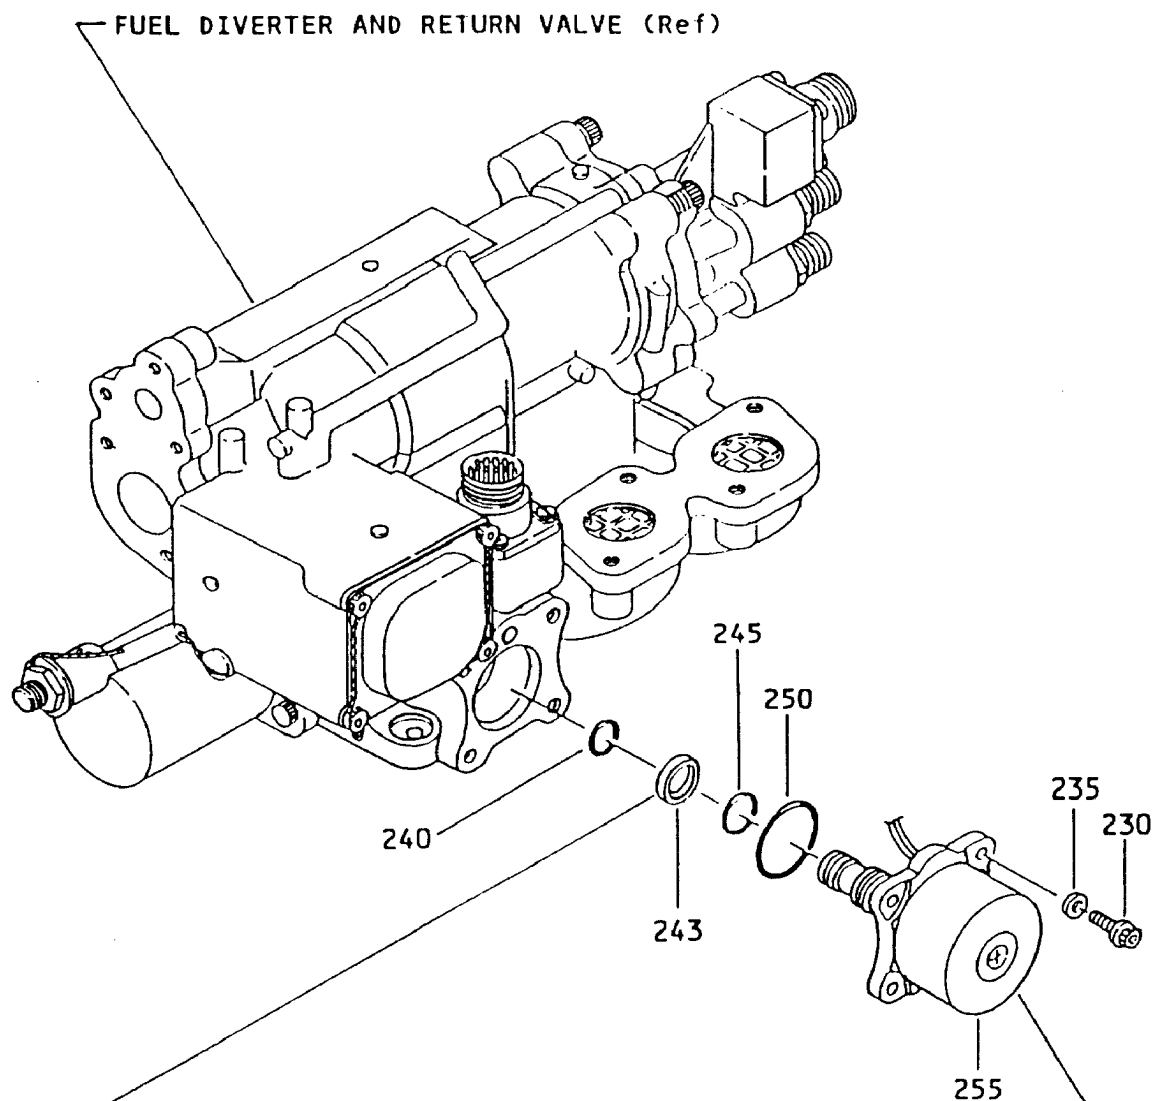
Location of the Cap Seal and Solenoid Assembly
(Additional, Old and New Part Configuration)
Figure 1

Wear occurrence have been observed on packing of solenoid valve in the Fuel Diverter Valve (FDV).

Wear of the solenoid valve packing in the FDV causes internal fuel leakage and FDV can not operate correctly in solenoid de-energized condition.

- (f) Remove the M25988/1-119, M25988/1-014 and M25988/1-013, installed packing on solenoid assembly (Refer to Figure 1).
- (g) Install the M25988/1-014, packing on to the solenoid assembly.

INSTALL THE 2411770, CAP SEAL (1 Off)
ON PACKING (245).

REPLACE THE EXISTING PN 2411760-7 SOLENOID ASSEMBLY (1 Off),
WITH THE NEW PN 2411760-9 SOLENOID ASSEMBLY (1 Off).

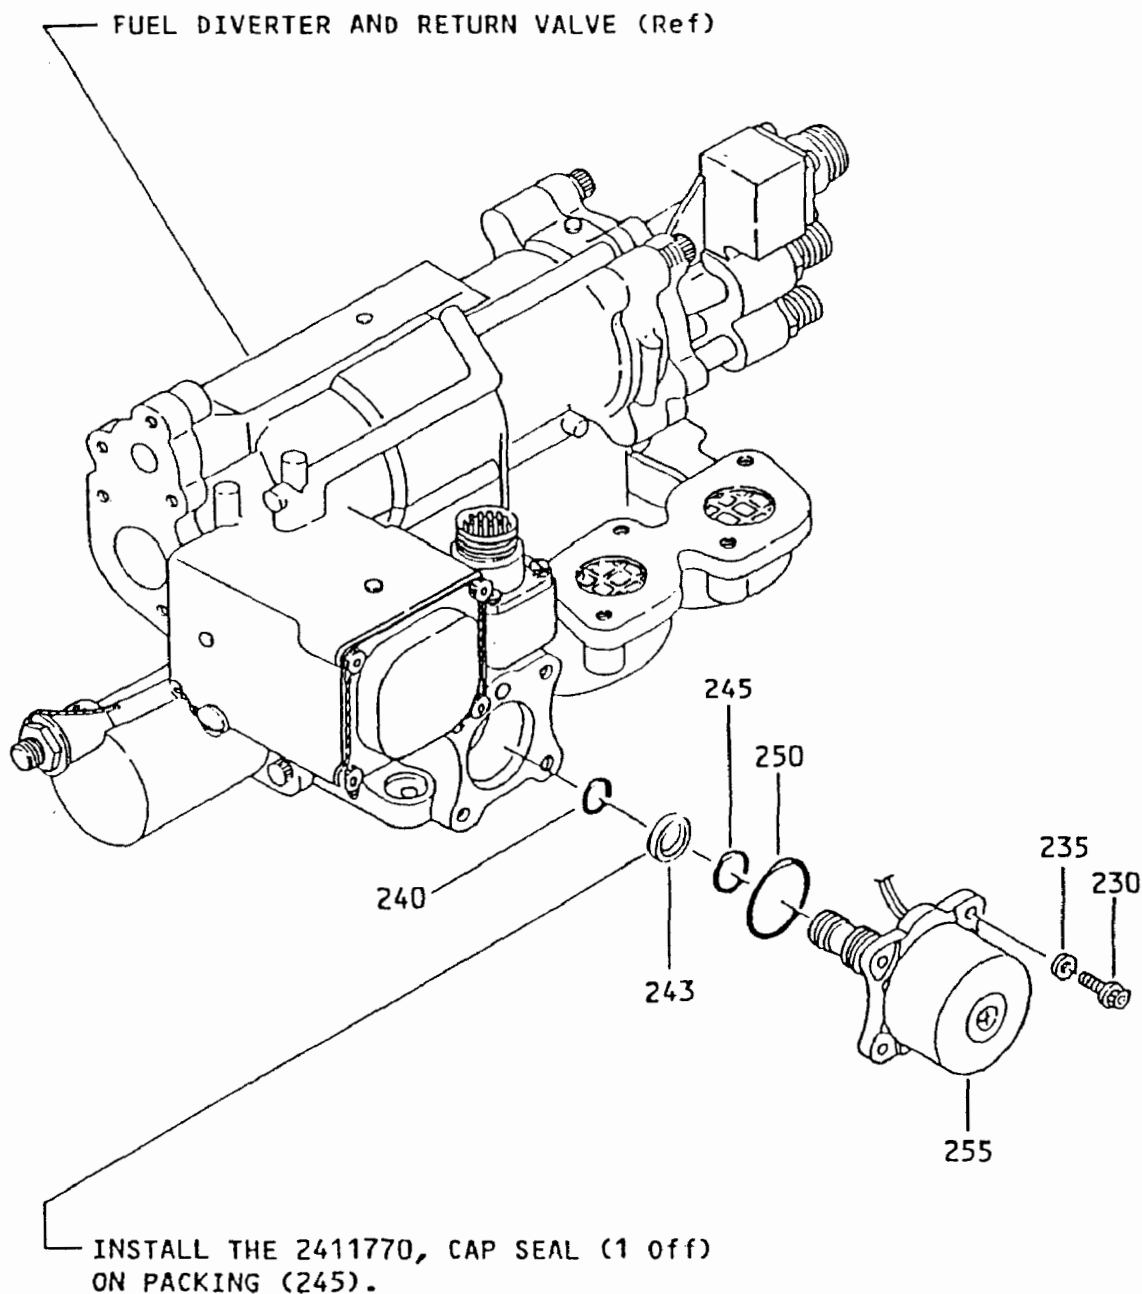
Location of the Cap Seal
(Additional New Part Configuration)
Figure 1

Wear occurrence have been observed on packing of solenoid valve in the Fuel Diverter Valve (FDV).

Due to wear in the FDV solenoid valve packing the FDV can not operate correctly under solenoid de-energized condition.
This condition causes fuel leaks.

- (a) A cap seal has been introduced which will prevent the packing from excessive wear.
- (b) Incorporation of this SB is designed to improve unit reliability.
