ENGINE - FUEL AND CONTROL - FUEL SYSTEM TUBES - TUBE SUPPORT BRACKET ATTACHED WITH  
HEX-HEAD BOLTS - CATEGORY CODE 6 - MOD.ENG-73-0059

**V2500-ENG-73-0059**

## SERVICE BULLETIN

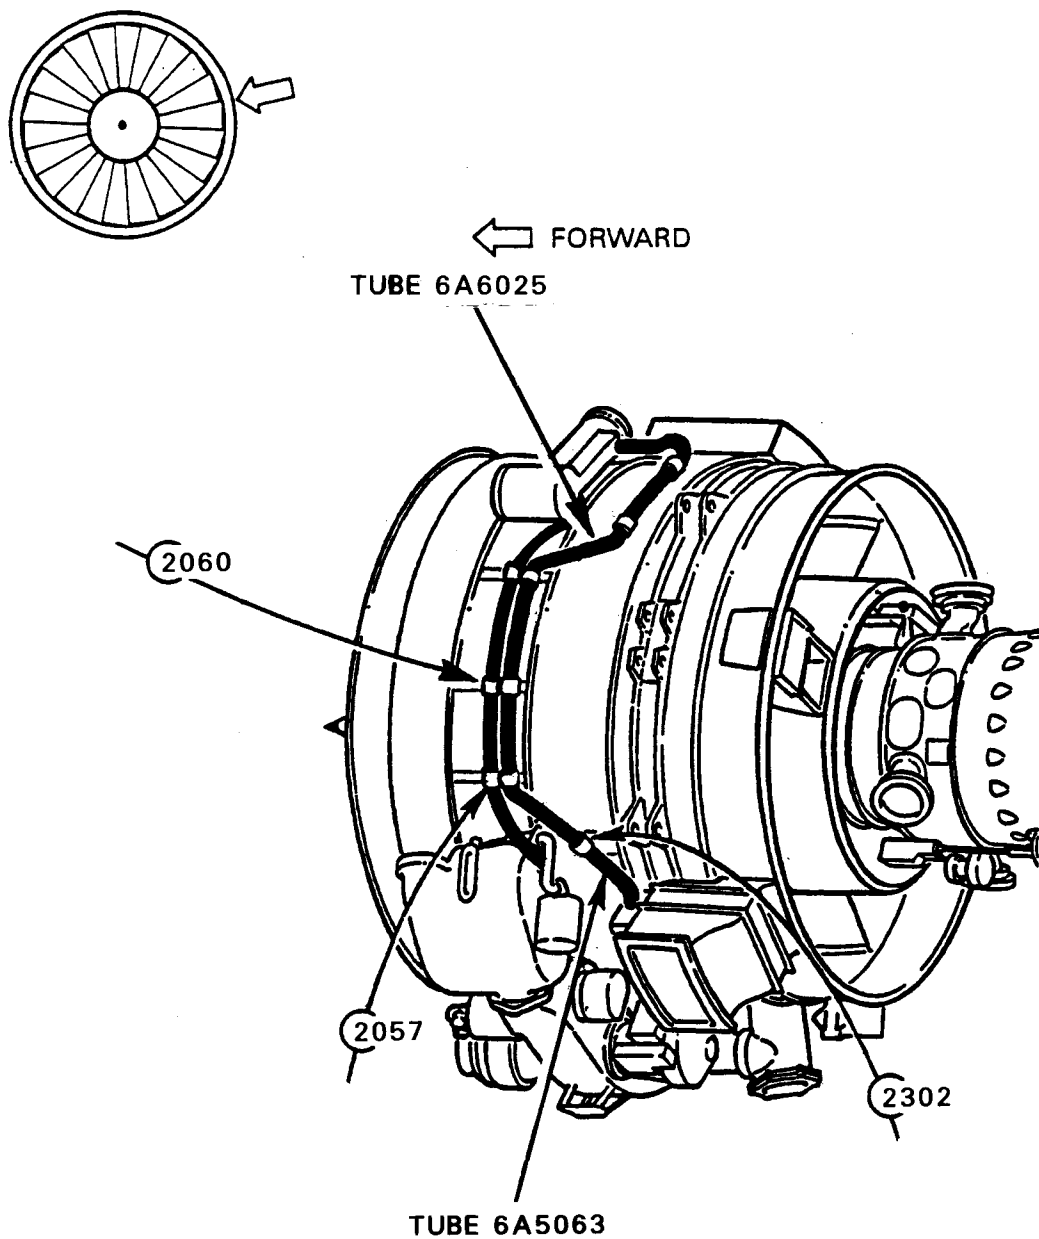
Location of clipping points 2057, 2060 and 2302  
Fig.1

- (1) Find 6A5063 oil tube. Refer to Figure 1.
- (2) Disconnect the electrical connector from the scavenge oil temperature thermocouple.
- (3) Remove the AS21016 bolts (3 off) that attach the 6A5063 oil tube to the Air Cooled Oil Cooler. Remove the 6A5063 oil tube and retain the AS21016 bolts.

- (4) Cut the lockwire and disconnect the union connecting the 6A5063 oil tube to the 6A6025 oil tube.
- (5) Disassemble clipping point CP2302 from bracket assembly and retain AS20908 bolt.

- (6) Disassemble clipping points CP2057 and CP2060 sufficiently to remove the clipping points from bracket assemblies. Install 4W0001 slave nuts (2 off) at clipping points to retain parts.

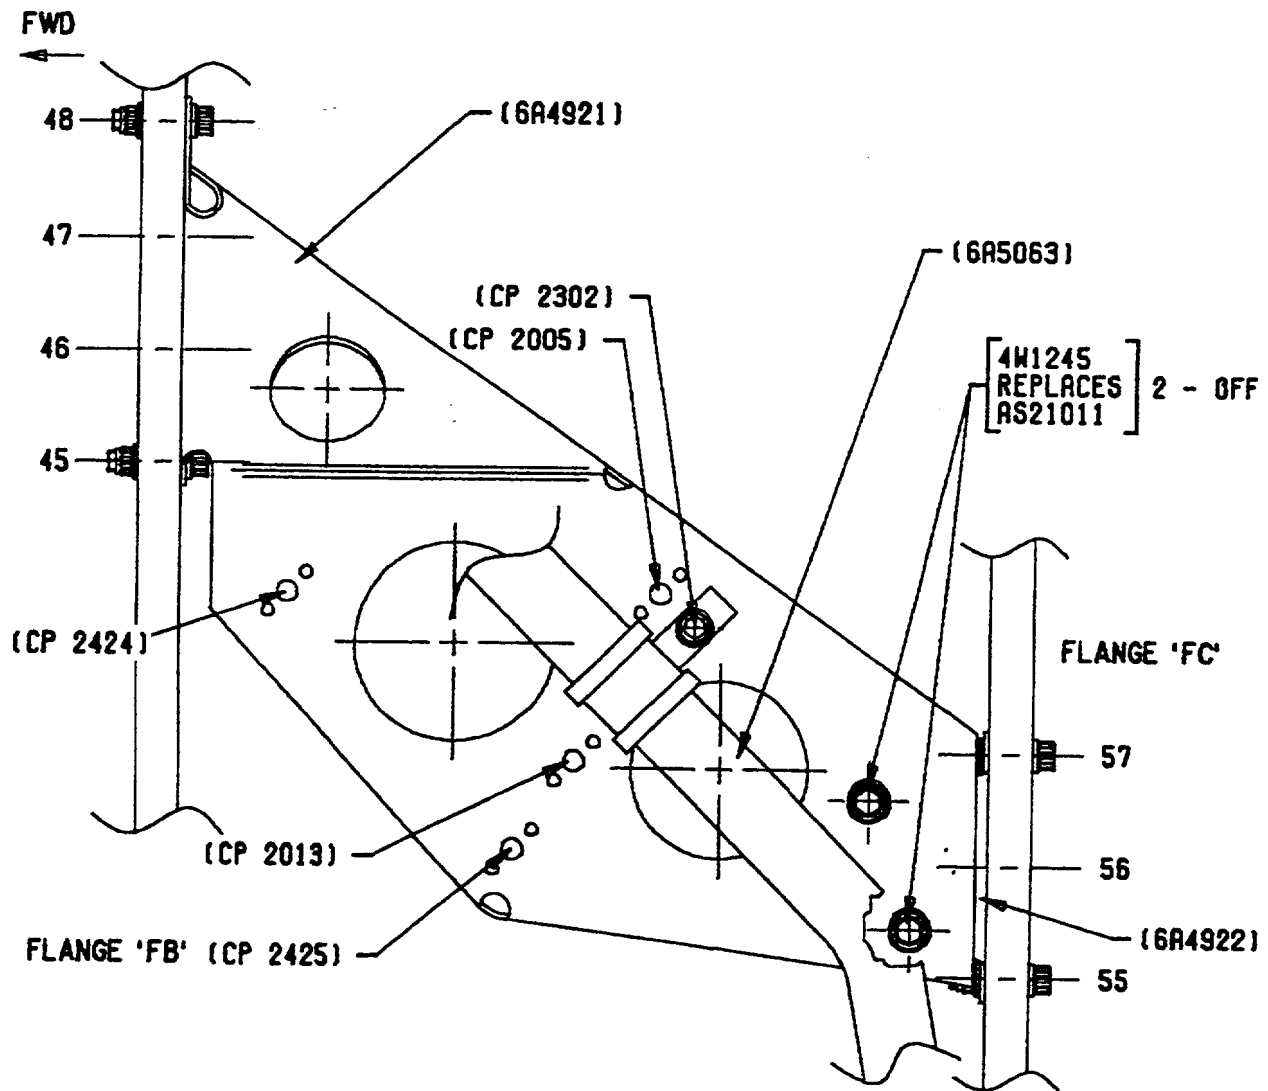
Limited clearance exists between the Air Cooled Oil Cooler to Fuel Cooled Oil Cooler oil tube and tube support bracket retaining bolt heads.

During assembly it was highlighted that limited clearance existed between the Air Cooled Oil Cooler to Fuel Cooled Oil Cooler oil tube and the bolts which secure the tube support bracket to mounting bracket located on Fan Case flange FC.

View on bracket raft assembly showing location of modified bolts - Before and after alteration  
Fig.2

- (1) The tube support bracket bi-hex bolts are replaced with hex-headed bolts.

- (8) Remove the AS21011 bolts (2 off) and 4W2622 washers (2 off). Retain the washers, discard the bolts. Refer to Figure 2.
- (9) Install the new 4W1245 bolts (2 off) and 4W2622 washers (2 off). Torque the bolts to 85 to 105 lbfin (10 to 12 Nm). Refer to Figure 2.
