ENGINE - FUEL AND CONTROL - REPLACE THE TUBE CLIP AT CLIPPING POINT 0795 - CATEGORY
CODE 4 - MOD.ENG-73-0060

V2500-ENG-73-0060

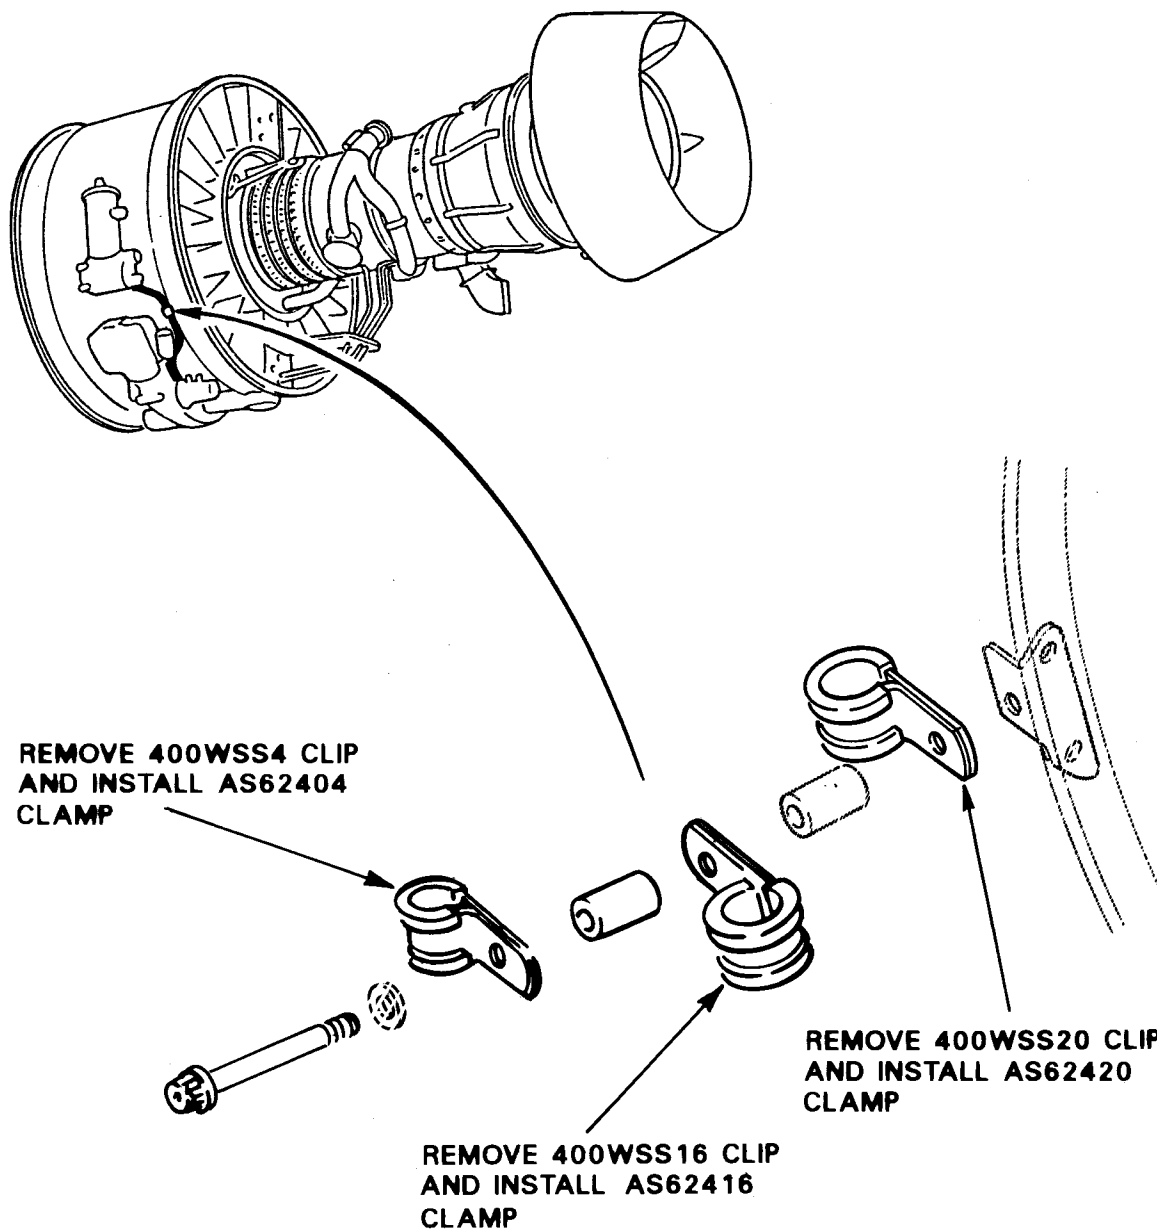
Location at clipping point 0795
Fig.1

Fretting could occur on the fuel cooled oil cooler (F.C.O.C.) to fuel pump fuel tube in the area of clipping point 0795.

The fretting results from relative movement between the clip and tube, the metal clip eventually wearing through the rubber sleeve to fret directly on the tube. The movement is permitted due to a loose fit of the clip on the tube.

- (1) Remove the bolt AS20940, the washer K8831, the two spacers UP10481 and UP10482 from clipping point 0795. Refer to Figure 1.
- (2) Remove clips 400WSS4, 400WSS16 and 400WSS20.
- (3) Discard clips.

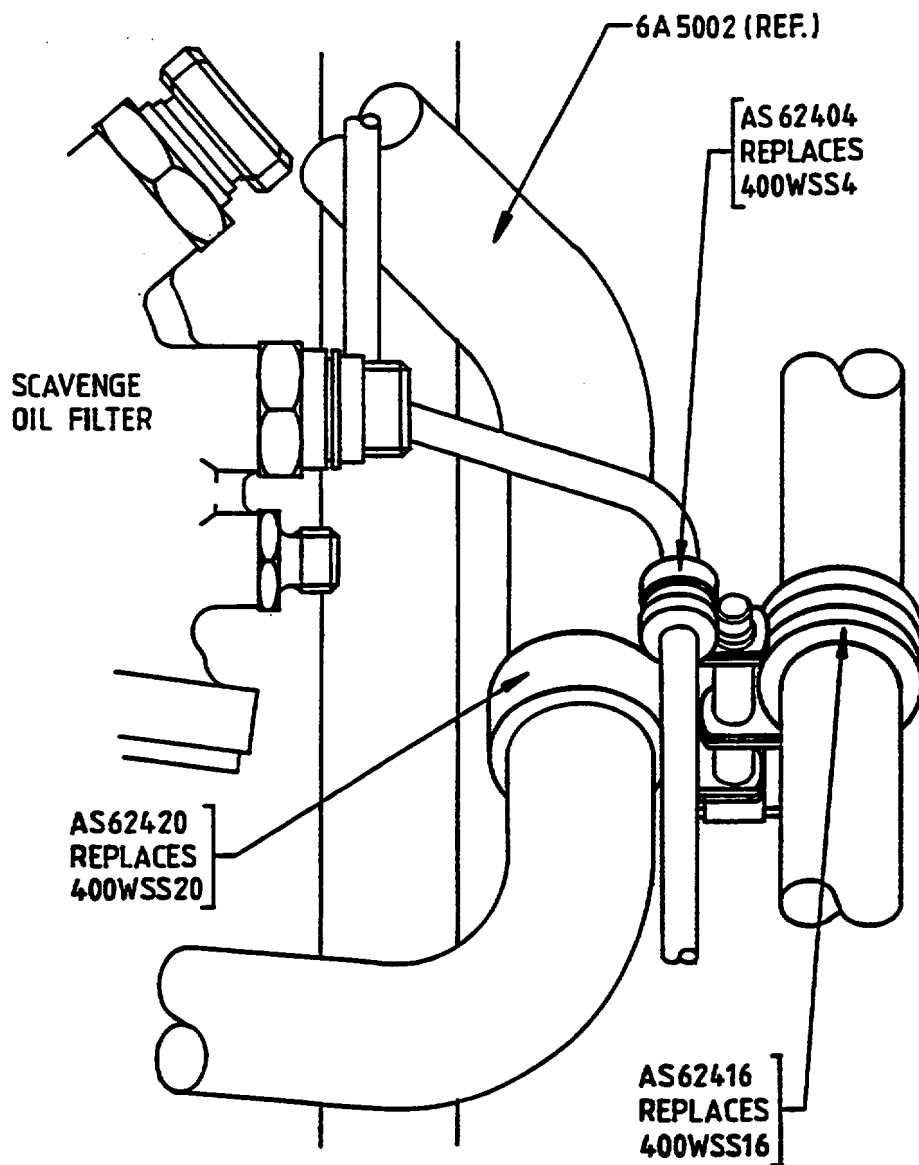
View of clipping point 0795 - Before and after alteration
Fig.2

- (a) Tube clamps with a thicker rubber sleeve replace the existing clips at clipping point 0795. The new clamps have a tighter fit with the tube compared to the existing clips.

- (1) Secure the F.C.O.C. to fuel pump fuel tube to clipping point 0795 using clamps AS62404, AS62416, bolt AS20940, washer K8831, spacers UP10481 and UP10482. Torque the bolt to 36 to 45 lbf·in (4 to 5 Nm). Refer to Figures 1 and 2.
