ENGINE - FUEL AND CONTROL - FUEL SYSTEM AIR TUBES - RE-POSITIONED CLIPPING POINT -
CATEGORY CODE 6 - MOD.ENG-73-0064

V2500-ENG-73-0064

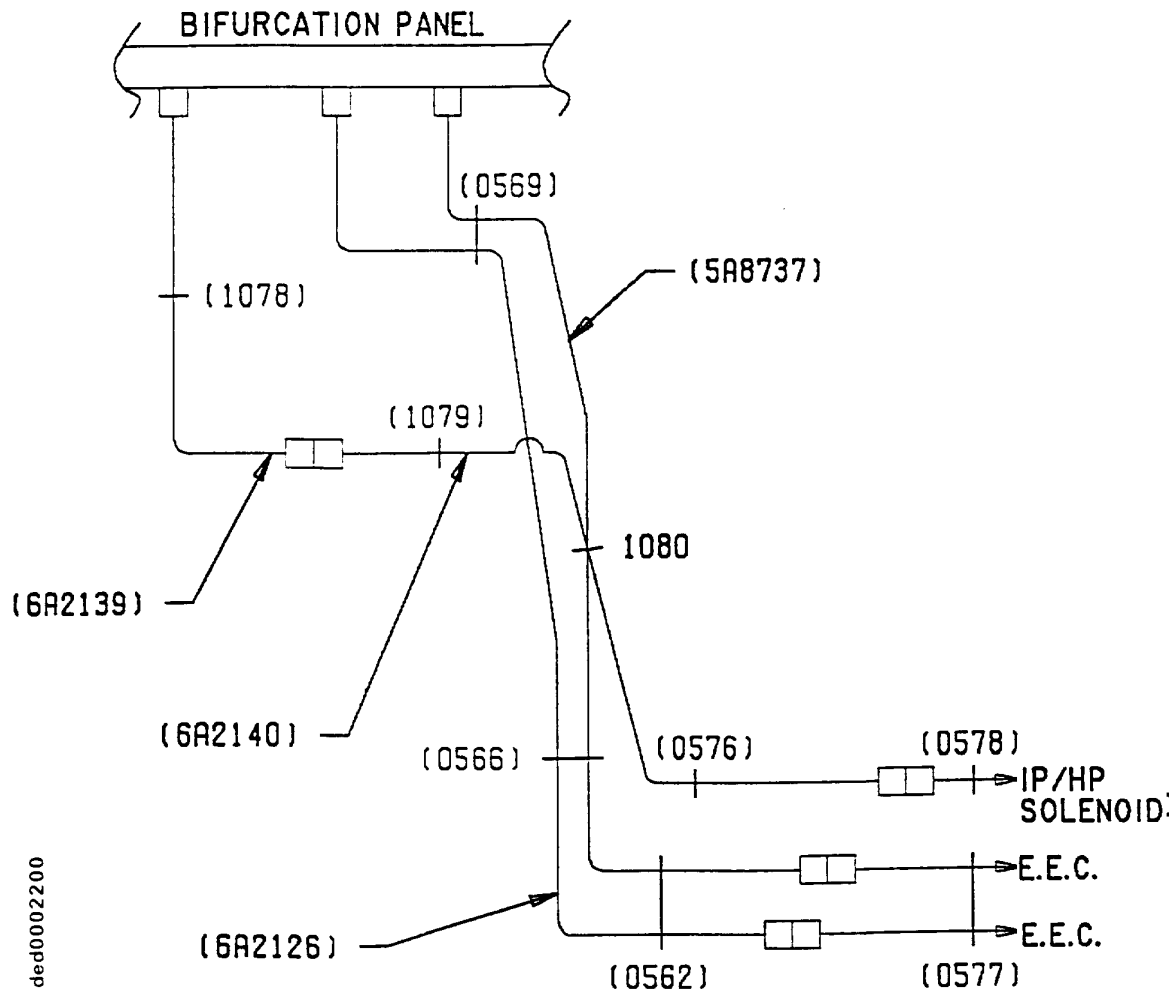
Assembly of clipping point CP1080 can be difficult.

The problem is caused by insufficient space around the clipping point.

Schematic view of clipping configuration of air tubes - Before alteration
Fig.1

- (1) Replace the bolt of CP1080 (Refer to Figures 1 and 3)
 - (a) Remove the clip point from tubes 5A8737 and 6A2140
 - (b) Discard the bolt 4W0104.
- (2) Install CP1080 in a different position (Refer to Figures 2 and 3)
 - (a) Install the top clip of CP1080 to tube 6A2126
 - (b) Install the bottom clip of CP1080 to tube 6A2140
 - (c) Safety CP1080 with the bolt 4W0103, washers and nut.

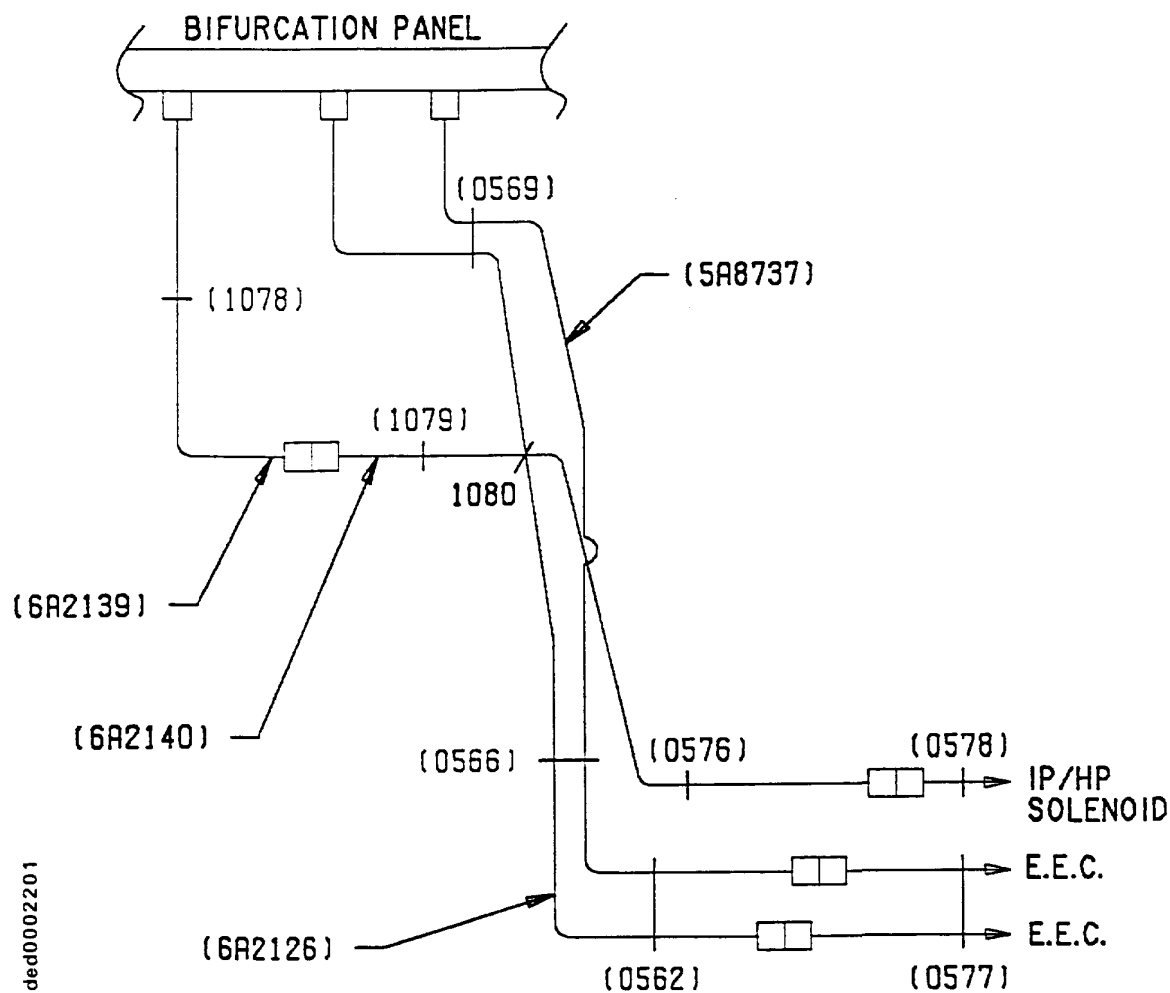
- (a) The length of the bolt at clipping point CP1080 has been shortened. In addition the clipping point CP1080, has been moved approximately 0.5in. along the over-ride air tube of the Stage 10 bleed valve. The clipping point is attached to the P2.5 not the P4.9 air-tube assembly.

Schematic view of clipping configuration of air tubes - After alteration
Fig.2

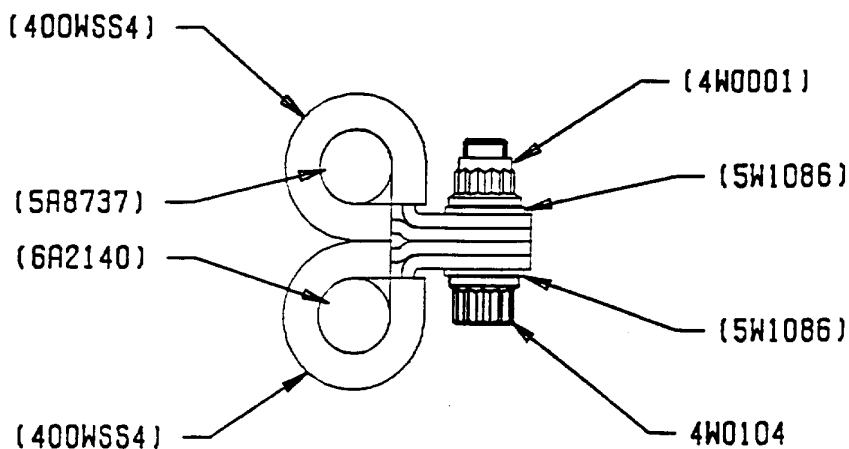
VIEW ON C.P.I080
BEFORE ALTERATION

View on CP1080 - Before and after alteration
Fig.3

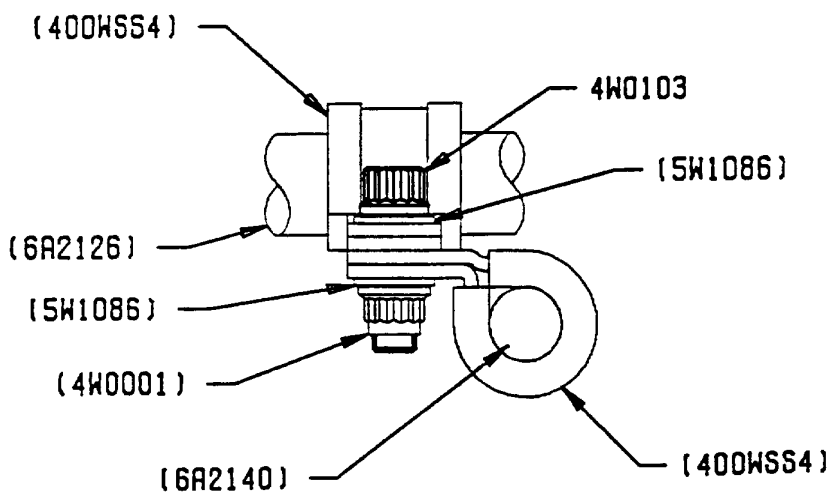
VIEW ON C.P.I080
AFTER ALTERATION
