ENGINE - FUEL AND CONTROL - FUEL TUBES - INTRODUCTION OF SMALLER CLIP AT CLIPPING POINT  
7031 - CATEGORY CODE 6 - MOD.ENG-73-0066

V2500-ENG-73-0066

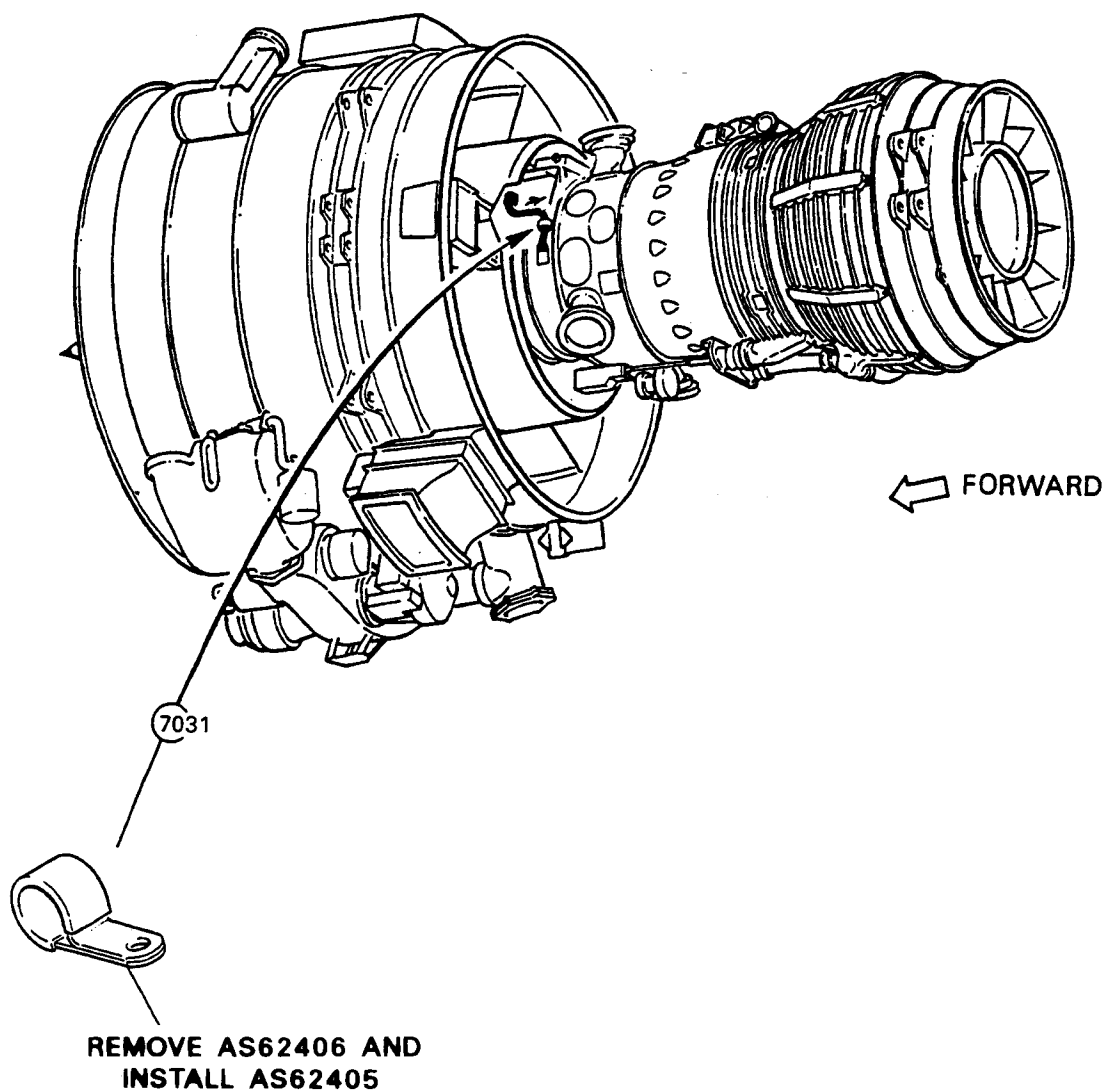
Location of clip at clipping point 7031  
Fig.1

During assembly it was highlighted that the clip currently installed at clipping point 7031 is too large to make sure the Bleed Valve Actuator Master to disconnect fuel pipe is correctly secured.

A smaller clip replaces the existing clip at clipping point 7031.

- (1) Remove the AS20624 nut and 4W0133 bolt, disassemble clipping point 7031 sufficiently to remove AS62406 clip. Refer to Figures 1 and 2.

- (1) Assemble existing clipping point 7031, using new AS62405 clip, existing AS20624 nut, 4W0133 bolt and hardware. Refer to Figures 1 and 2.
- (2) Torque the nut to 36 to 45 lbfin (4 to 5 Nm)
