ENGINE - FUEL AND CONTROL - REPLACE THE FUEL PUMP PACKINGS WITH PACKINGS MADE FROM
IMPROVED MATERIAL - CATEGORY CODE 6 - MOD.ENG-73-0067

V2500-ENG-73-0067

NO. STS-73-001

ENGINE - FUEL AND CONTROL - REPLACEMENT OF LP/HP FUEL PUMPS FACE SEAL
ASSEMBLY AND O-RINGS

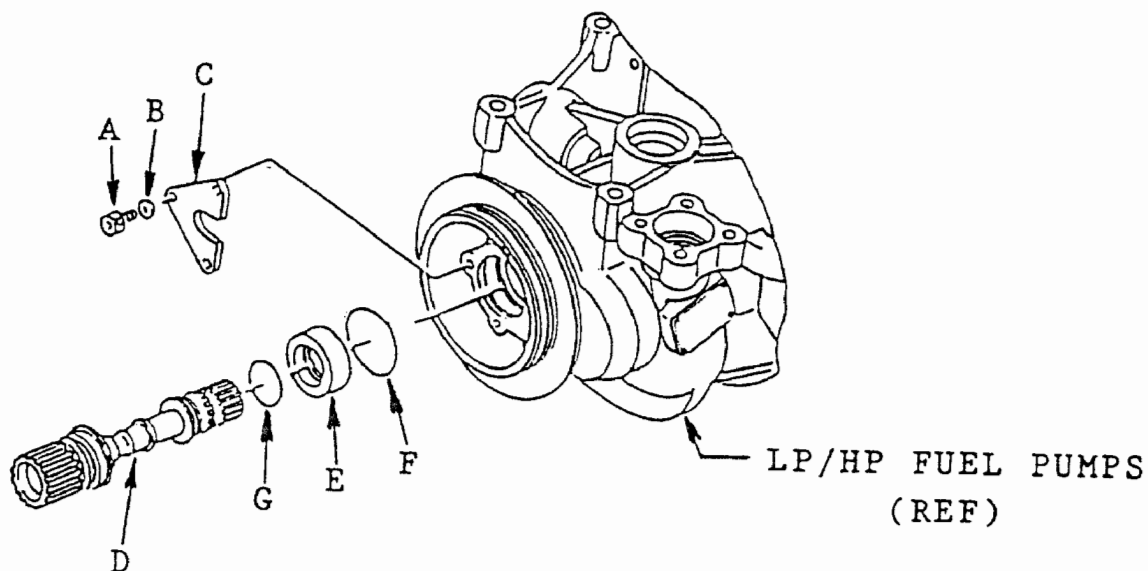
Figure 1
Input shaft sealing portion

Inspection on several returned units from operators due to static leakage revealed deterioration (Compression Set) on fluorosilicone packings which are installed the input shaft of the LP/HP Fuel Pump.

The Face Seal Assembly includes internal and external O-Rings and one O-Ring installed on input shaft. These were made of Fluorosilicone and deteriorated under high temperature

condition. The O-Rings swell and take a permanent compression set. When boost pressure on the pump was cut off at room temperature, the O-Ring then reduces in size but still compresses and looses its squeeze and hence leaks.

- (1) Remove the screws (A), washers (B), seal retaining plate (C), and input shaft (D) from the pump.
- (2) Remove the face seal assembly (E) and packing (F) from the pump.
- (3) Remove the packing (G) from the input shaft (D).
- (4) Discard the face seal assembly (E) and packings (F and G).

Visual check mating surface on end of drive gear. There shall be no radial or spiral scratches on the surface. If there are radial or spiral scratches on the surface, the pump should be returned for repair.

Assemble the pump in accordance with the following instructions (refer to the Figure 1, Input shaft sealing portion of this service bulletin) with a new Face Seal Assembly and new O-Rings of Fluorocarbon.

NOTE: Pay attention that carbon face of the face seal assembly (E) to be facing toward drive gear.

- (2) Install the packing (G) on the input shaft (D).
- (3) Install the input shaft (D) and the seal retaining plate (C). Attach with the screws (20) and washers (B). Torque screws to 51 to 56 in-lbs. (5.76 to 6.32 Newton metres).

NOTE: Apply a small amount of vaseline (commercially available), when the O-Rings are installed to the input shaft and pump.
