ENGINE - FUEL AND CONTROL - INTRODUCTION OF AN IMPROVED FUEL PUMP - CATEGORY CODE 6 -  
MOD.ENG-73-0068

V2500-ENG-73-0068

NO. STS-73-002

ENGINE - FUEL AND CONTROL - MODIFICATION OF LP/HP FUEL PUMPS  
IMPELLER/INDUCER

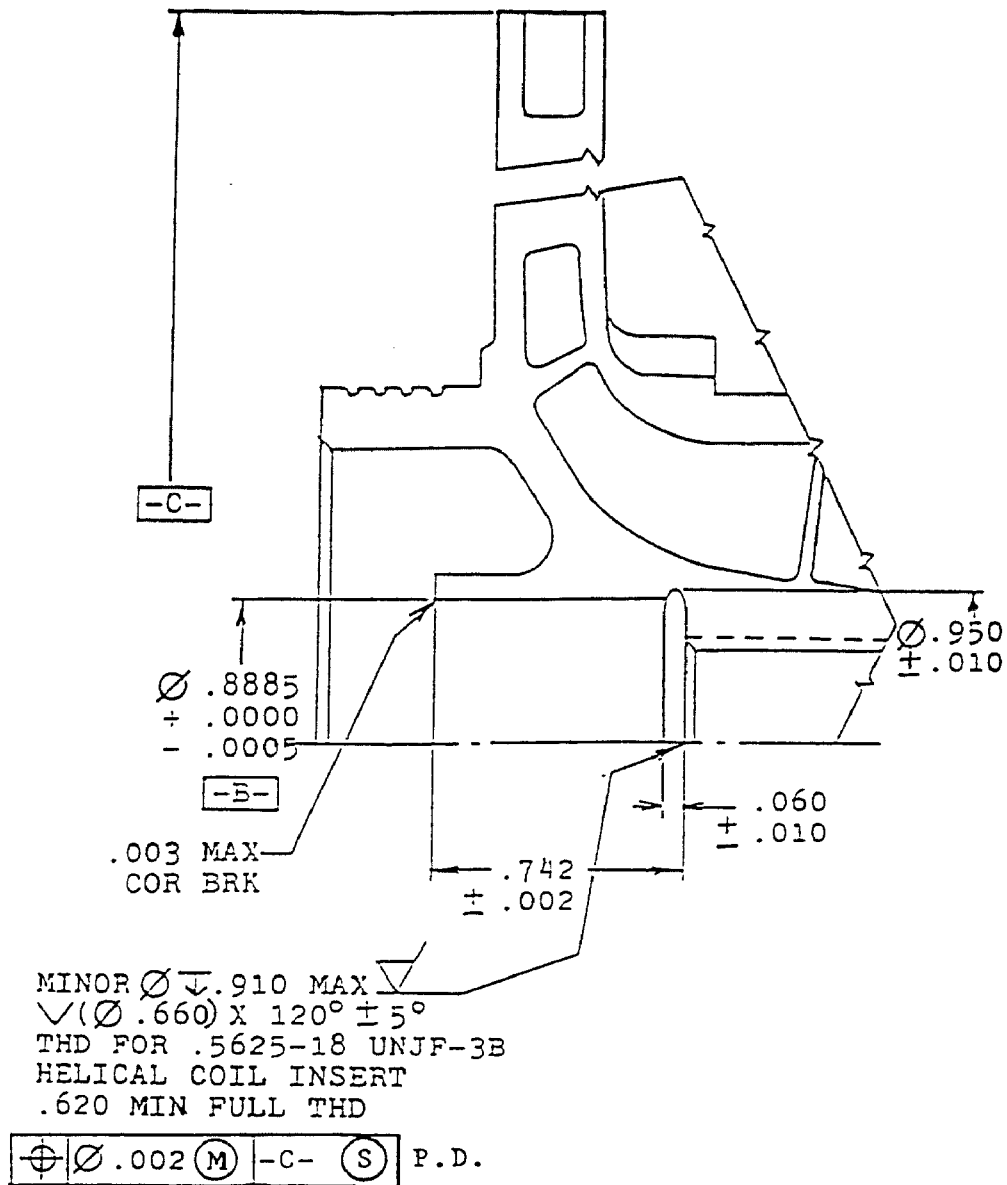
Modification of Impeller/Inducer  
Figure 1

Inspection of several LP/HP Fuel pumps from operators revealed wear on the impeller/inducer pilot and threads connecting the impeller/inducer to the fuel pump drive shaft.

Wear to the impeller/inducer was found to be the result of thermal cycling. Thermal cycling caused expansion and contraction of the aluminum impeller/inducer resulting in localized yielding of the aluminum impeller/inducer at the attachment to the steel drive shaft. In some pumps the localized yielding allowed enough axial movement of the impeller/inducer to cause interference with the center

plate housing. This interference caused a seizure of the impeller/inducer to the housing resulting in a sheared drive shaft during engine starting.

- (a) Machine impeller/inducer. (Refer to the Figure 1 of Modification of Impeller/Inducer.)
- (b) Perform local fluorescent penetrant inspection according to Sundstrand Standard Practices Manual, Bulletin 985, CHECK or Military Specification MIL-STD-6866.
- (c) Install helical coil (P/N MS21209F9-10) and spacer (P/N 762724).

- (d) Heat impeller/inducer and cool sleeve (P/N 762723) as required to obtain a temperature differential of at least 350 degrees Fahrenheit between the impeller and sleeve.
- (e) Install sleeve to bottom on spacer. Allow impeller/inducer to cool to room temperature.
- (f) Peen impeller/inducer on surface - D - of Figure 2 of Modification of Impeller/Inducer in four places to retain sleeve.
- (g) Finish machine impeller/inducer according to Figure 2.
- (h) Clean according to Sundstrand Standard Practices Manual, Bulletin 985, CLEANING or Cleaning instruction of the appropriate STS CMM (73-12-41 or 73-18-41 or 73-18-42).
