SERVICE BULLETIN

ENGINE - FUEL AND CONTROL - PROVIDE A NEW ELECTRONIC ENGINE CONTROL (EEC) WITH THE
SCN12C SOFTWARE CONFIGURATION - CATEGORY CODE 4 - MOD.ENG-73-0069

V2500-ENG-73-0069

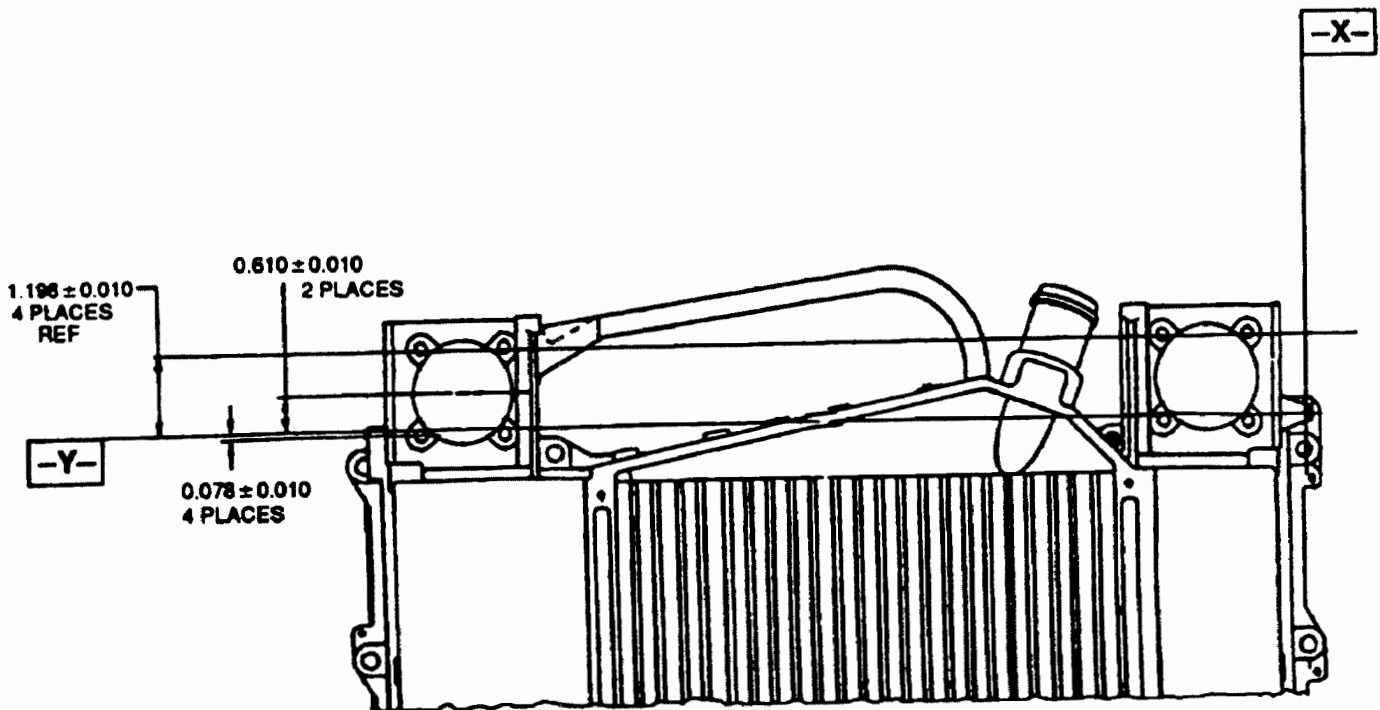
FIGURE 1 LOCATION OF X AND Y PLANES

- (s) **EEC FLUID DRAINAGE:** During the nacelle drainage certification testing on the A321/V2500-A5, the EEC150-20 upper shock mounts retained fluid in excess of the 3 cc maximum allowed. The cause of the fluid retention is a result of the position the EEC is mounted on the fan case. Since the EEC150-1 has a similar housing design, retention of fluid will also occur.

- A. Remove the flame shields as necessary to get access to the two vibration isolators adjacent to the EEC housing handle. To remove the flame shields, refer to DISASSEMBLY in CMM 73-22-34.
- B. Remove the two vibration isolators adjacent to the handle on the EEC housing. To remove the vibration isolators, refer to DISASSEMBLY in CMM 73-22-34.
- C. Refer to Figure 1 to establish X and Y planes.
