ENGINE - FUEL AND CONTROL - INTRODUCTION OF A NEW FUEL DIVERTER AND RETURN VALVE WITH
NEW MICROSWITCH ASSEMBLIES - CATEGORY CODE 6 - MOD.ENG-73-0081

V2500-ENG-73-0081

No: 13298-73-006

**ENGINE - FUEL AND CONTROL - NEW FUEL DIVERTER AND RETURN VALVE
WITH NEW MICROSWITCH ASSEMBLIES****1. Planning Information****A. Effectivity****(a) Engine**

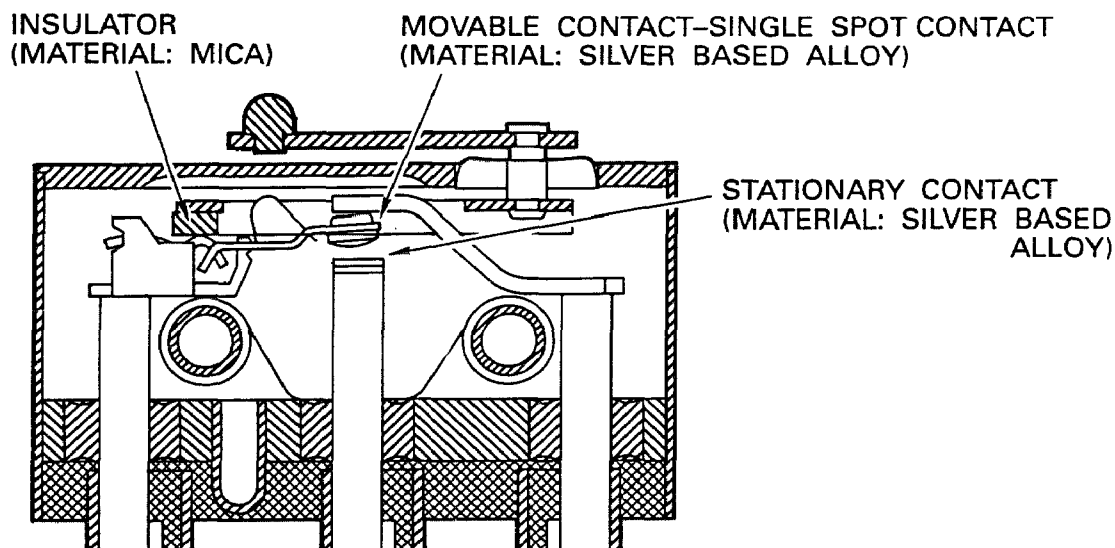
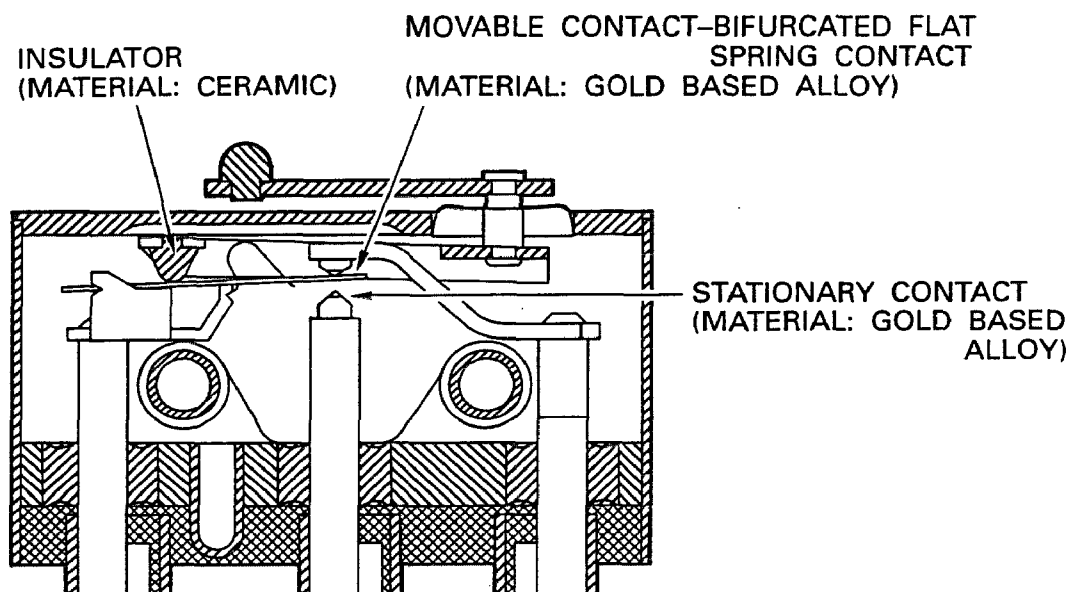
Specification Difference between the existing and the new Microswitches
Figure 2

High resistance material was formed on the electrical contact of the Fuel Diverter Return Valve (FD&RV) Microswitch. It is considered that this was caused due to high temperature and high vibration.

- a) The Movable Contact in the Microswitch is changed from the single spot contact to the bifurcated flat spring contact.
- b) The contact material in Microswitch is changed from silver based alloy to gold based alloy.
- c) The insulator material in Microswitch is changed from mica to ceramic.

Existing Microswitch (Part No. 2411798-1 or 2411798-3/Type: 6HM1-1)

New Microswitch (Part No. 2411798-5 or 2411798-7/Type: 20HM1-1)

To change the materials of contact and insulator in the FD&RV Microswitch to prevent forming of high resistance material.

- (2) Existing FD&RV can be reworked by replacing the existing Microswitches with the new ones.
- (3) New Microswitches will be available for replacement purposes.
- (4) This Service Bulletin is comprised of the following two parts:

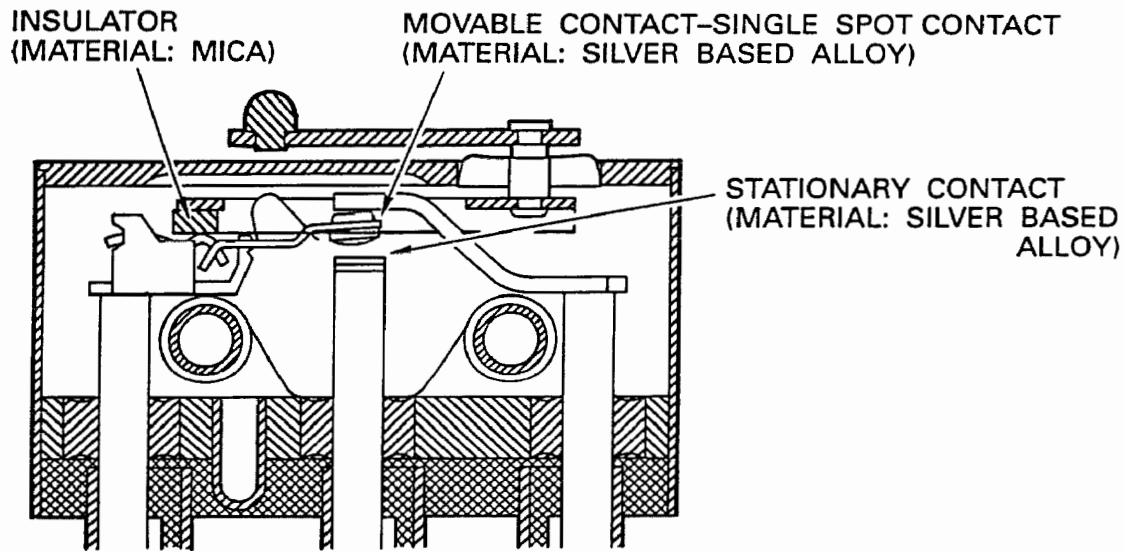
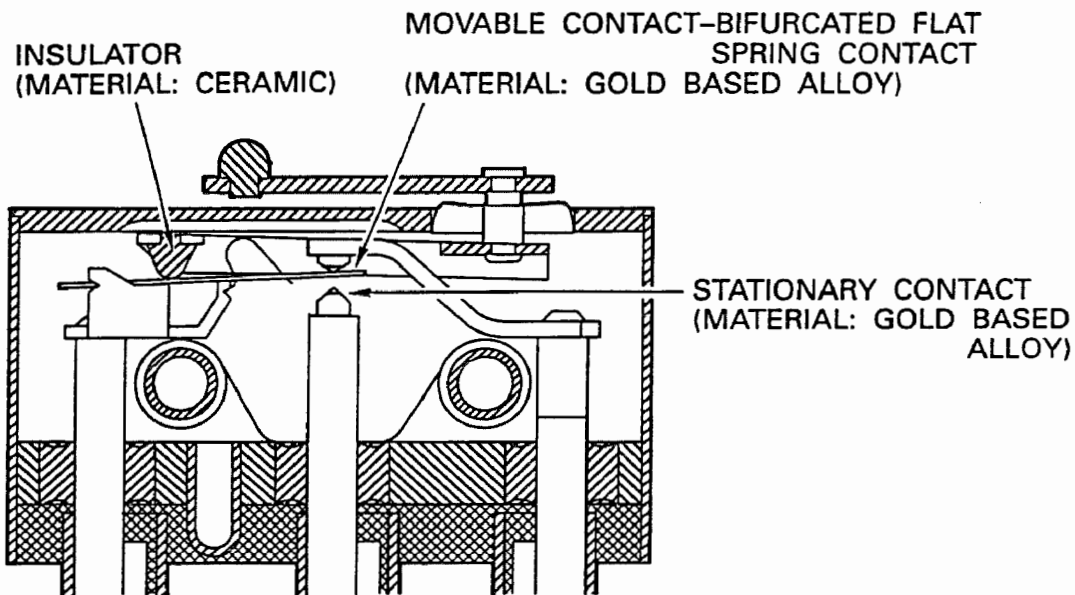
Specification Difference between the existing and the new Microswitches
Figure 2

High resistance material was formed on the contact of the Fuel Diverter Return Valve (FD&RV) Microswitch. It is considered that this was caused due to high temperature and high vibration.

- a) The Movable Contact in Microswitch is changed from the single spot contact to the bifurcated flat spring contact.
- b) The contact material in Microswitch is changed from silver based alloy to gold based alloy.
- c) The insulator material in Microswitch is changed from mica to ceramic.

Existing Microswitch (Part No. 2411798-1 or 2411798-3/Type: 6HM1-1)

New Microswitch (Part No. 2411798-5 or 2411798-7/Type: 20HM1-1)

To change the materials of contact and insulator in the FD&RV Microswitch to prevent forming of high resistance material.

(2) Existing FD&RV can be reworked by replacing the existing Microswitches with the new ones.
