SERVICE BULLETIN

ENGINE - FUEL AND CONTROL - ENGINE - ELECTRONIC ENGINE CONTROL - PROVIDE A NEW ELECTRONIC ENGINE CONTROL (EEC) WITH THE SCN12D SOFTWARE CONFIGURATION - CATEGORY CODE 4 - MOD.ENG-73-0082

V2500-ENG-73-0082

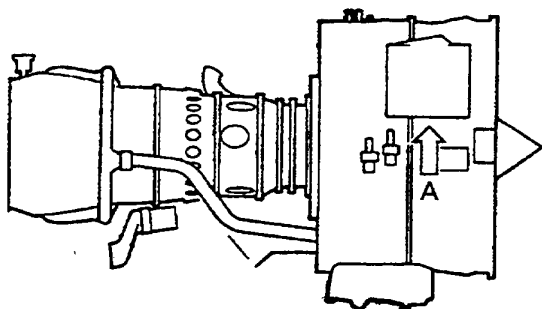
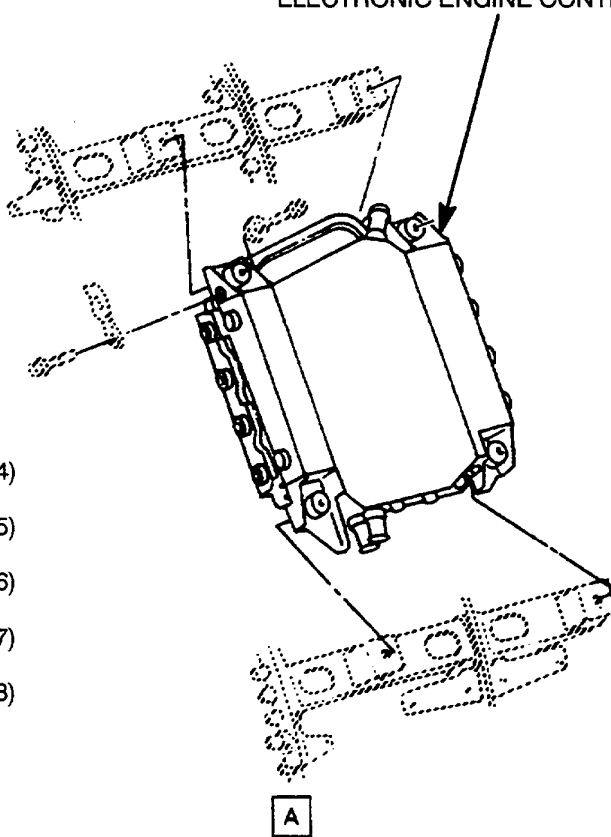
Location of the Electronic Engine Control (EEC)
Fig.1

REMOVE THE ELECTRONIC ENGINE CONTROL, DO THE CHANGE SPECIFIED, IDENTIFY AND INSTALL THE NEW ELECTRONIC ENGINE CONTROL (1 off) *
