# International Aero Engines SERVICE BULLETIN

Subject: Transmittal of Revision 1 to Service Bulletin No. V2500-ENG-73-0084

ENGINE - FUEL AND CONTROL - FUEL SYSTEM TUBES -  
INTRODUCTION OF RE-ALIGNED LP FUEL TUBE  
ASSEMBLY PRODUCED FROM STAINLESS STEEL MATERIAL

# V2500-ENG-73-0084

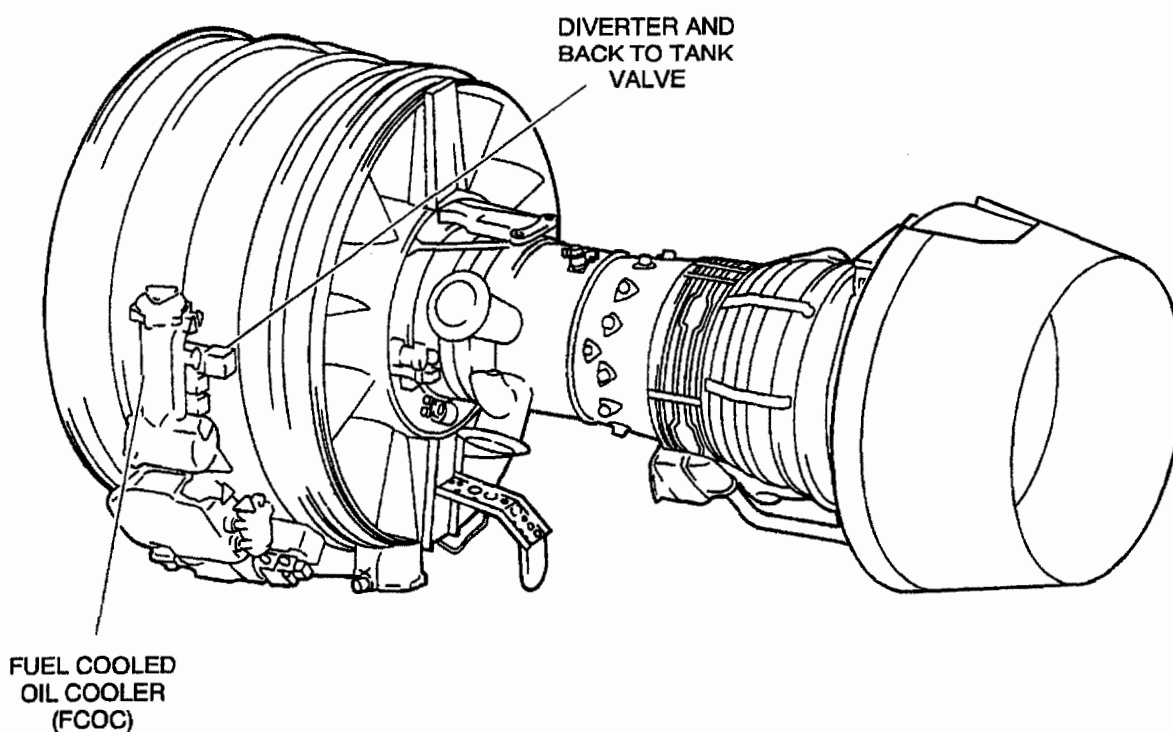
General View  
Fig 1

Wear of the Fuel Cooled Oil Cooler (FCOC) to diverter valve tube assembly can occur where the tube engages with the seal housing on the FCOC. In extreme cases this has resulted in fuel leaks.

R The problem is caused by a combination of the mis-alignment of the tube  
R and seal housing and the fretting resistance of the material not being  
R sufficient.

R This Service Bulletin introduces a revised LP fuel tube assembly between  
R the FCOC and the diverter valve with the changes that follow:

- (a) The tube material has been changed from titanium to stainless steel.
- R (b) The ferrule has been revised to contain a centralising spigot to  
control alignment to the FCOC mounted seal housing.
- R (c) The length of the tube assembly has been increased so that more of  
R the ferrule goes into the FCOC mounted seal assembly.
- R (d) The tube assembly will be produced with more tightly controlled  
R tolerances at the tube end locations. This will make sure that the  
tube is manufactured correctly and as a result, reduce the  
possibility of misalignment.
