ENGINE - FUEL AND CONTROL - INSPECT THE FUEL NOZZLE SUPPLY MANIFOLD ASSEMBLIES FOR THE  
CONDITION OF THE BRAZE JOINTS - CATEGORY CODE 6 - MOD.ENG-73-0089

V2500-ENG-73-0089

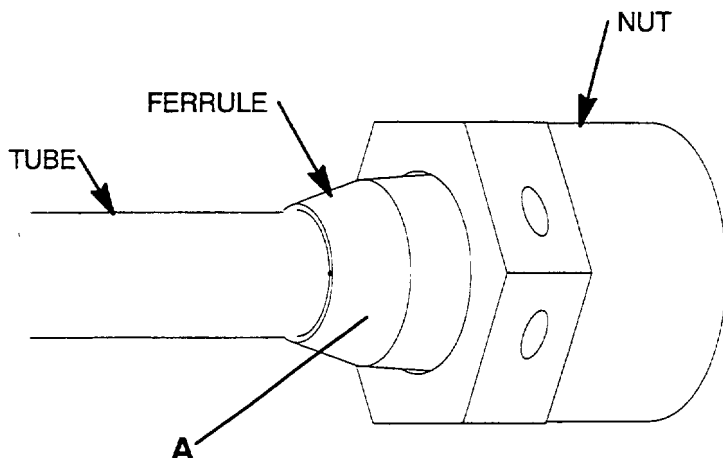
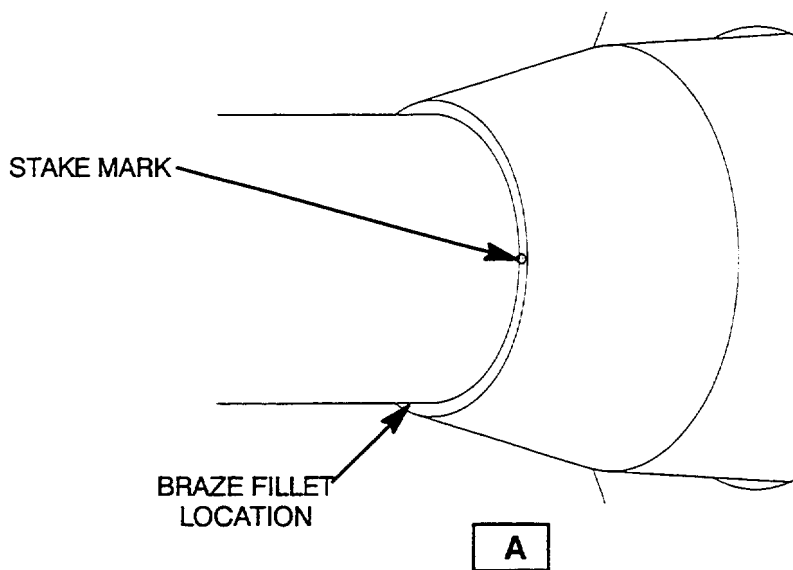
Inspection of the Fuel Nozzle Supply Manifold  
FIG.1

- (1) Do a visual inspection of the tube to ferrule braze joint, at the end furthest from the tee. You must inspect at this location.

(b) The braze joint at the ferrule furthest from the tee is the only location on each Fuel Nozzle Supply Manifold Assembly that must be inspected.

TYPICAL VIEW OF FUEL NOZZLE SUPPLY MANIFOLD  
ASSEMBLY AT TUBE NUT AND FERRULE LOCATION

VERY IMPORTANT INSPECTION LOCATIONS

(d) Replace any Fuel Nozzle Supply Manifold Assembly which has the conditions specified in steps 1. (b) or (c).

(c) Cracks in the Fuel Nozzle Supply Manifold Assemblies at this location are not acceptable. Replace any assembly that has this condition.

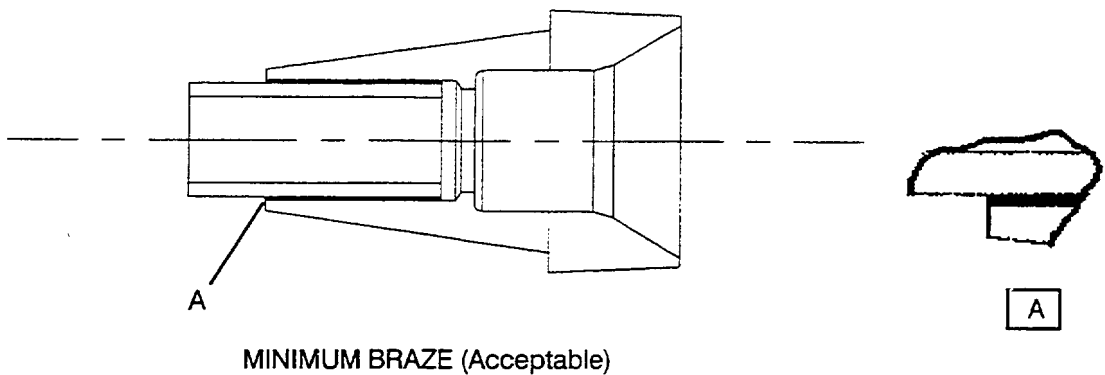
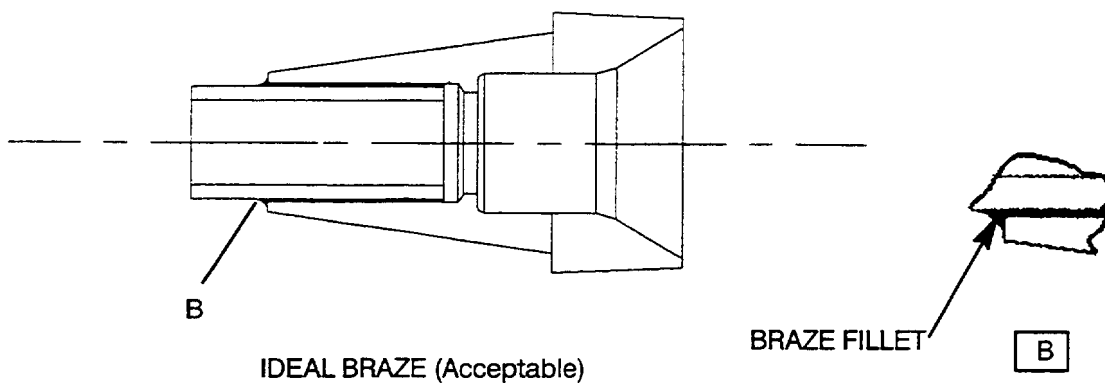
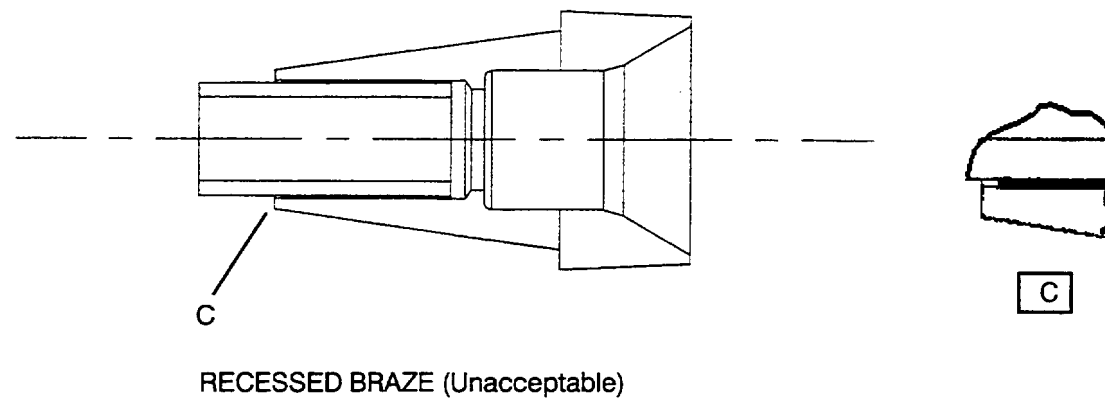
Inspection of the Fuel Nozzle Supply Manifold  
Fig.2

(c) Look for recessed braze.

NOTE: Recessed braze is braze material that does not completely fill the gap between the component parts at the joint.

- 1 The braze joint must create a smooth transition between the joined components.
