SERVICE BULLETIN

<u>OF REVISED OVERSPEED VALVE WITH INCREASED BYPASS FLOW - LUCAS FUEL SYSTEMS</u>
S.B.500-73-6968, 530-73-6968 - CATEGORY CODE 7 - MOD.ENG-73-0091

ENGINE - FUEL AND CONTROL - FUEL METERING UNIT - INTRODUCTION

OF AN OVERSPEED VALVE WITH AN INCREASED BYPASS FLOW

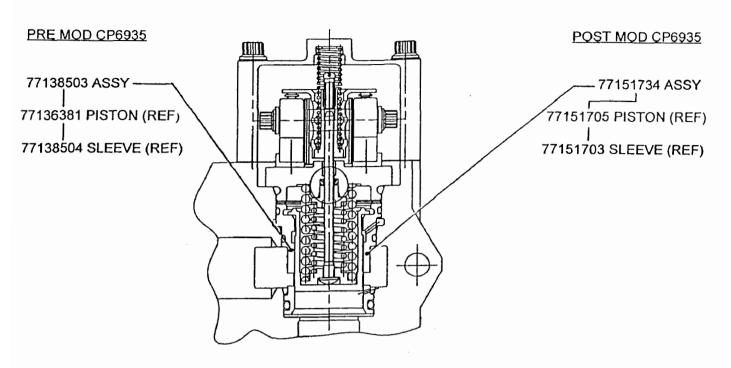
BEFORE MODIFICATION

Identification of Pre and Post CP6968 Assemblies Figure 1

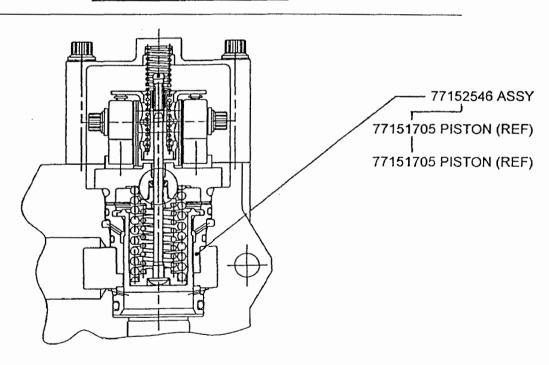
AFTER MODIFICATION

The number of bypass holes in the overspeed valve sleeve has been increased from one to four. Each hole measures 1,23/1,20mm dia (0.0485/0.0475in dia) supplying a flow rate that will conform to the customer requirement of 850 to 1050 pph at operating temperatures of -50°C to 155°C.

The additional holes will reduce the possibility of complete blockage of the overspeed valve in the event of fuel contamination.

Assemble post CP6968 parts to the FMU in accordance with the CMM (1.K. References) and Figure 1 of this Service Bulletin.

NOTE: The overspeed valve piston and the overspeed valve sleeve are a mated assembly and must be retained as a set.
