ENGINE - FUEL AND CONTROL - POWER PLANT- EEC CHANNEL A AND B HARNESSSES (LOOM A AND B) -
ENGINE DEDICATED ALTERNATOR HARNESS CONNECTORS WITH IMPROVED LOCKING FEATURE -
CATEGORY CODE 4 - MOD.ENG-73-0092

V2500-ENG-73-0092

SERVICE BULLETIN

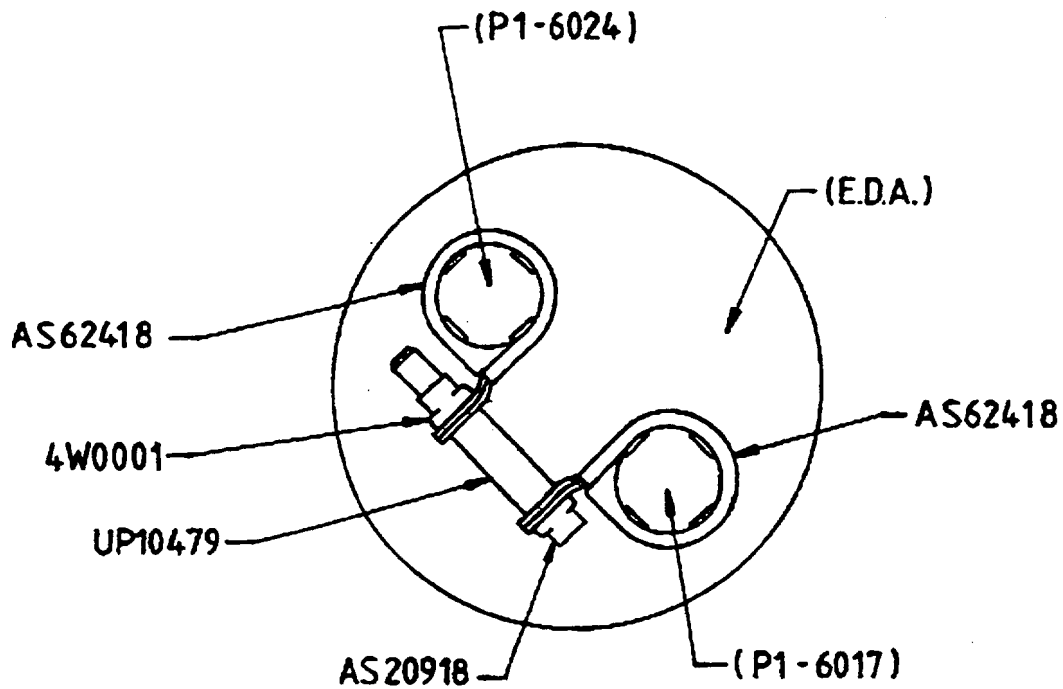
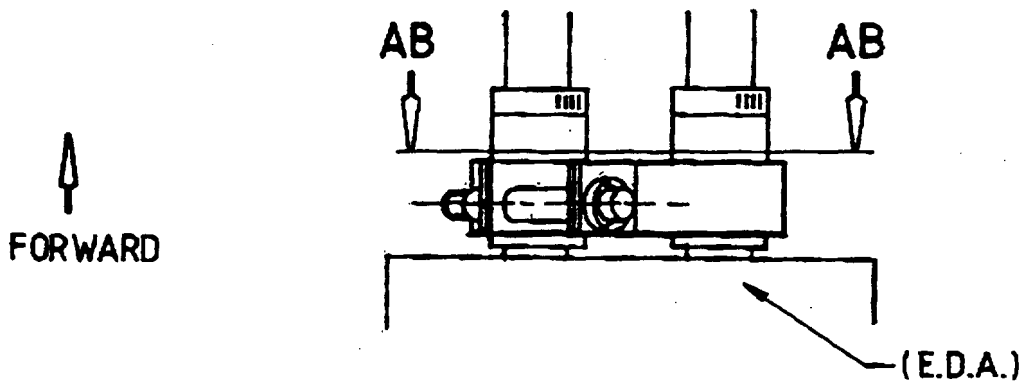
E.D.A. connection - assembly of
Fig.2

The Engine Dedicated Alternator (E.D.A.) stator connectors have suffered from faults caused by overheating and pin burning on the MD-90 installation.

A number of E.D.A. stator connections for loom A (pl-8024) and loom B (pl-8017) were found to be inadequately locked on engines in service this resulted in pin burning in the stator or the harness. In each case they were apparently undisturbed since delivery, indicating that the connectors had worked themselves loose.

SECTION AB
SHOWING CLIP POINT 2684

VIEW AT AA SHOWING THE E.D.A.

- (1) This Service Bulletin introduces back-to-back clipping fitted over the E.D.A. connector nuts P1-6017 and P1-6024 to overcome the possibility of the connectors unlocking.

- (a) Clip point 2684 is added to prevent the connector nuts unlocking.

- (1) Use soft-jaw pliers to tighten the two connectors.
- (2) Use OMat 262, marker, to make a mark on the connector nut and backshell to show if the connectors are not locked.
- (3) Put the two clips in position over the connector backshells and assemble the clips, refer to Fig.2.
- (4) Make sure the connector coupling nuts are tight.
- (5) Push the two clips over the connector coupling nuts and tighten the nut (4W0001), refer to Fig.3.
- (6) Make sure the clips are positioned correctly, then torque the clip nut (4W0001).
