DATE ~~R~~ Aug.10/01**V2500-A5/D5 PROPULSION SYSTEMS SERVICE BULLETIN**

This document transmits Revision 5 to Service Bulletin EV2500-73-0094

ENGINE – FUEL AND CONTROL – REROUTE THE LEFT AND RIGHT PRESSURE CONTROL TUBE  
ASSEMBLIES

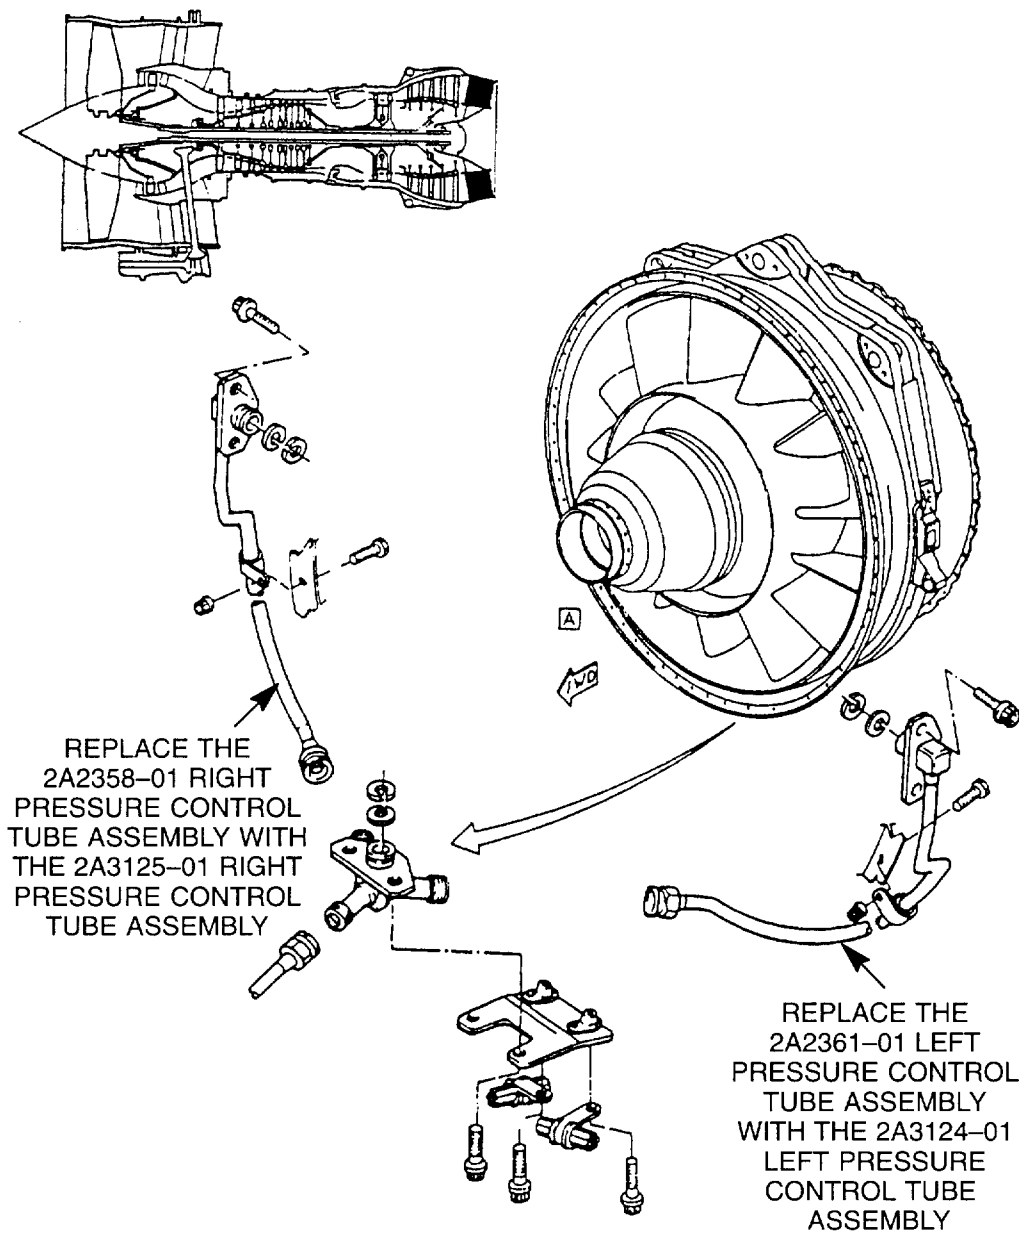
Location of the P4.9 manifolds  
Fig 1

- (1) Condition: There is a possibility of interference between the P4.9 manifolds and the nacelle thrust reverser heatshields that can lead to contact wear of the manifolds.
- (2) Background: The shape of the P4.9 Manifold Assemblies can cause contact between the Manifolds and the Nacelle Thrust Reverser Heatshields in some situations. There have been several reports of manifold wear in service run engines.
- (3) Objective: Revise the shape of the P4.9 Manifold Tube Assemblies to eliminate the possibility of interference between it and the thrust reverser heatshields.
- (4) Substantiation: The Manifold Assemblies were successfully installed and operated on flight test aircraft.
- (5) Effect of Bulletin on:
- Removal/Installation: Not affected.
- Disassembly/Assembly: Not affected.

Install a new set of P4.9 Manifold Assemblies.
