International Aero Engines SERVICE BULLETIN

ENGINE FUEL AND CONTROL - DEDICATED ALTERNATOR
(STATOR) - INTRODUCTION OF REVISED RECEPTACLES

V2525-D5
V2528-D5

V2500-ENG-73-0096

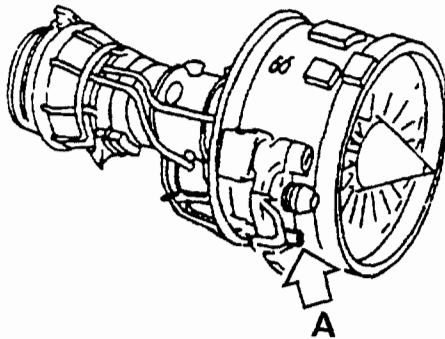
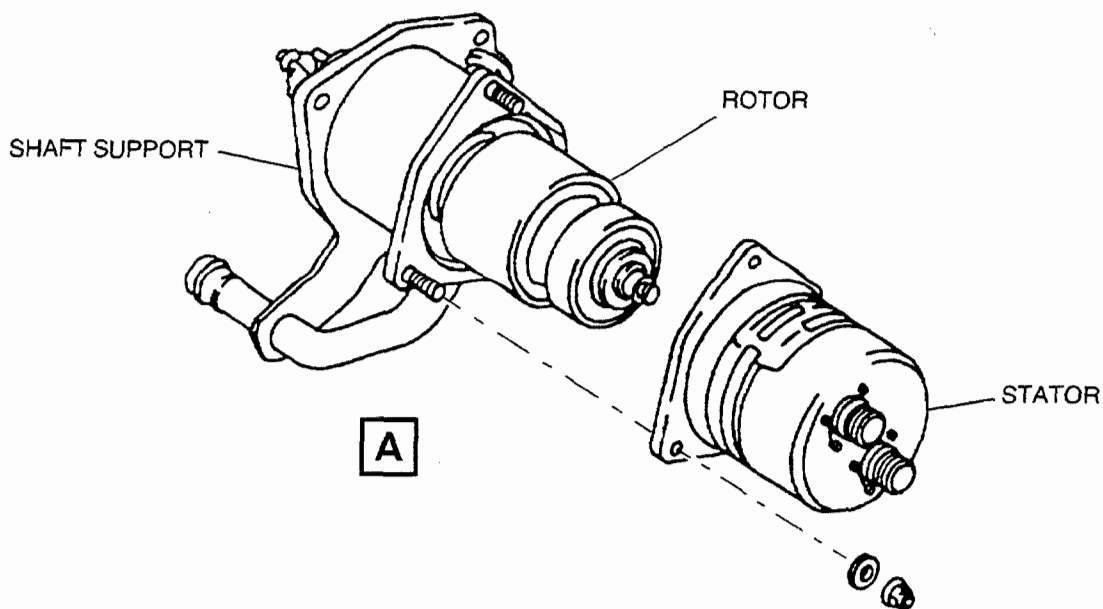
General view
Fig 1

Inadequate locking of the Engine Dedicated Alternator (EDA) stator connectors for Loom A and Loom B has led to an unacceptably high incidence of pin burning and connector overheating.

A revised Engine Dedicated Alternator (EDA) stator is introduced similar to the existing stator but with receptacles that feature improved locking features.

- (1) Install the revised Engine Dedicated Alternator using the approved procedures, Ref. Aircraft Maintenance Manual, Chapter/Section 73-22-38, Removal/Installation.
