SERVICE BULLETIN

ENGINE – FUEL AND CONTROL – ENGINE FUEL AND CONTROL – FUEL SYSTEM TUBES – ENGINE –
INTRODUCTION OF A REVISED TUBE ASSEMBLY WITH MATERIAL CHANGE AND REVISED CLIPPING –
CATEGORY CODE 6 – MOD.ENG-73-0102

V2500-ENG-73-0102

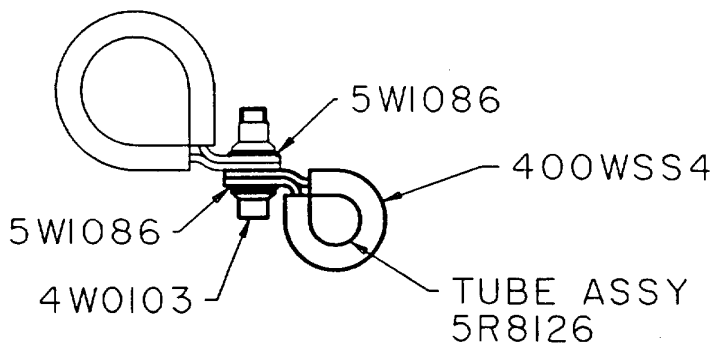
SCHEMATIC VIEW OF CLIP
POINT 1049 BEFORE CHANGE

Early deterioration of the fuel tube assembly between the FMU and the ACOC can occur.

Fretage can occur between the Fuel Metering Unit to ACOC fuel tube assembly and the supporting silicon cushion clips.

(b) Clip point CP1049 has changed, the changes are as follows:

- (i) The clip that holds the fuel tube assembly is deleted.
- (ii) The length of the bolt has been increased.
- (iii) Another spacer has been added.
