ENGINE - FUEL AND CONTROL - ENGINE FUEL AND CONTROL - FUEL METERING UNIT - INTRODUCTION
OF FUEL METERING UNIT WITH REVISED HP SOV TORQUEMOTOR - CATEGORY CODE 7 -
MOD.ENG-73-0107

V2500-ENG-73-0107

NUMBER FMU 530-73-8037

ENGINE - FUEL AND CONTROL - FUEL METERING UNIT - INTRODUCTION OF THE SERVOVALVE-SOV WITH 87 OHM MINIMUM COCKPIT COIL WINDINGS

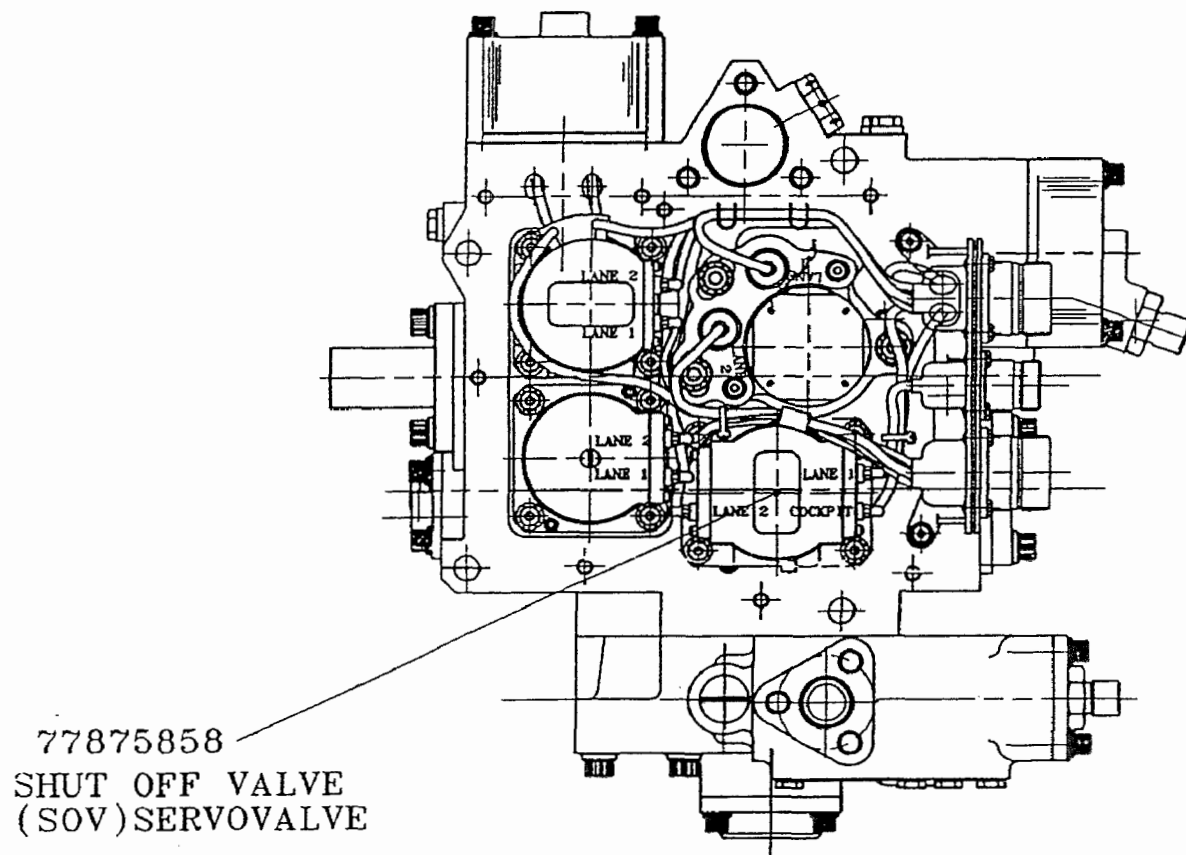
BEFORE MODIFICATION

The resistance of the two parallel cockpit/pilot coils of the servovalve-SOV (shut off valve) can change. It is possible for the engine not to stop or the circuit breakers can trip.
- (2) Background

This Service Bulletin (Modification) introduces a servovalve-SOV with an increased number of winding turns on the two parallel "cockpit/pilot" coils. Each coil has a minimum resistance of 87 Ohm.

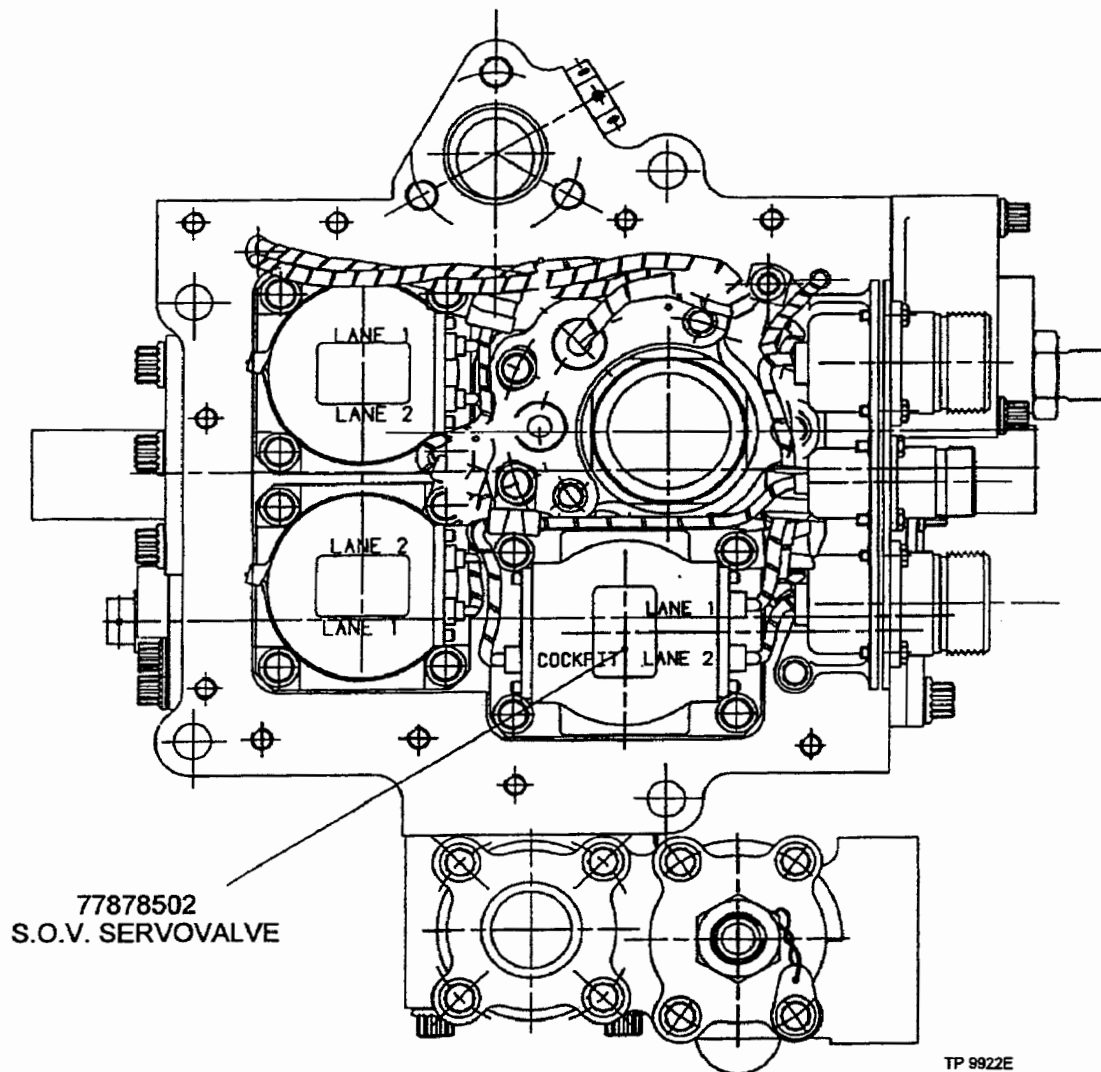
BEFORE MODIFICATION

The resistance of the two parallel cockpit/pilot coils of the servovalve-SOV (shut-off valve) can change. It is possible for the engine not to stop or the circuit breakers can trip.

This Service Bulletin (Modification) introduces a servovalve-SOV with an increased number of winding turns on the two parallel "cockpit/pilot" coils. Each coil has a minimum resistance of 87 Ohm.
