# SERVICE BULLETIN

ENGINE - FUEL AND CONTROL - ENGINE FUEL AND CONTROL - FUEL SYSTEM TUBES - ENGINE -  
INTRODUCTION OF REVISED EXTERNAL FUEL TUBE ASSEMBLY WITH WELDED-IN LUG AND AMENDED  
CLIPPING - CATEGORY CODE 7 - MOD.ENG-73-0115

V2500-ENG-73-0115

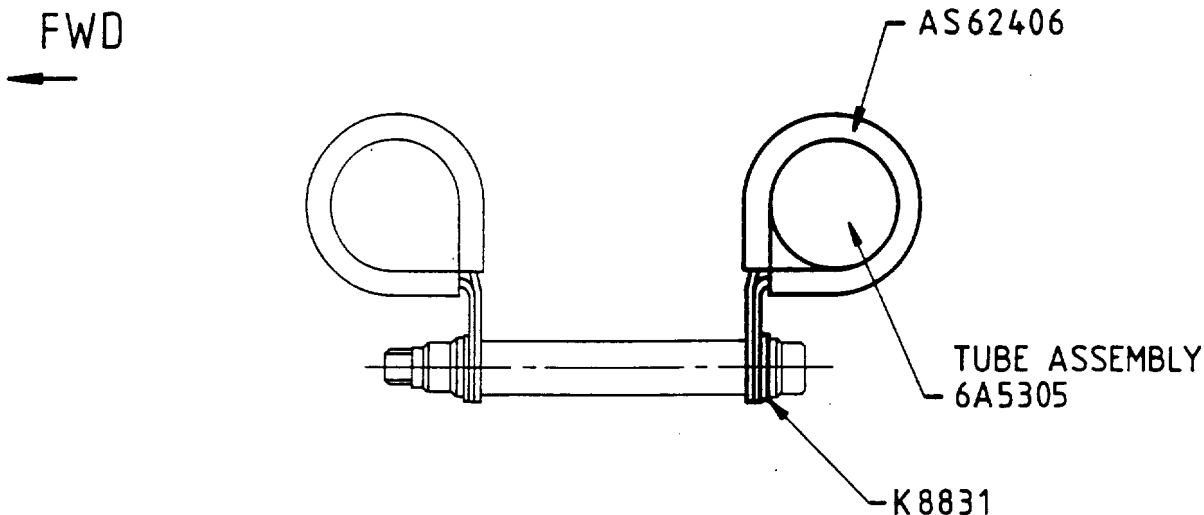
BEFORE ALTERATION

Wear of the HP servo fuel-tube can occur at clip point CP5747. To stop the wear, a clip lug has been welded on the tube at the correct position for CP5747.
