ENGINE - FUEL AND CONTROL - ENGINE FUEL AND CONTROL - FUEL SYSTEM TUBES - INTRODUCTION  
OF REVISED HP SERVO EXTERNAL FUEL TUBE ASSEMBLY WITH WELDED-IN LUG AND AMENDED CLIPPING  
- CATEGORY CODE 7 - MOD.ENG-73-0116

V2500-ENG-73-0116

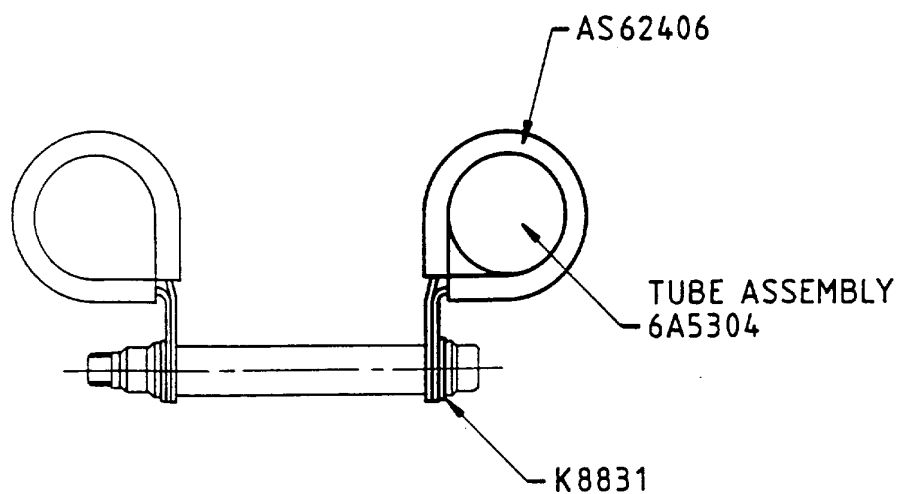
CP5747 BEFORE ALTERATION

To attach the HP-servo external fuel-tube assembly to clip point CP5747 by a better method, design changes must be made.

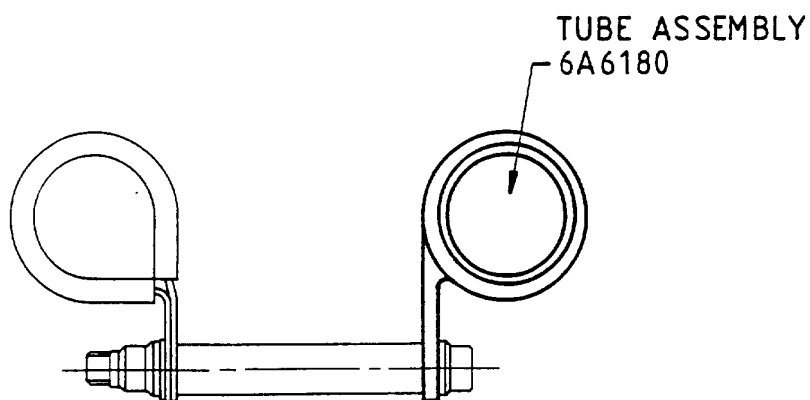
CP5747 AFTER ALTERATION

- (a) The HP-servo fuel-tube assembly is changed. A welded-in lug has been added to give a fixed position for clipping point CP5747.
- (b) Clip points CP5747 and CP6058 have changed.
- (c) The ATA Fig Item numbers for the end connectors and nuts, within the HP-servo fuel-tube assembly have changed. This change has no effect on the hardware.

- (1) This modification introduces a different method to attach the HP-servo fuel-tube assembly to clip point CP5747 by the addition of a permanent fixed location point.
