V2500-A5/D5 SERIES PROPULSION SYSTEMS SERVICE BULLETIN

This document transmits Revision 1 to Service Bulletin EV2500-73-0124

V2500-ENG-73-0124

ENGINE – WOODWARD GOVERNOR COMPANY (WGC) FUEL METERING UNIT – SHUT-OFF VALVE AND
OVERSPEED VALVE SERVO VALVE – ONE-TIME INSPECTION – NON-MODIFICATION SERVICE BULLETIN

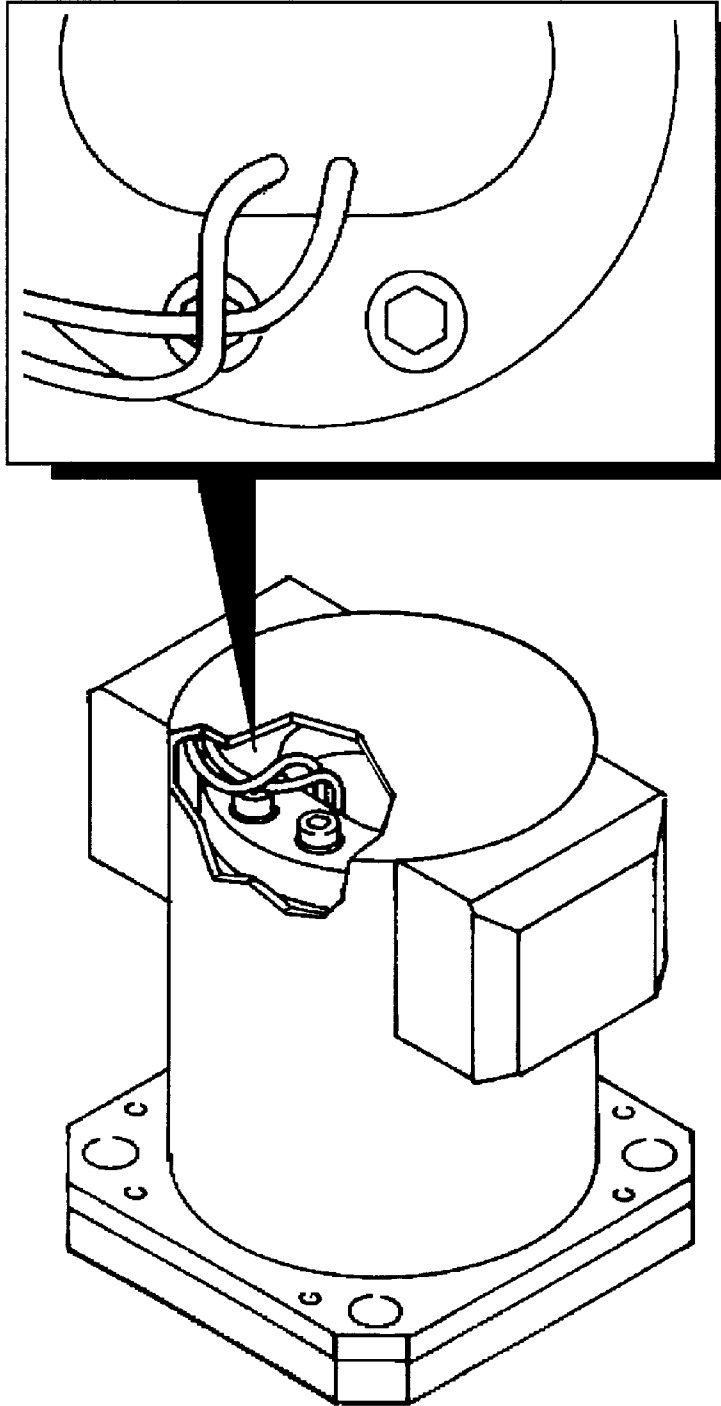
Inspection of servovalve X-Rays
Fig 3 sheet 1

A low insulation resistance reading in an FMU caused an FMU single channel failure. An investigation of the failure found trapped leadwires of the HP Shut-Off Valve servo valve due to mis-assembly.

Reject the FMU if it is found that two leadwires from either servo valve are crossed on top of each other over a screw head and pinched. If the X-Rays do not give the right results, reject the FMU and return it to Woodward for more inspection using real-time X-Ray. Refer to Figure 3 Sheet 1.

Reject the FMU if it is determined that two leadwires from either servo valve are crossed on top of each other over a screw head and pinched. If the X-Rays do not give the right results reject the FMU, and return it to Woodward for additional inspection using real-time X-Ray. Refer to Figure 3 Sheet 1.

NOT ACCEPTABLE

A rejected FMU will be exchanged for a known serviceable FMU and returned to WGC for rework.

Rejected FMU will be exchanged for a known serviceable FMU and returned to WGC for rework.

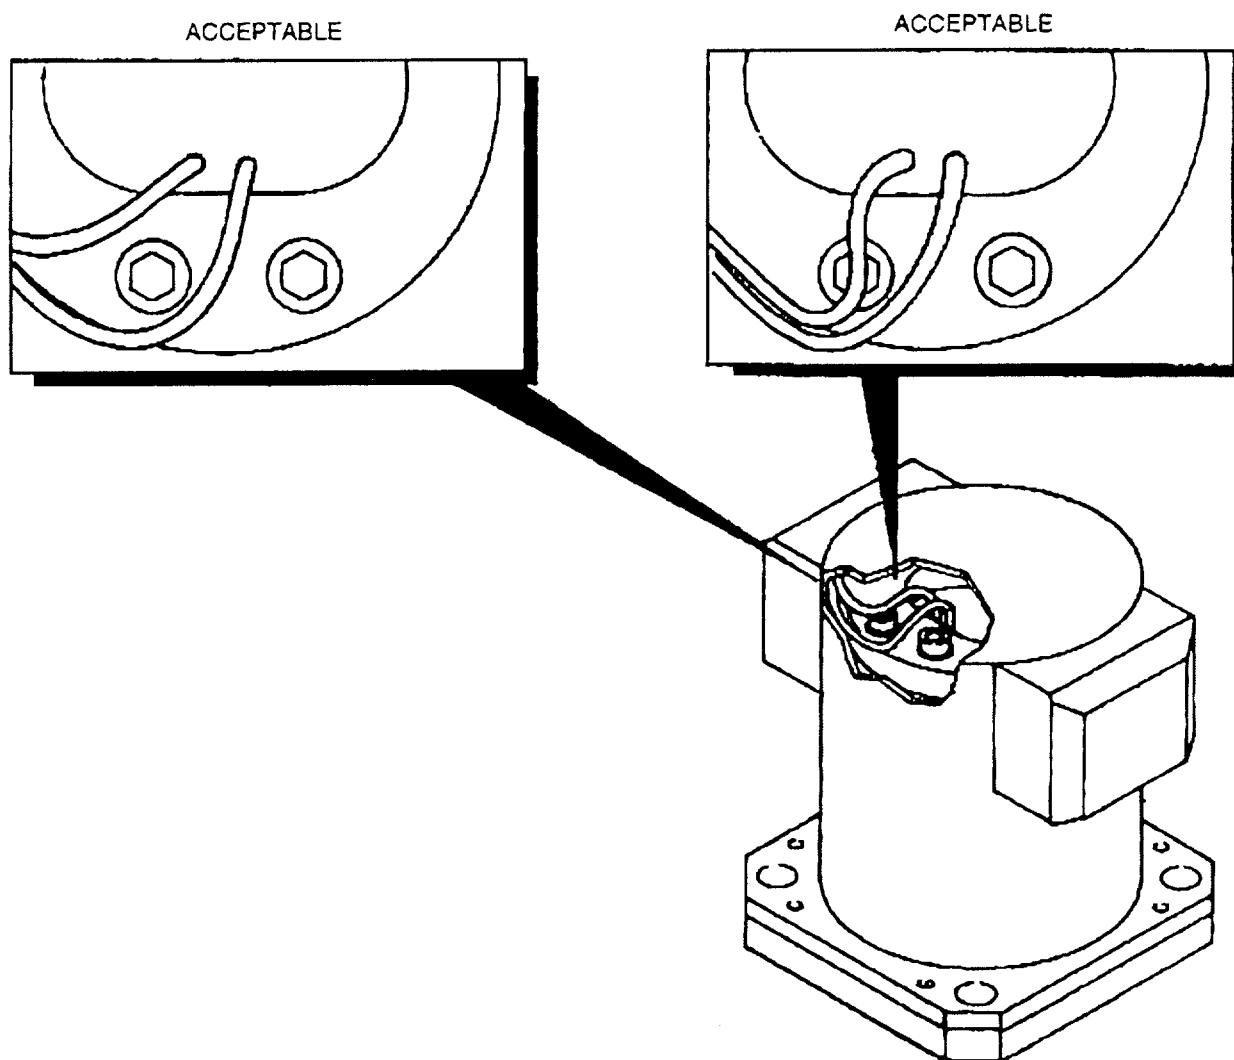
Inspection of servovalve X-Rays
Fig 3 sheet 2

Any number of wires over the screw heads, if no wires are crossed and on top of each other when they are over a screw head. Refer to Figure 3 Sheet 2.
