DATE ~~R~~ Mar. 6/03**V2500-A5 PROPULSION SYSTEMS SERVICE BULLETIN**

V2500-ENG-73-0128
 Transmittal - Page 1 of 2

ENGINE FUEL AND CONTROL – FUEL SYSTEM AIR TUBES – INTRODUCTION OF HEAT RESISTANT CLIPS FOR THE PB SENSE-LINE TUBE ASSEMBLY AND THE DELETION OF A CLIP AT CP6094

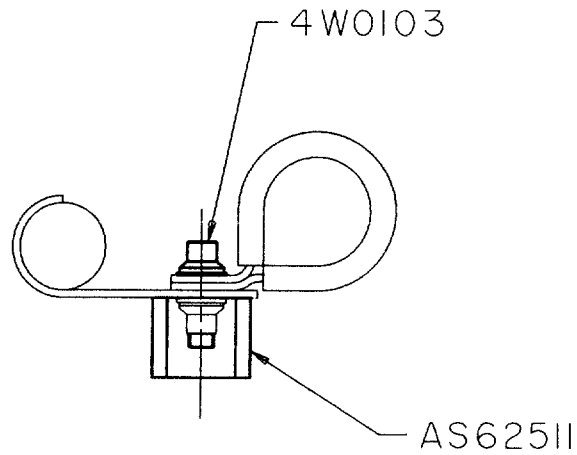
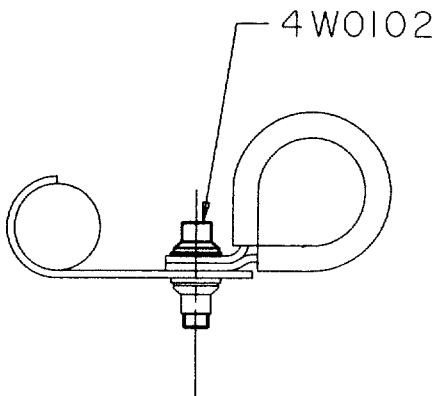
Clip Point CP6094 Before and After Alteration
Figure 1

Also, insufficient clearance can exist between the cushion on a clip at CP6094 limb connector NP4009VC and the adjacent EEc core harness.

To increase the clearance, the clip (AS62511, Figure 1) that supports the EEC core-harness limb to the bifurcation panel connector NM4008VC at clip point CP6094 has been deleted.
