Subject: Transmittal of Revision 4 to Service Bulletin V2500-ENG-73-0130.

ENGINE - FUEL AND CONTROL - FUEL SYSTEM AIR TUBES - INTRODUCTION OF REVISED PB  
SENSE LINE TUBES WITH INCREASED DIAMETER

V2525-D5

# V2500-ENG-73-0130

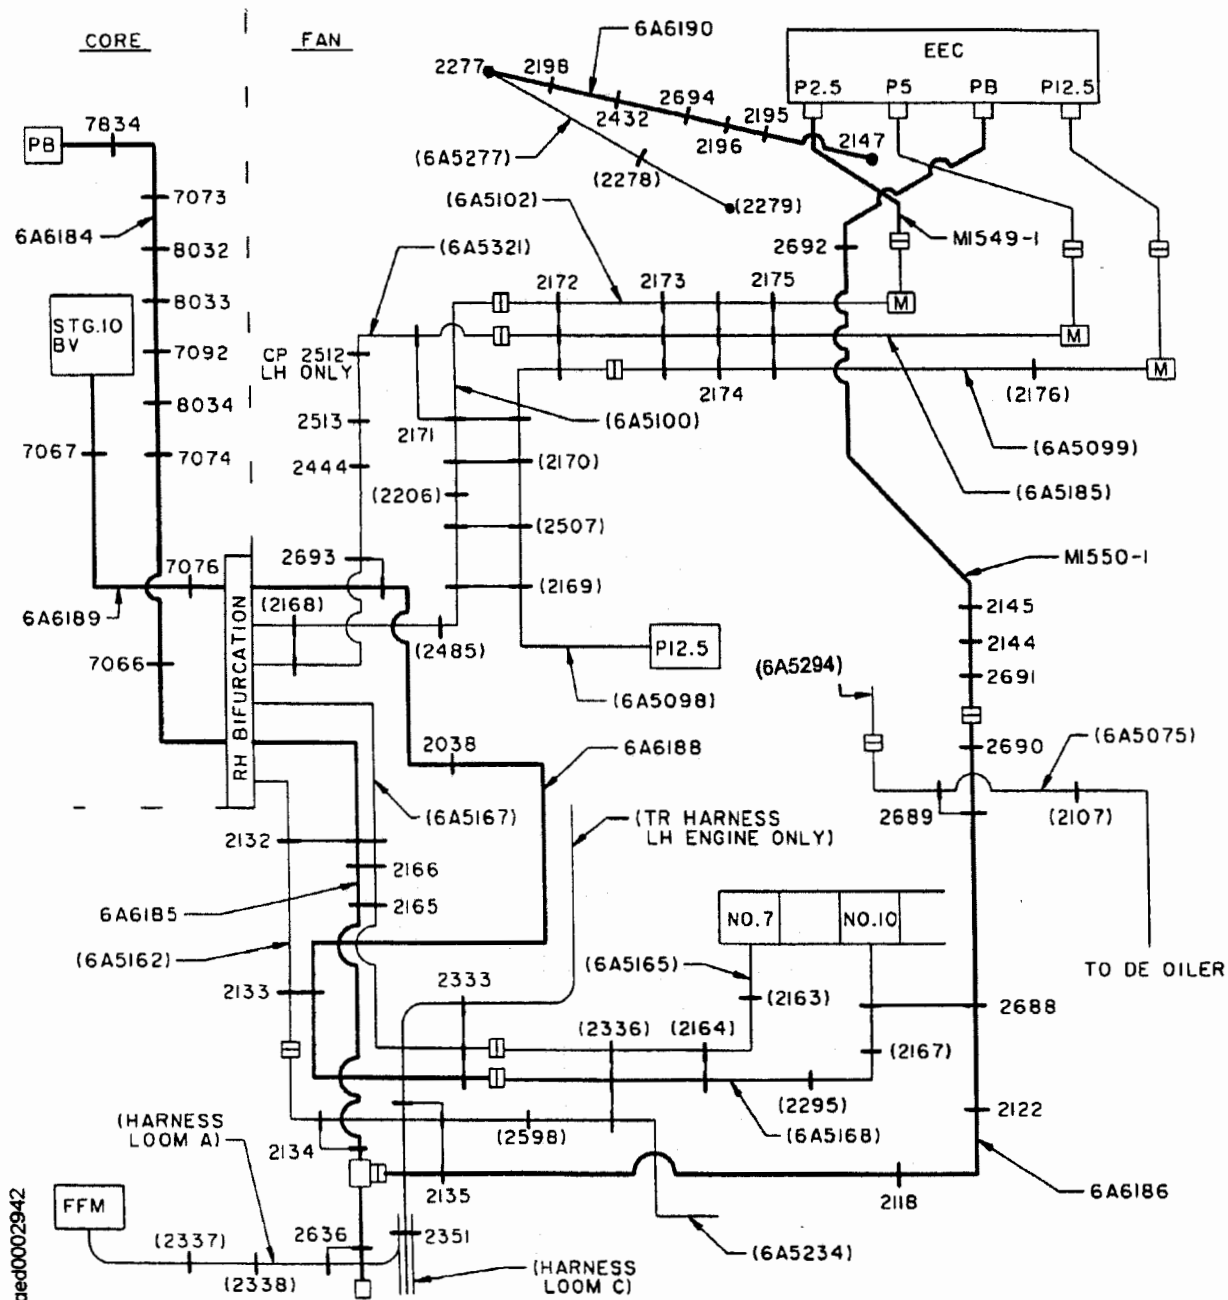
Figure 5  
Schematic view of affected tubes and raceways - After alteration

- (1) This Service Bulletin introduces a different run for the Pb sense line tubes. The run goes from the EEC to a different moisture trap at the lowest part of the run. The run then goes from the moisture trap to the bifurcation panel. The diameter of the tubes has increased to make the flow of water to the moisture trap easier. The changes are as follows:

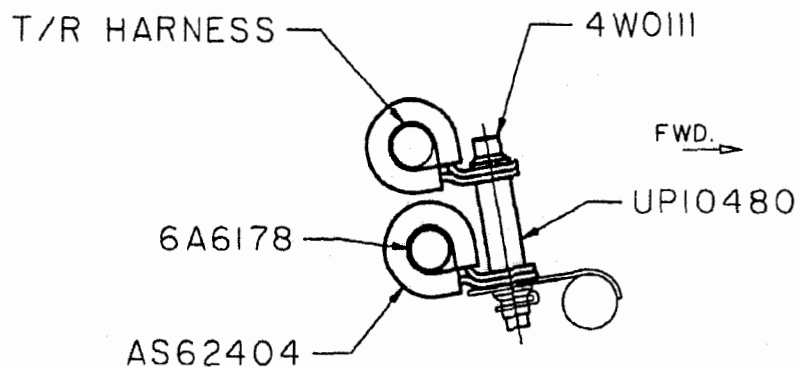
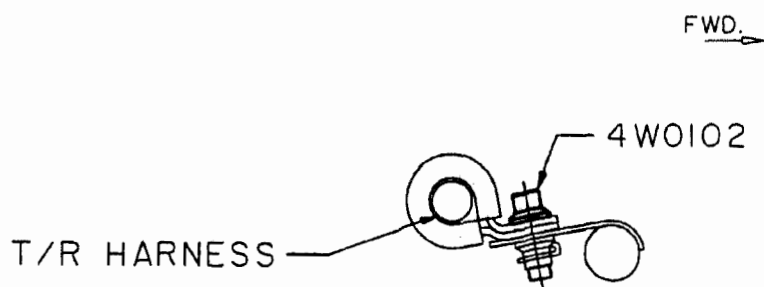
(i) CP2512 has been changed and is only applicable to the left hand engine.

THIS CLIP POINT IS DELETED FOR NEUTRAL INSTALLATION
