**International  
Aero Engines**

V2500 Propulsion System — Engine

Subject: Transmittal of Revision 1 to Service Bulletin Number V2500-ENG-73-0135

## ENGINE - POWERPLANT - REWORK OF THE TERMINAL BLOCK ASSEMBLY

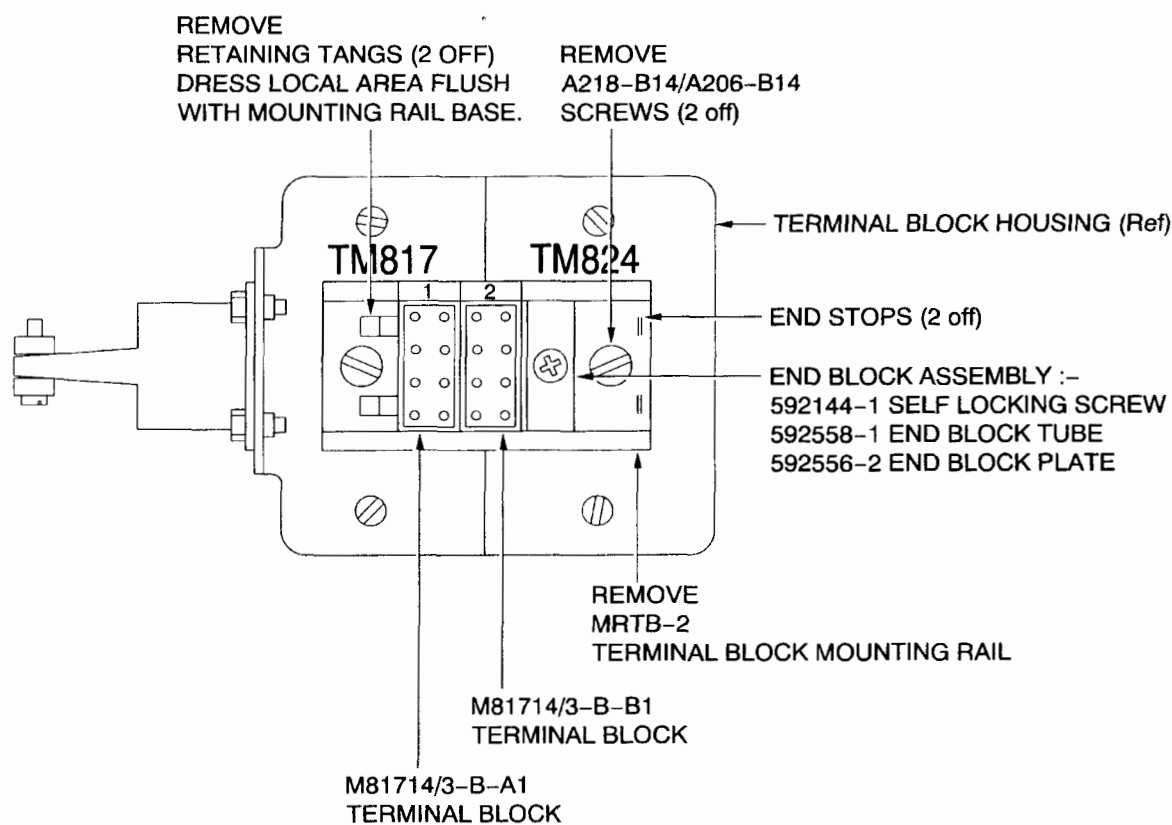
REWORK OF TERMINAL BLOCK ASSY  
FIGURE 1 SHEET 2

The Tangs that hold the Terminal Blocks in place inside the Terminal Block Assembly may chafe and cause fretting of the Terminal Block.

- (6) Carefully remove the Mounting Rail from the Terminal Block Housing.
- (7) Carefully break off the Mounting Rail Tangs from the Mounting Rail and make the remaining stems of the Tangs level with the Mounting Rail Base. Remove all sharp edges.
