International Aero Engines

SERVICE BULLETIN

ENGINE FUEL AND CONTROL - FUEL SYSTEM AIR TUBES - INTRODUCTION OF REVISED EEC
PIPE-SUPPORT BRACKET

V2500-ENG-73-0140

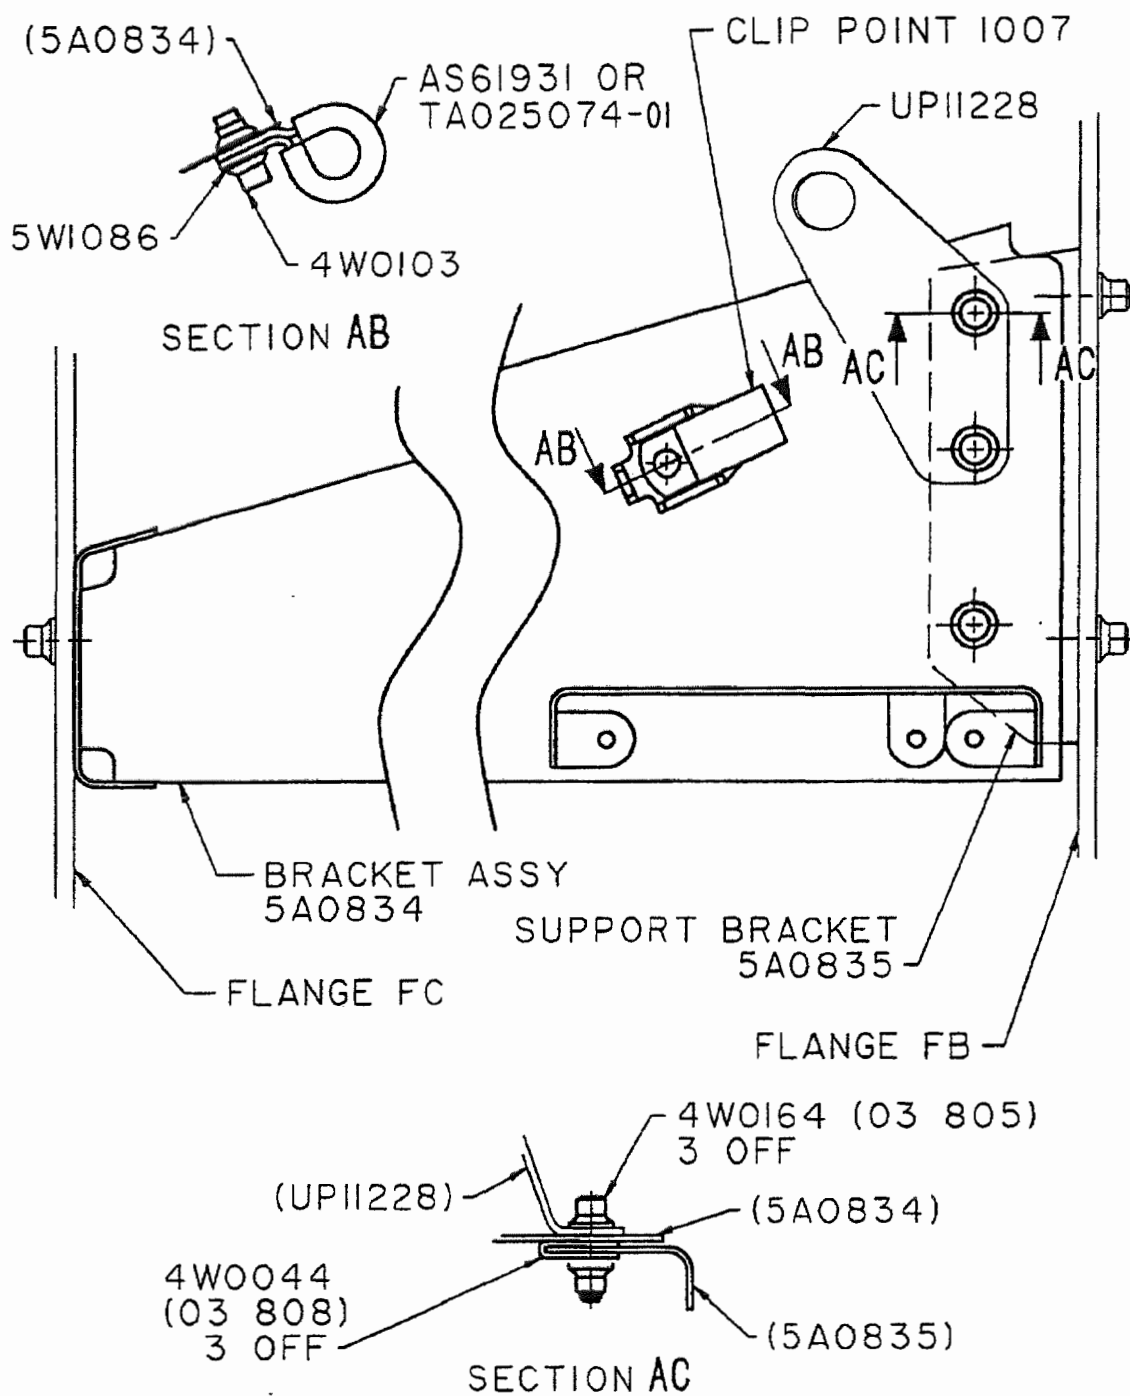
View of Fuel Systems Air-Tubes Bracket - Before alteration
Figure 1

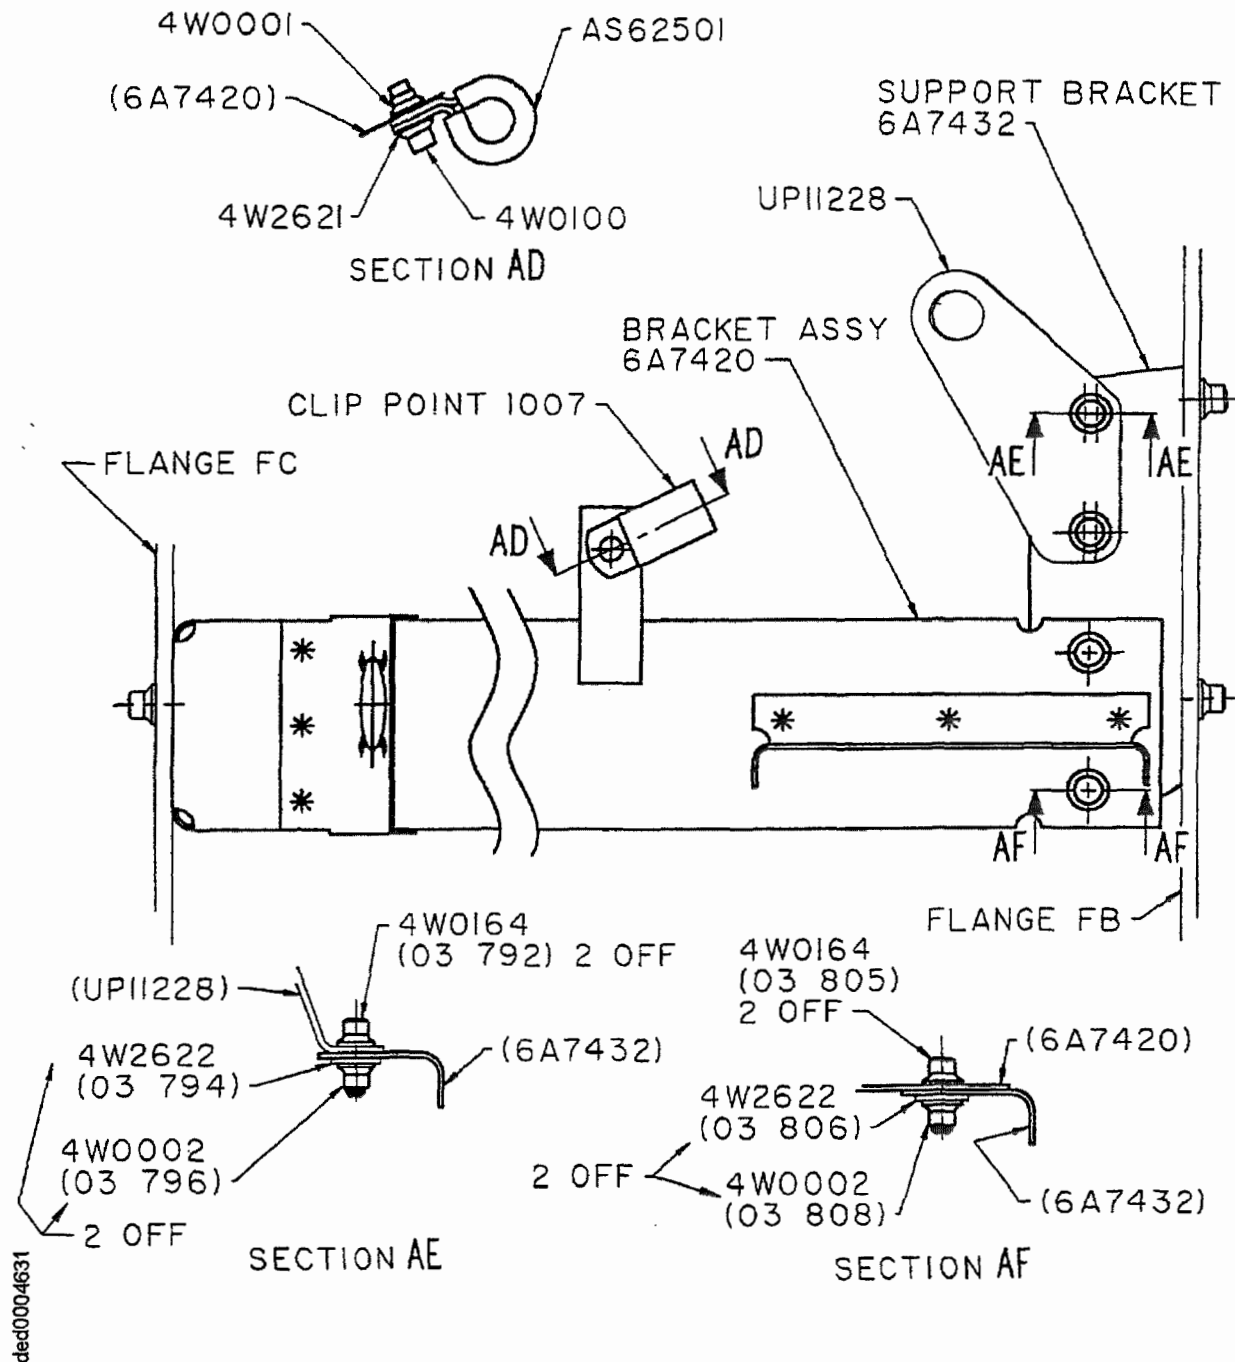
View of Fuel Systems Air-Tubes Bracket - After alteration
Figure 2

- (2) The EEC Pipe-support bracket has been revised, the changes introduced are as follows:
 - (a) The method of manufacture has changed. The component is fabricated by spot and fillet welding, not rivets which are deleted.

- (b) The material has changed from Titanium (TCA) to Stainless Steel (EBM).
 - (c) The profile of the bracket has changed from triangular to rectangular.

- (d) Due to the profile change the anti-rotation lug and anchor nut used to attach clip point CP1007 has been deleted and an additional Spur-bracket has been welded on.

- (e) The number of holes for attaching the L-Shaped fixing bracket at flange FB have decreased from three to two. In addition, the slots have been changed to holes.
